## **APPENDIX F-4: HAZARDOUS, TOXIC, AND RADIOACTIVE WASTE (HTRW)**

### UPDATE MEMORANDUM HAZARDOUS, TOXIC, AND RADIOACTIVE WASTE (HTRW) EVALUATION SUPPLEMENT NO. 2 TO THE 1982 YAZOO AREA PUMP PROJECT FINAL ENVIRONMENTAL IMPACT STATEMENT

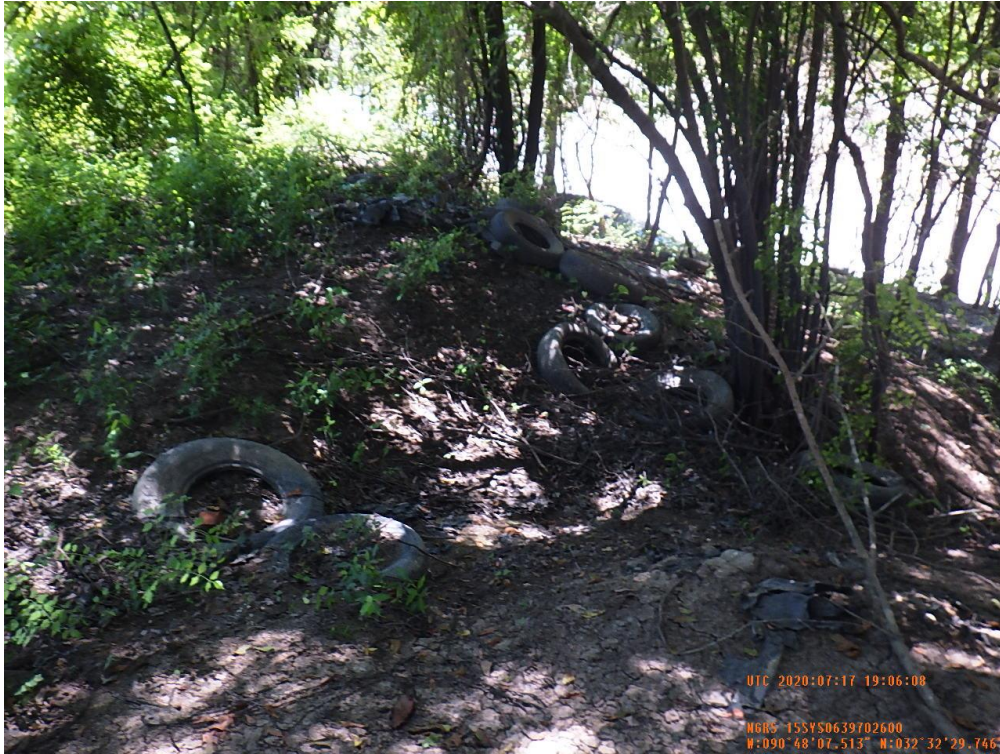
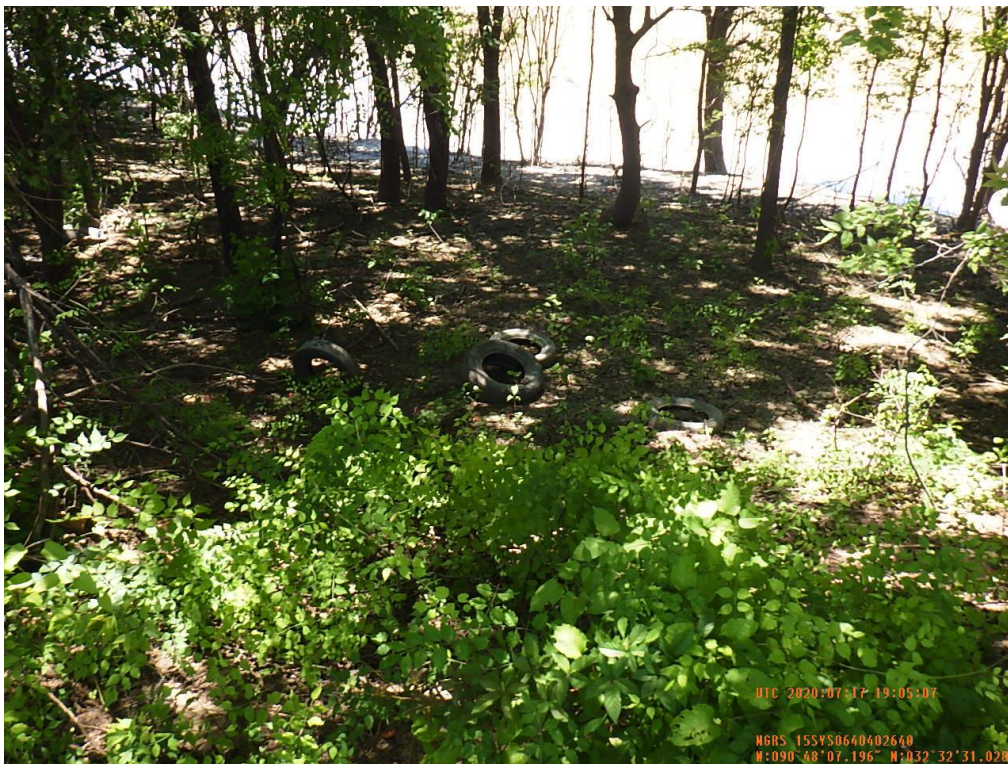
pens, fencing, feed and watering troughs for cattle were observed within the footprint of the pump station ROW. Several used tires were observed along the left descending bank of the auxiliary channel at the proposed location of the pump station inlet channel (Figures 1-2). Remnants of an old barn were observed in the wooded area of the southeast corner of the pump station ROW (Figures 3-5). Old farm implements were observed scattered in the wooded area around the partially dilapidated site (Figure 6). A large cylindrical tank and a rusted truck frame were also observed at the old barn site (Figures 7-8). The tank appeared to be out of use. Random debris was observed along the southern bank of the old Deer Creek channel which leads to the Yazoo River (Figures 9-10). Pictures were taken of areas within the Pump Station ROW which represent the typical landscape of the proposed work area (Figures 11-14).

**Figure 1. Used tires observed along the bank of the auxiliary channel at the proposed location of the pump station inlet channel.**

**Figure 2. Used tires observed along the bank of the auxiliary channel at the proposed location of the pump station inlet channel.**

It is recommended that the large quantity of used tires found along the left descending bank of the auxiliary channel be removed and disposed of at an approved disposal facility before construction of the inlet channel would commence. It is also recommended that the wooded area delineated in the southeast corner of the pump station ROW (approximately 2 acres) be excised

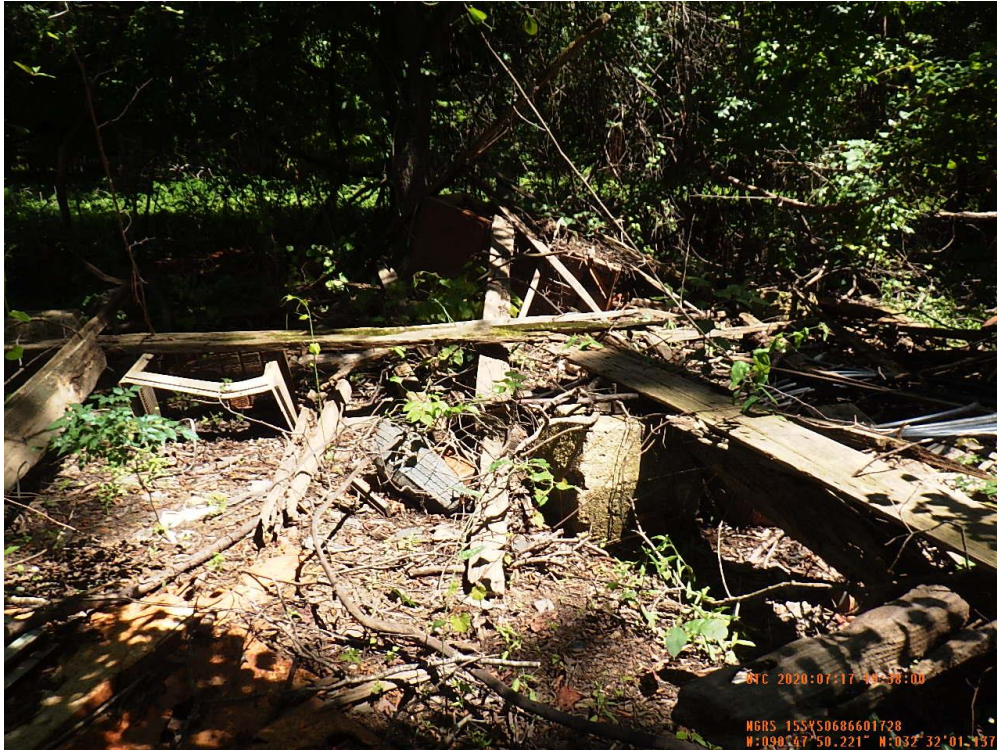
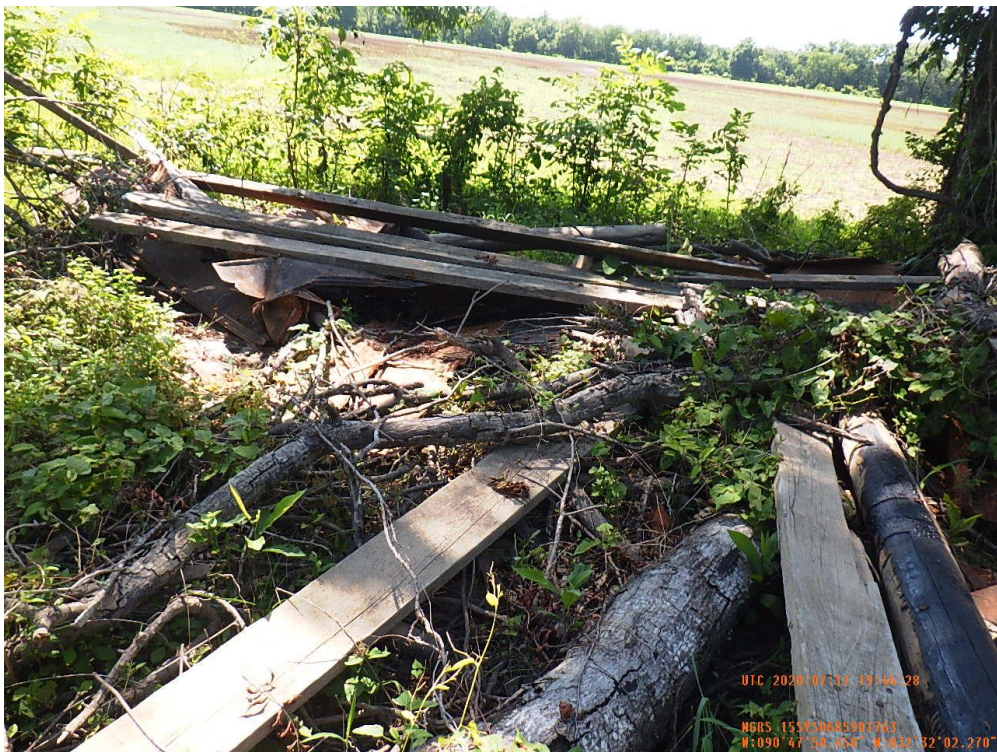
**Figure 3. Old structure (collapsed) observed in the southeast corner of the pump station ROW.**

**Figure 4. Old structure (collapsed) observed in the southeast corner of the pump station ROW.**

from the ROW limits of construction in an effort to avoid the dilapidated barn site where the large cylindrical tank, rusted truck frame, and rusted farm implements were observed.

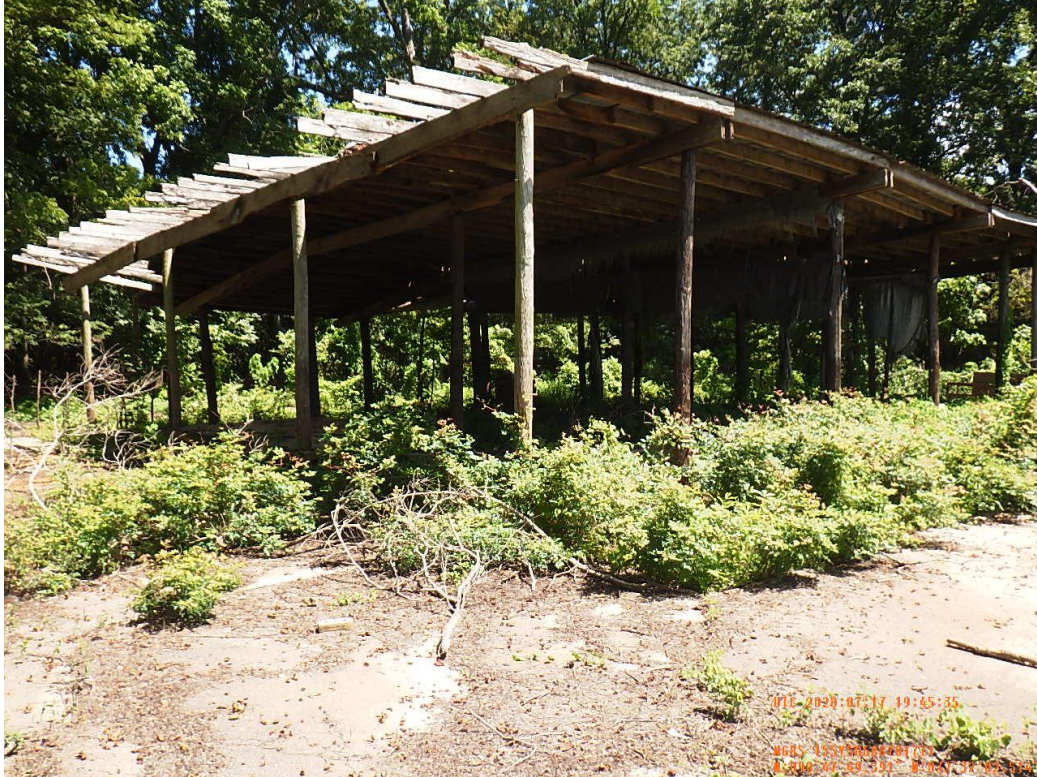
**Figure 5. Existing shed observed in the southeast corner of the pump station ROW.**

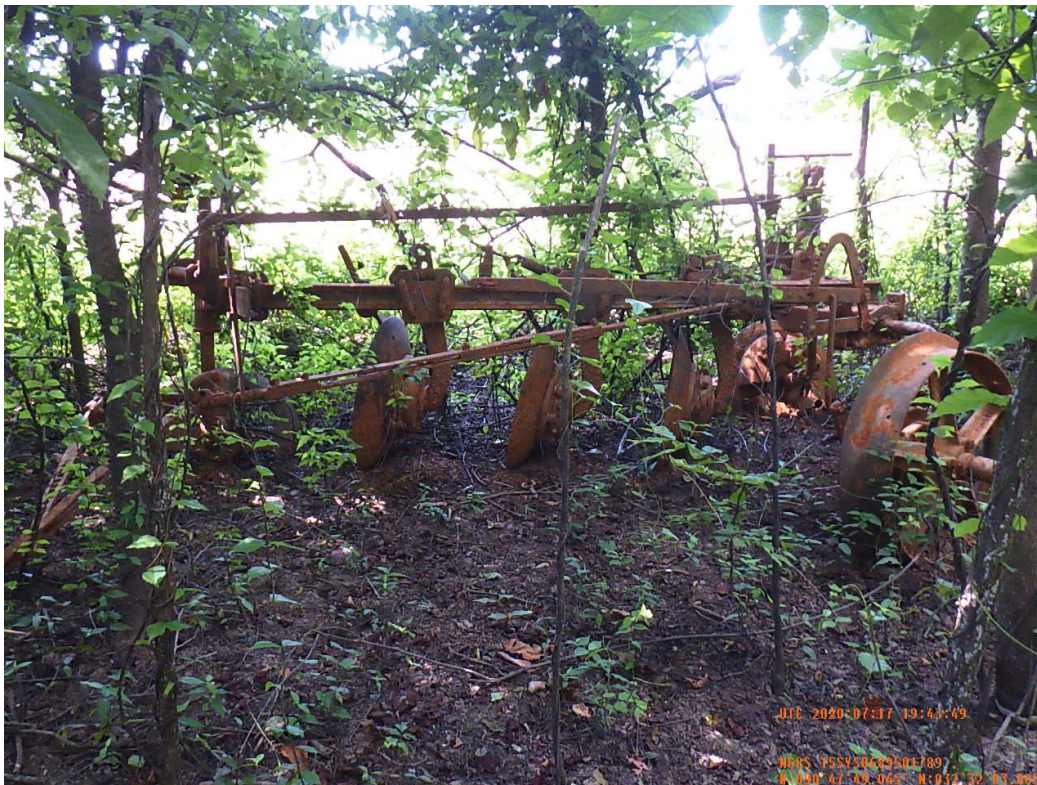
**Figure 6. Tractor implement observed in wooded area in the southeast corner of the pump station ROW.**

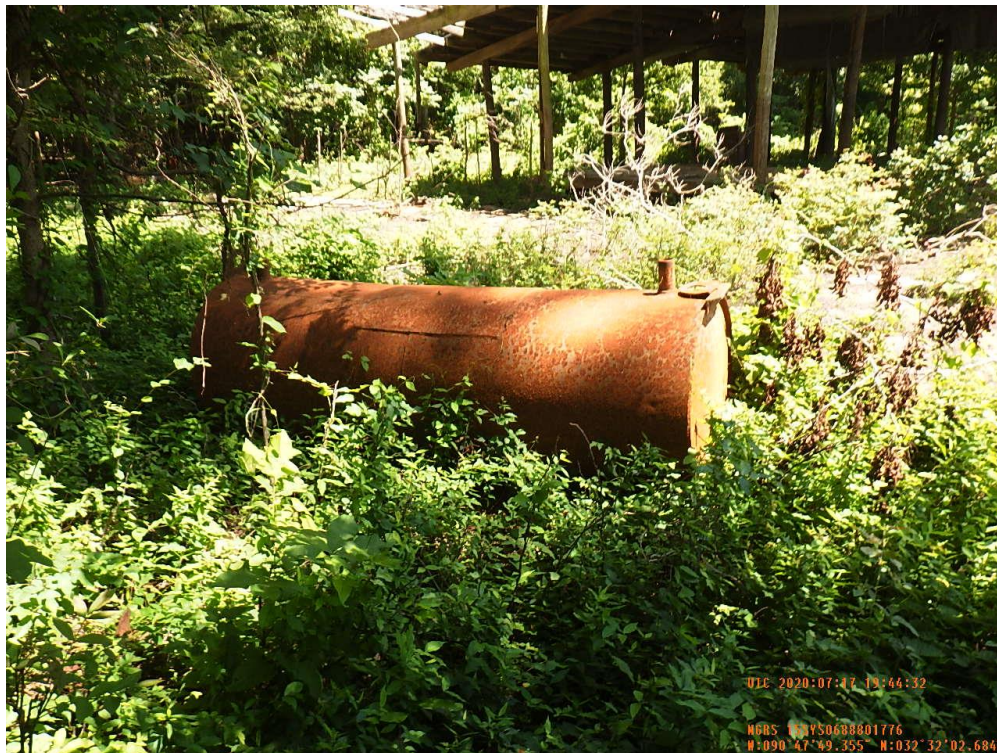
**Figure 7. Large cylindrical tank observed adjacent to existing shed in the southeast corner of the pump station ROW.**

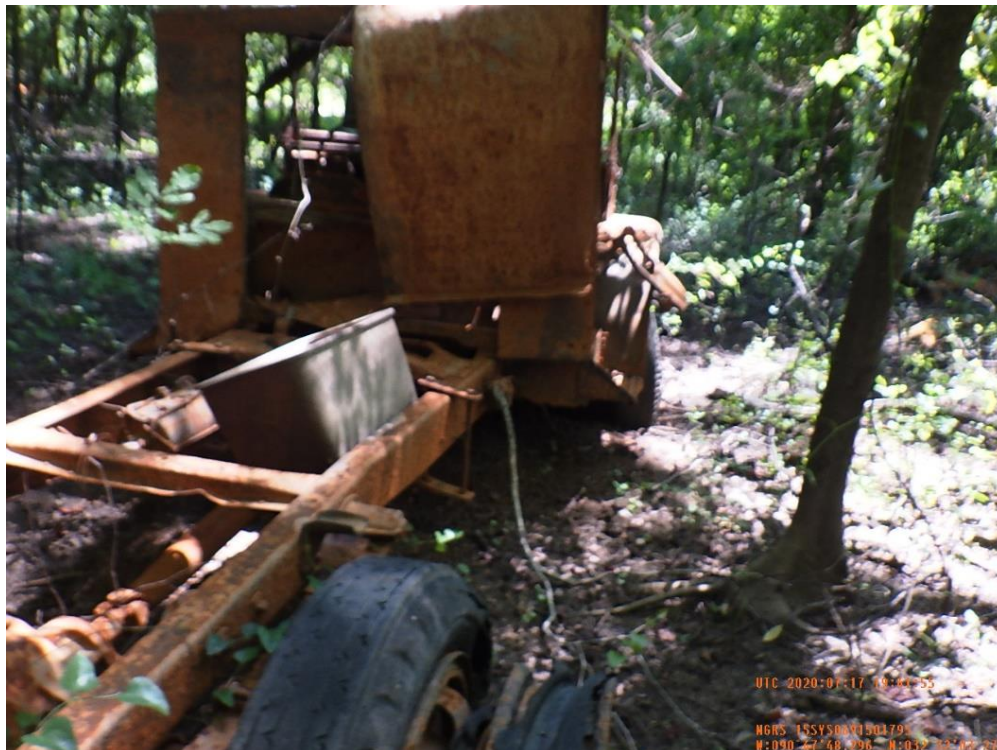
**Figure 8. Old truck observed in wooded area in the southeast corner of the pump station ROW.**

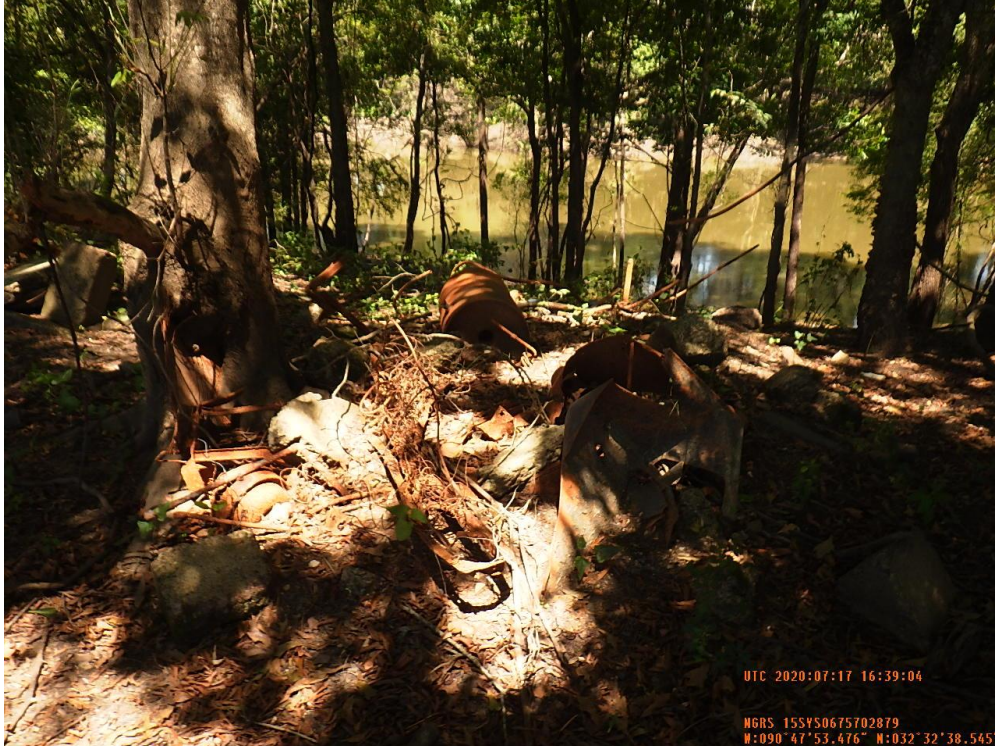
**Figure 9. Rusted debris observed along the southern bank of the old Deer Creek channel which leads to the Yazoo River.**

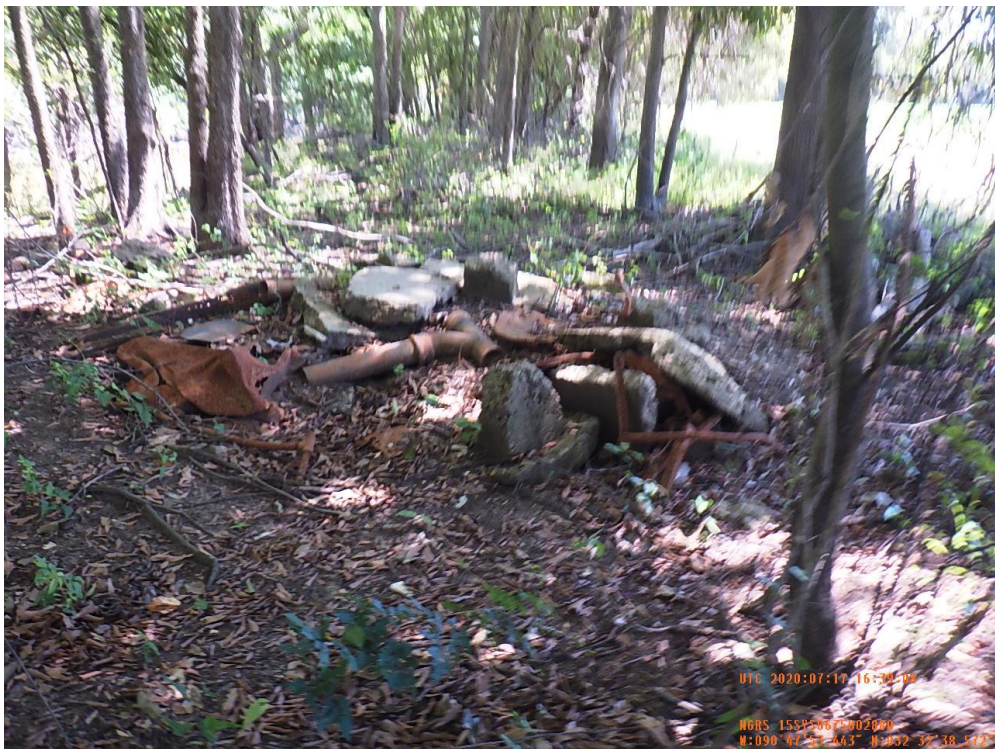
**Figure 10. Debris observed along the southern bank of the old Deer Creek channel which leads to the Yazoo River.**

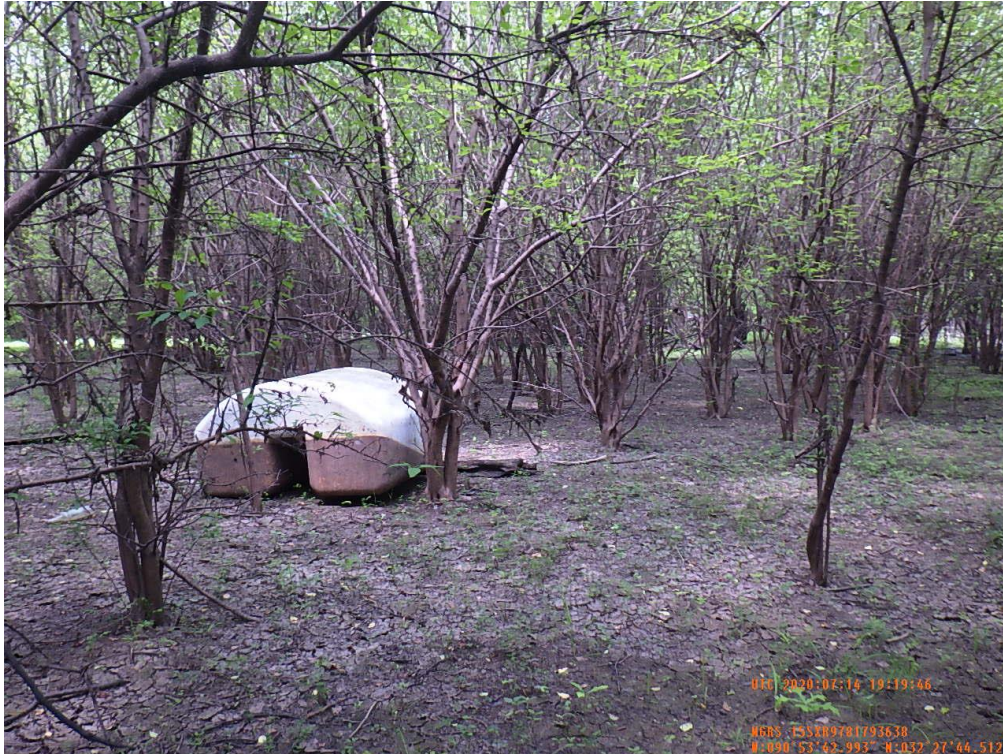
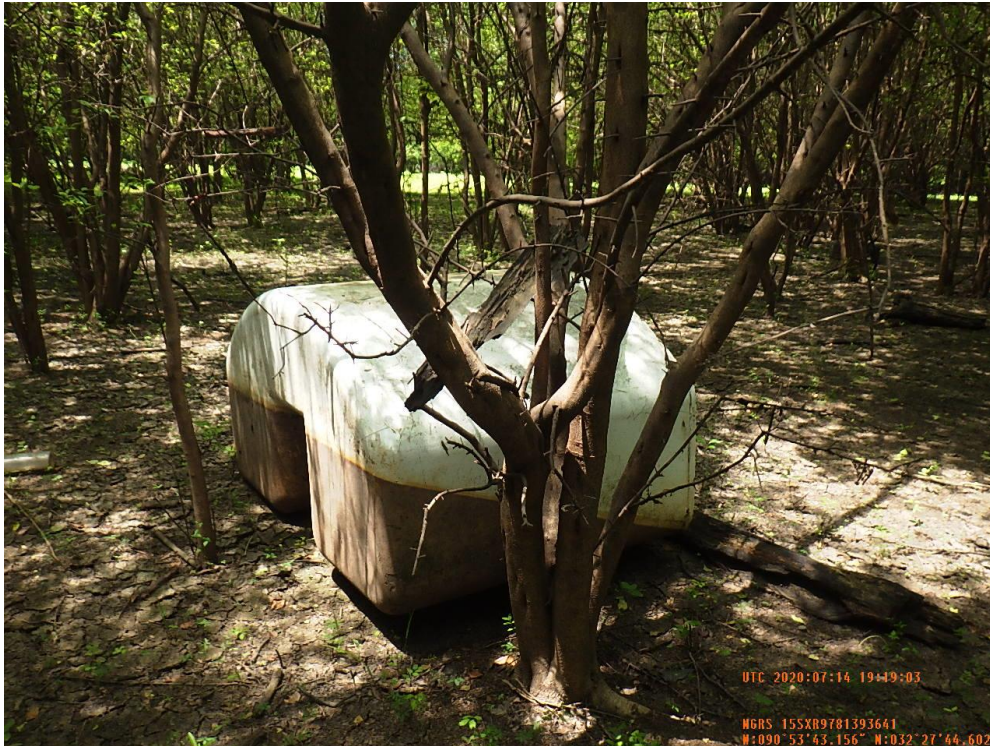
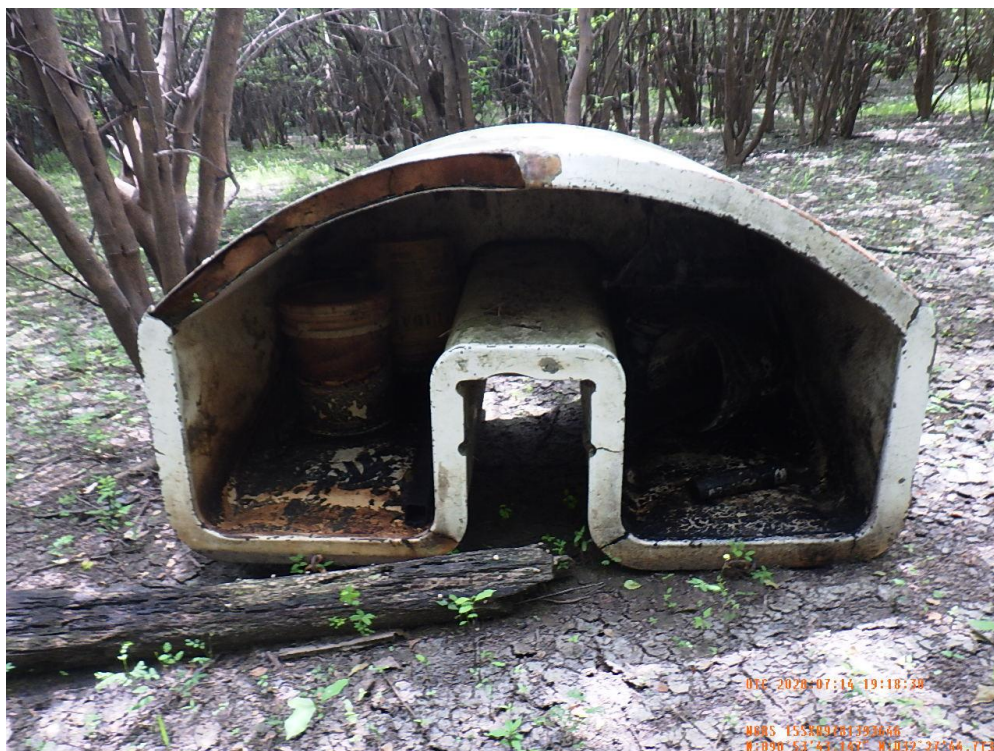
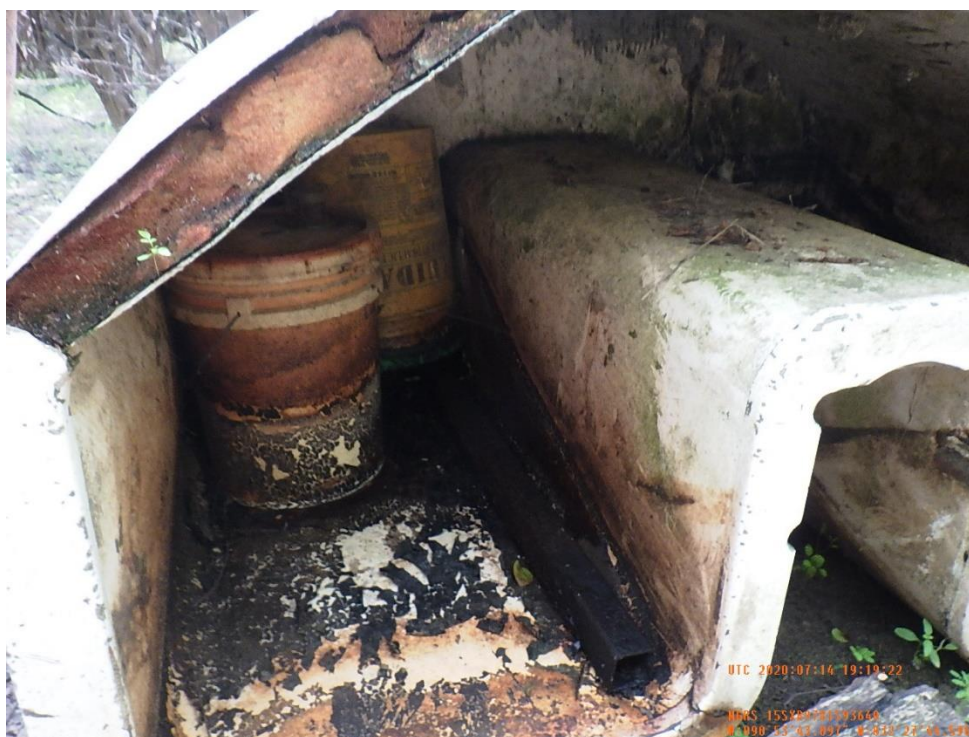
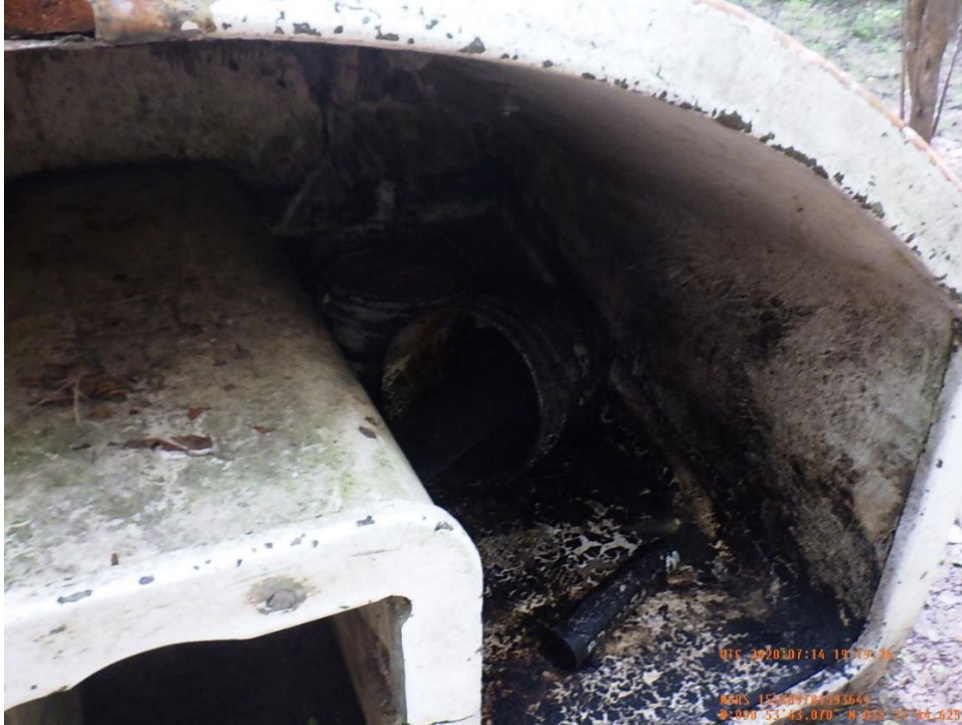
The irregularly shaped object containing used 5-gallon buckets of oil in the northeast quadrant of the borrow area appeared to have floated in to the observed location from the Steele Bayou channel during a high water event. No signs of petroleum products were observed in the surrounding vegetation or on the ground. It should be noted that no undergrowth was present in the area due to recent flooding. It is recommended that the irregularly shaped object and 5-gallon buckets be removed from the borrow area and disposed of at an approved disposal facility before construction of the borrow area would commence.

**Figure 15. Irregularly shaped object containing 5-gallon oil buckets observed in the northeast quadrant of the borrow area.**

**Figure 16. Irregularly shaped object containing 5-gallon oil buckets observed in the northeast quadrant of the borrow area.**

**Figure 17. Irregularly shaped object containing 5-gallon oil buckets observed in the northeast quadrant of the borrow area.**

**Figure 18. Irregularly shaped object containing 5-gallon oil buckets observed in the northeast quadrant of the borrow area.**

**Figure 19. Irregularly shaped object containing 5-gallon oil buckets observed in the northeast quadrant of the borrow area.**

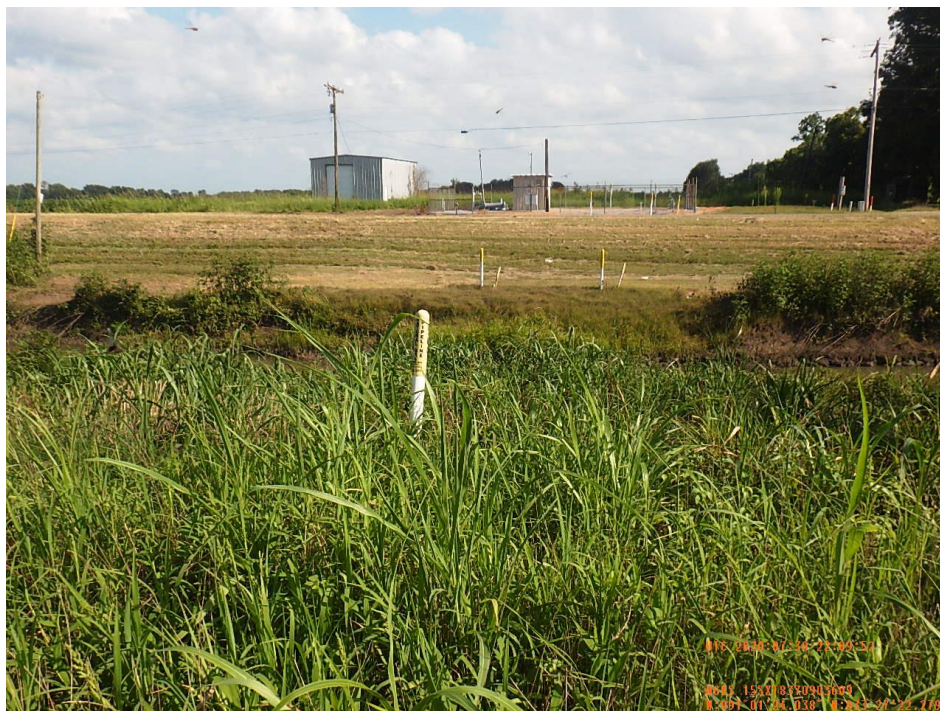
The land use around the 34 supplemental low flow groundwater well sites was predominantly row crop agriculture. The proposed well site labeled, YBP-BB-HB-34 (Horseshoe Bayou), is in close proximity to an existing underground gas pipeline crossing (Figure 21).

**Figure 21. South facing picture from agricultural field of typical area showing well site, YBP-BB-HB-34 (Horseshoe Bayou) as well as signage for gas pipeline crossing.**

Due to the presence of a gas pipeline crossing at the well site labeled YBP-BB-HB-34 (Horseshoe Bayou), it is recommended that the site footprint be moved toward the east a few hundred feet along top bank in the agricultural field to avoid impacts to the existing utility.
