THREE CREEKS MITIGATION BANK PROSPECTUS CLAIBORNE PARISH, LOUISIANA

Matrix Project No. 17-345

March 2018

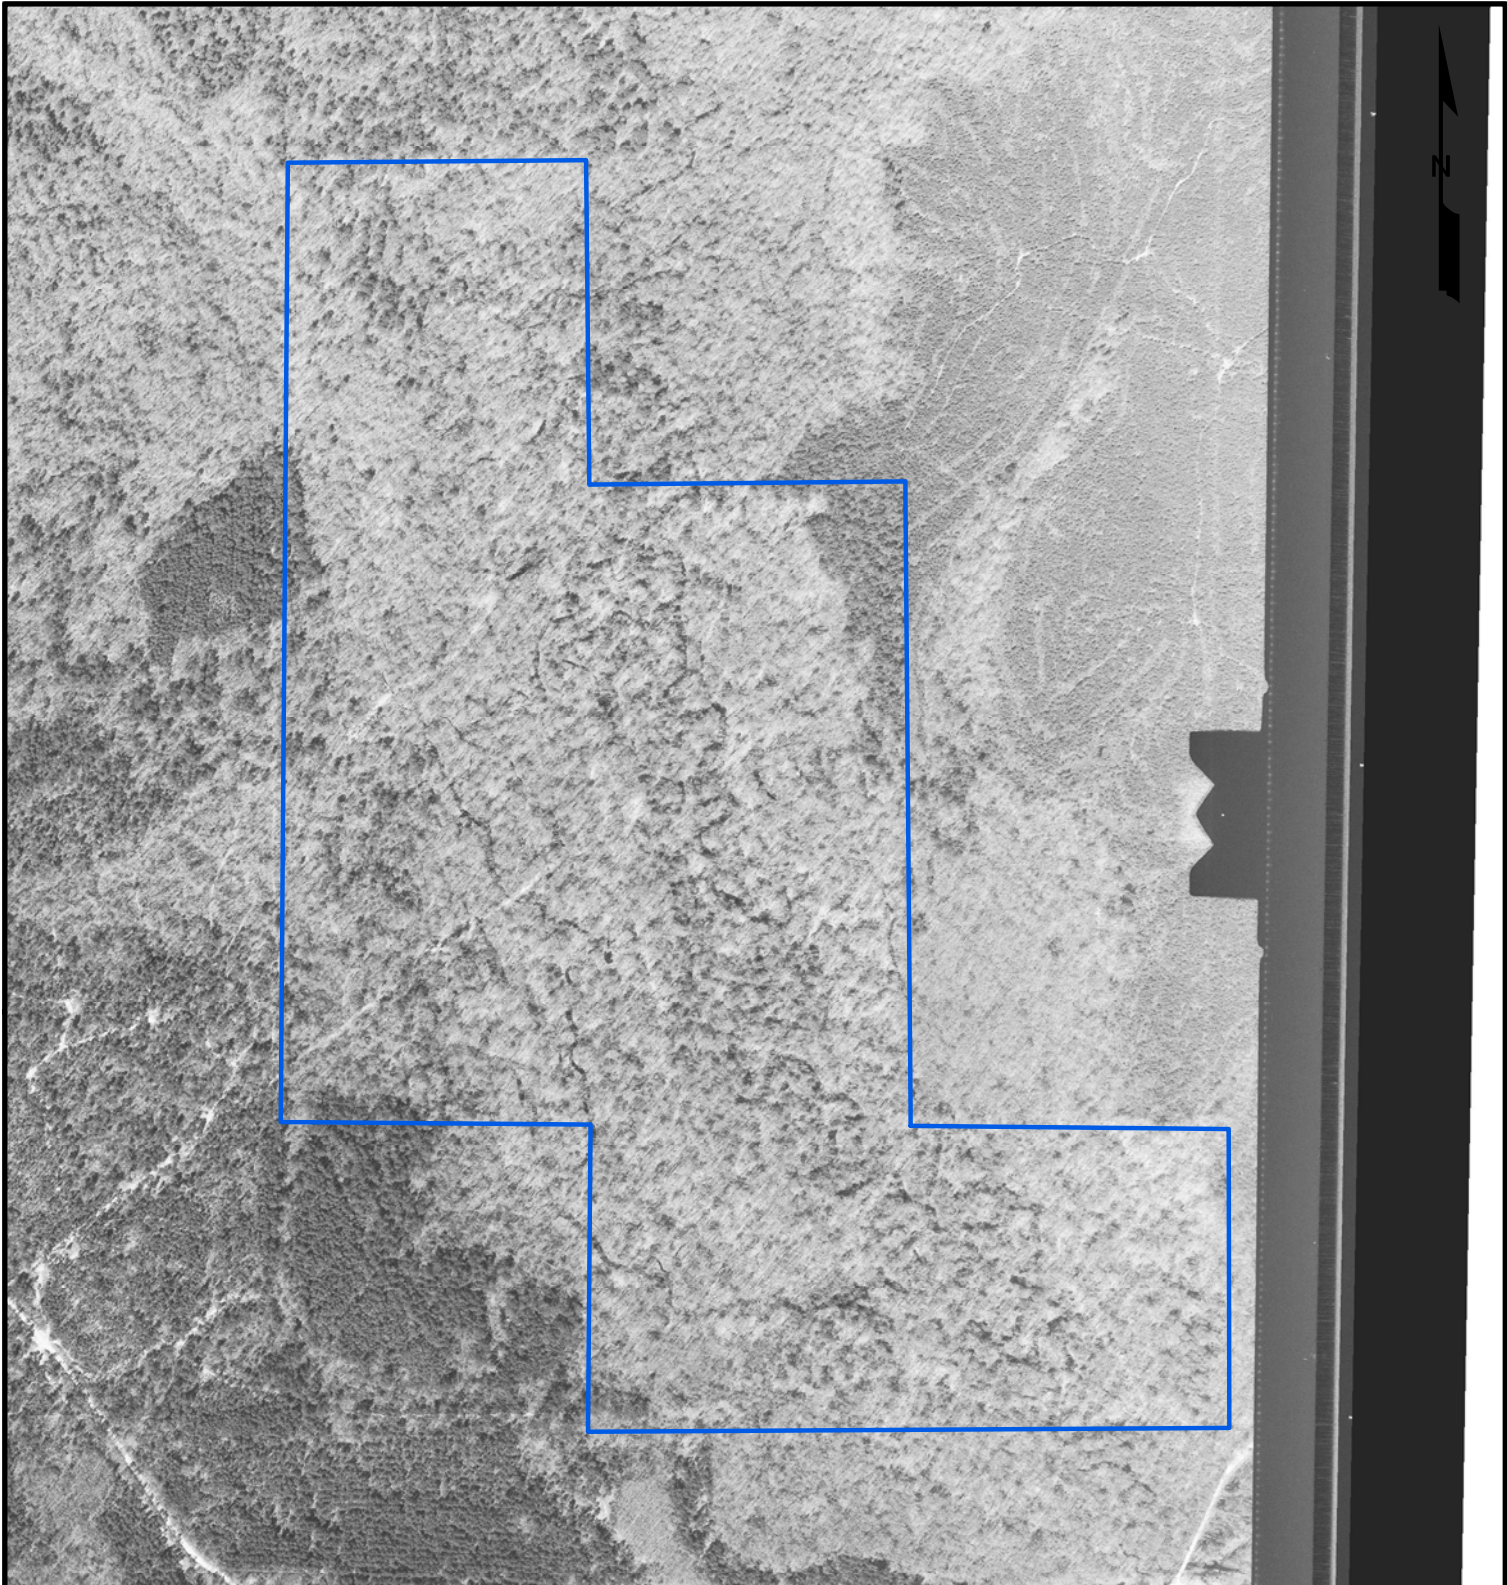
Figure No.

Source: U.S. Geological Survey (U.S.G.S). Aerial Single Frame Photo ID: ARA000690241566 [aerial photo]. Sioux Falls, S. Dak.: EROS Data Center, November 20, 1949.
