07 NOVEMBER 2024

MVK-2024-566

USACE  
Proposed  
Arkabutla Dam Repair Project  
Desoto & Tate Counties, MS

Preliminary  
Jurisdictional Determination

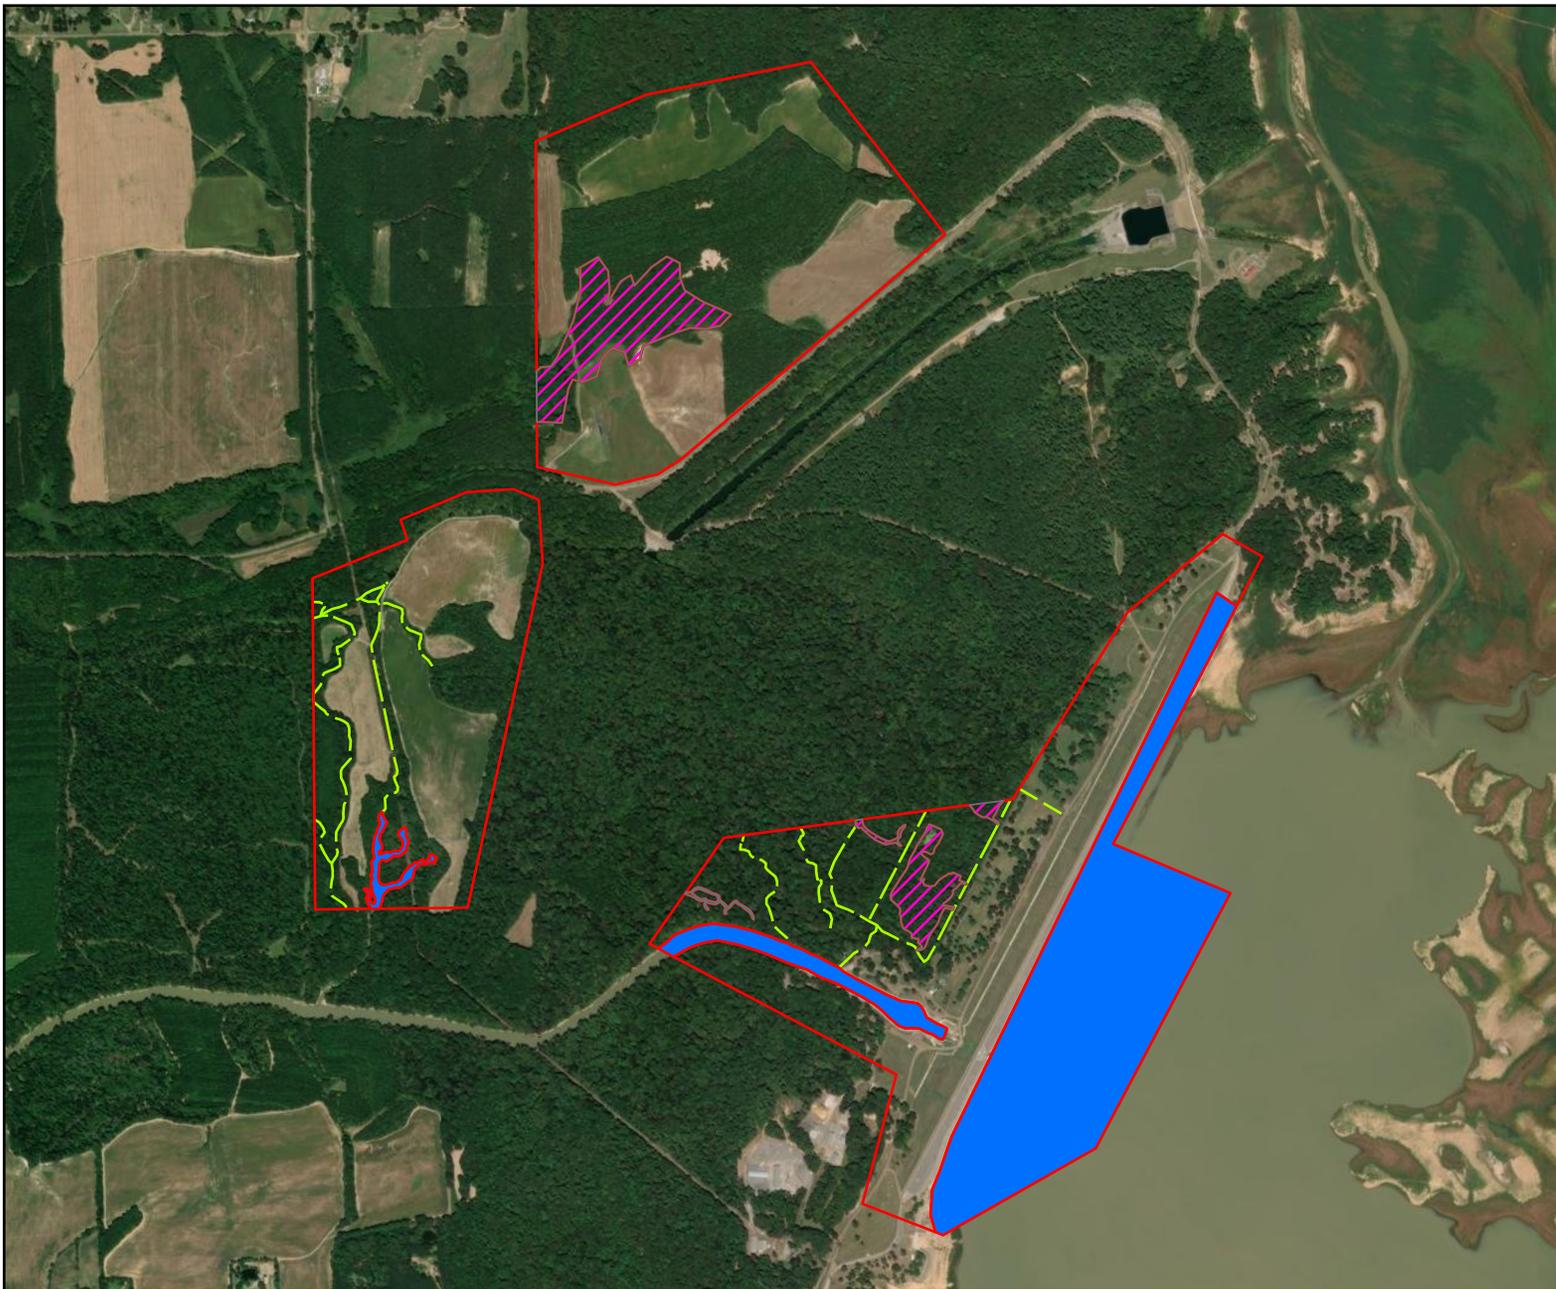
Potentially Jurisdictional  
Other Waters  
(Tributaries/RPW)  
(18,572')

Potentially Jurisdictional  
Open Water (Other  
Waters) (159.1 Acres)

Potentially Jurisdictional  
Forested Wetlands (42.5  
Acres)

Boundary
