**PROSPECTUS
TENSAS RIVER MITIGATION BANK
TENSAS PARISH, LOUISIANA
MVK-2016-364**

U.S. Army Corps of Engineers
Vicksburg District
4155 Clay Street
Vicksburg, Mississippi 39183-3435

Triple S Farms, Inc.
3611 Front Street
Winnsboro, Louisiana 71295

Headwaters, Inc.
P.O. Box 2836
Ridgeland, Mississippi 39158
www.headwaters-inc.com

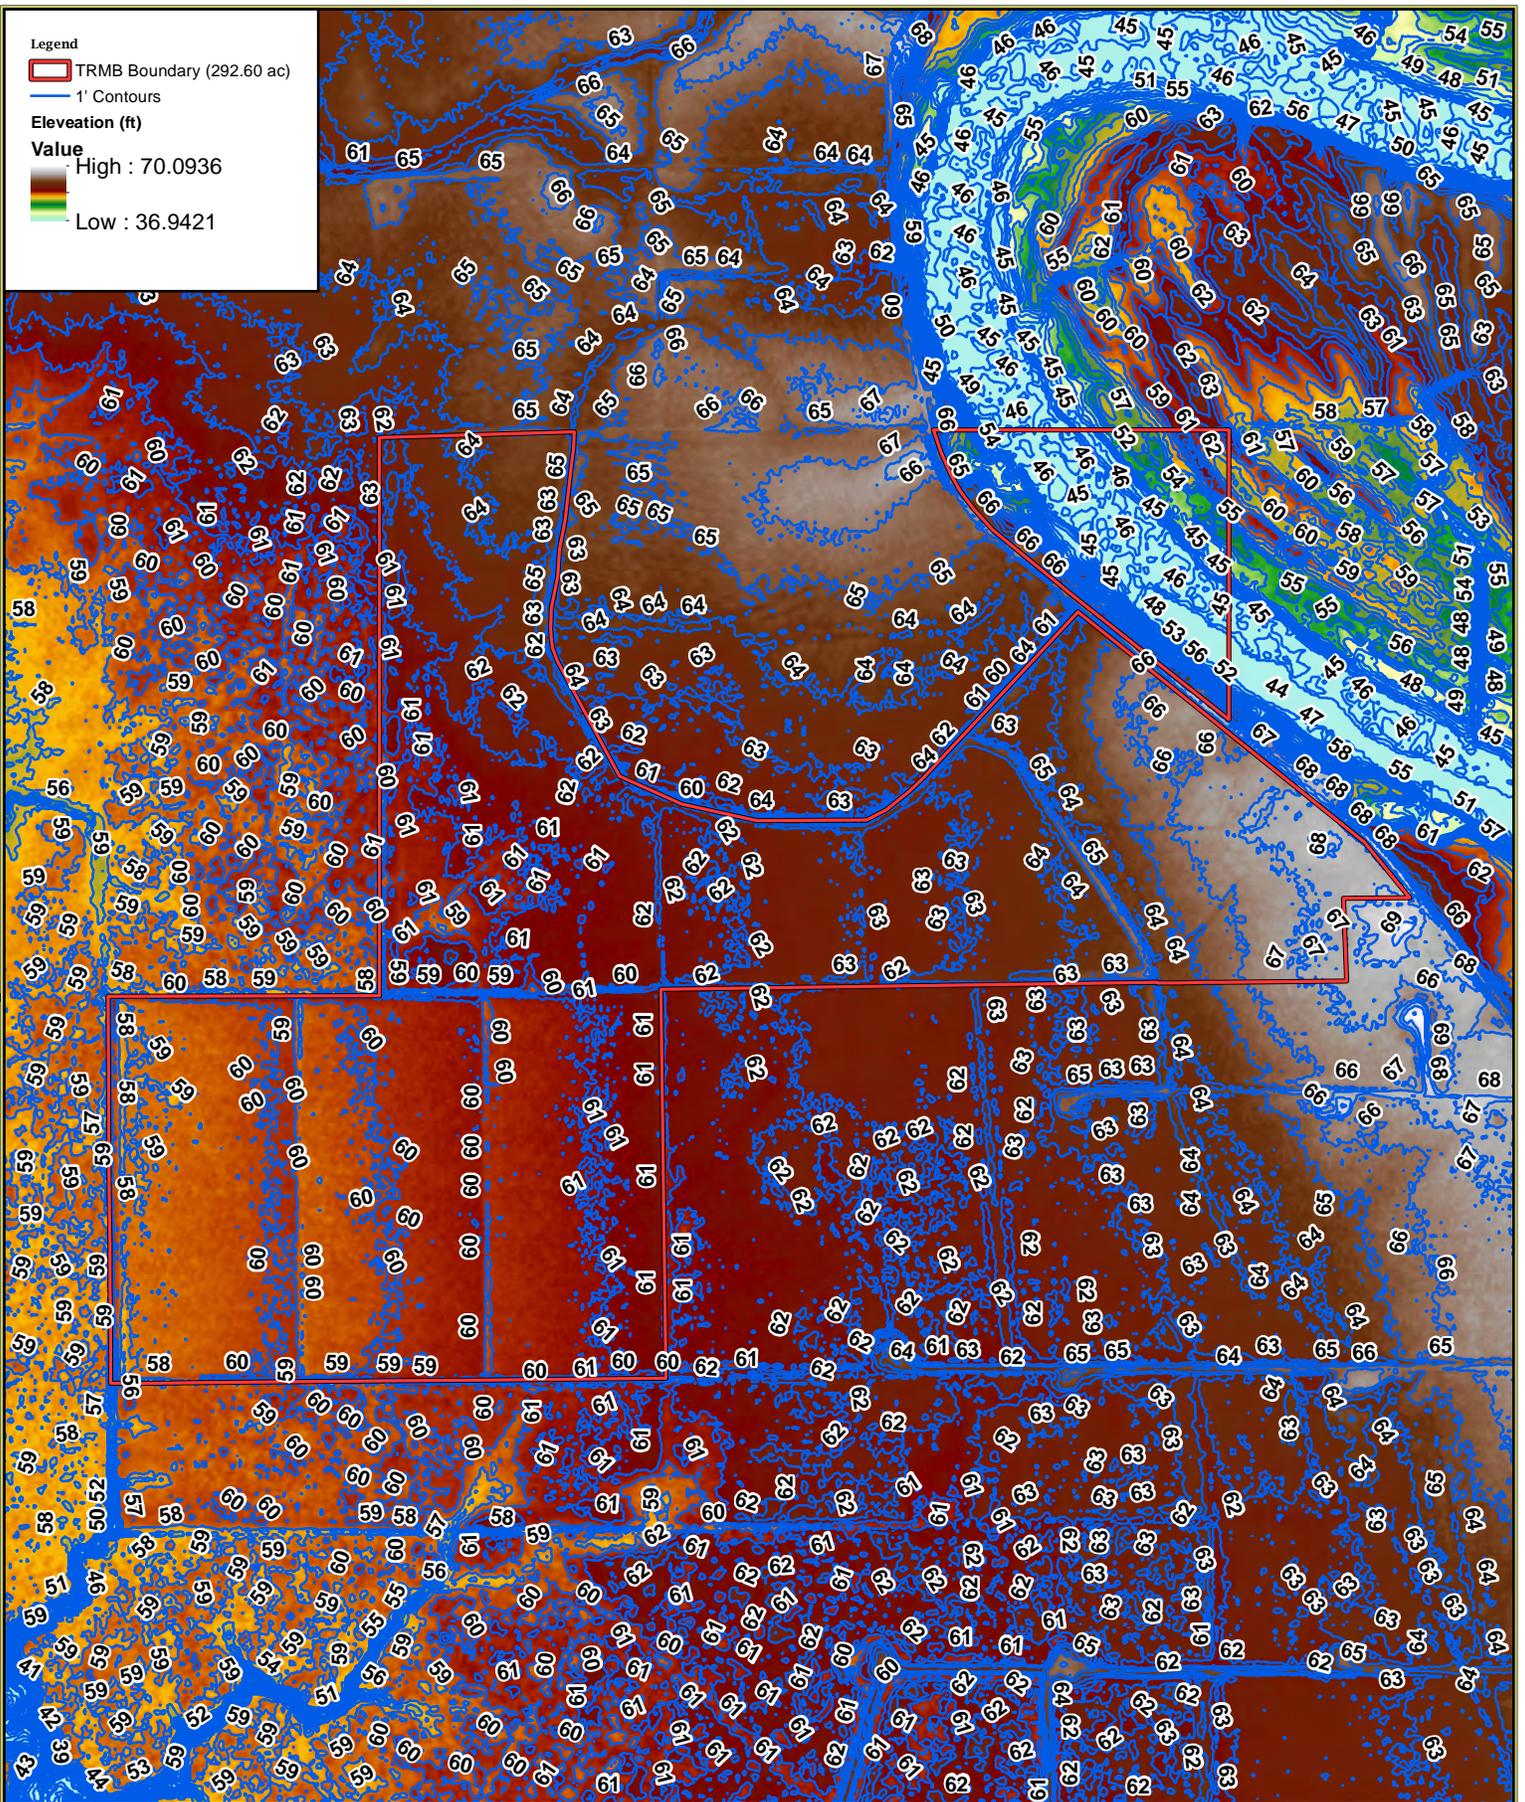
- TRMB Boundary (292.60 ac)
- 1' Contours
- Elevation (ft)**
- Value**
- High : 70.0936
- Low : 36.9421

Historic hydrology has been altered through the original conversion from bottomland hardwoods to open agricultural land and common agricultural practices during the 1950-60's. The historic hydrology and drainage patterns were determined through the use of available topographic maps and LIDAR remote sensing technology to determine elevations within the Bank Property and the adjacent properties located in the drainage area of the Bank Property ([Figure 8](#)).

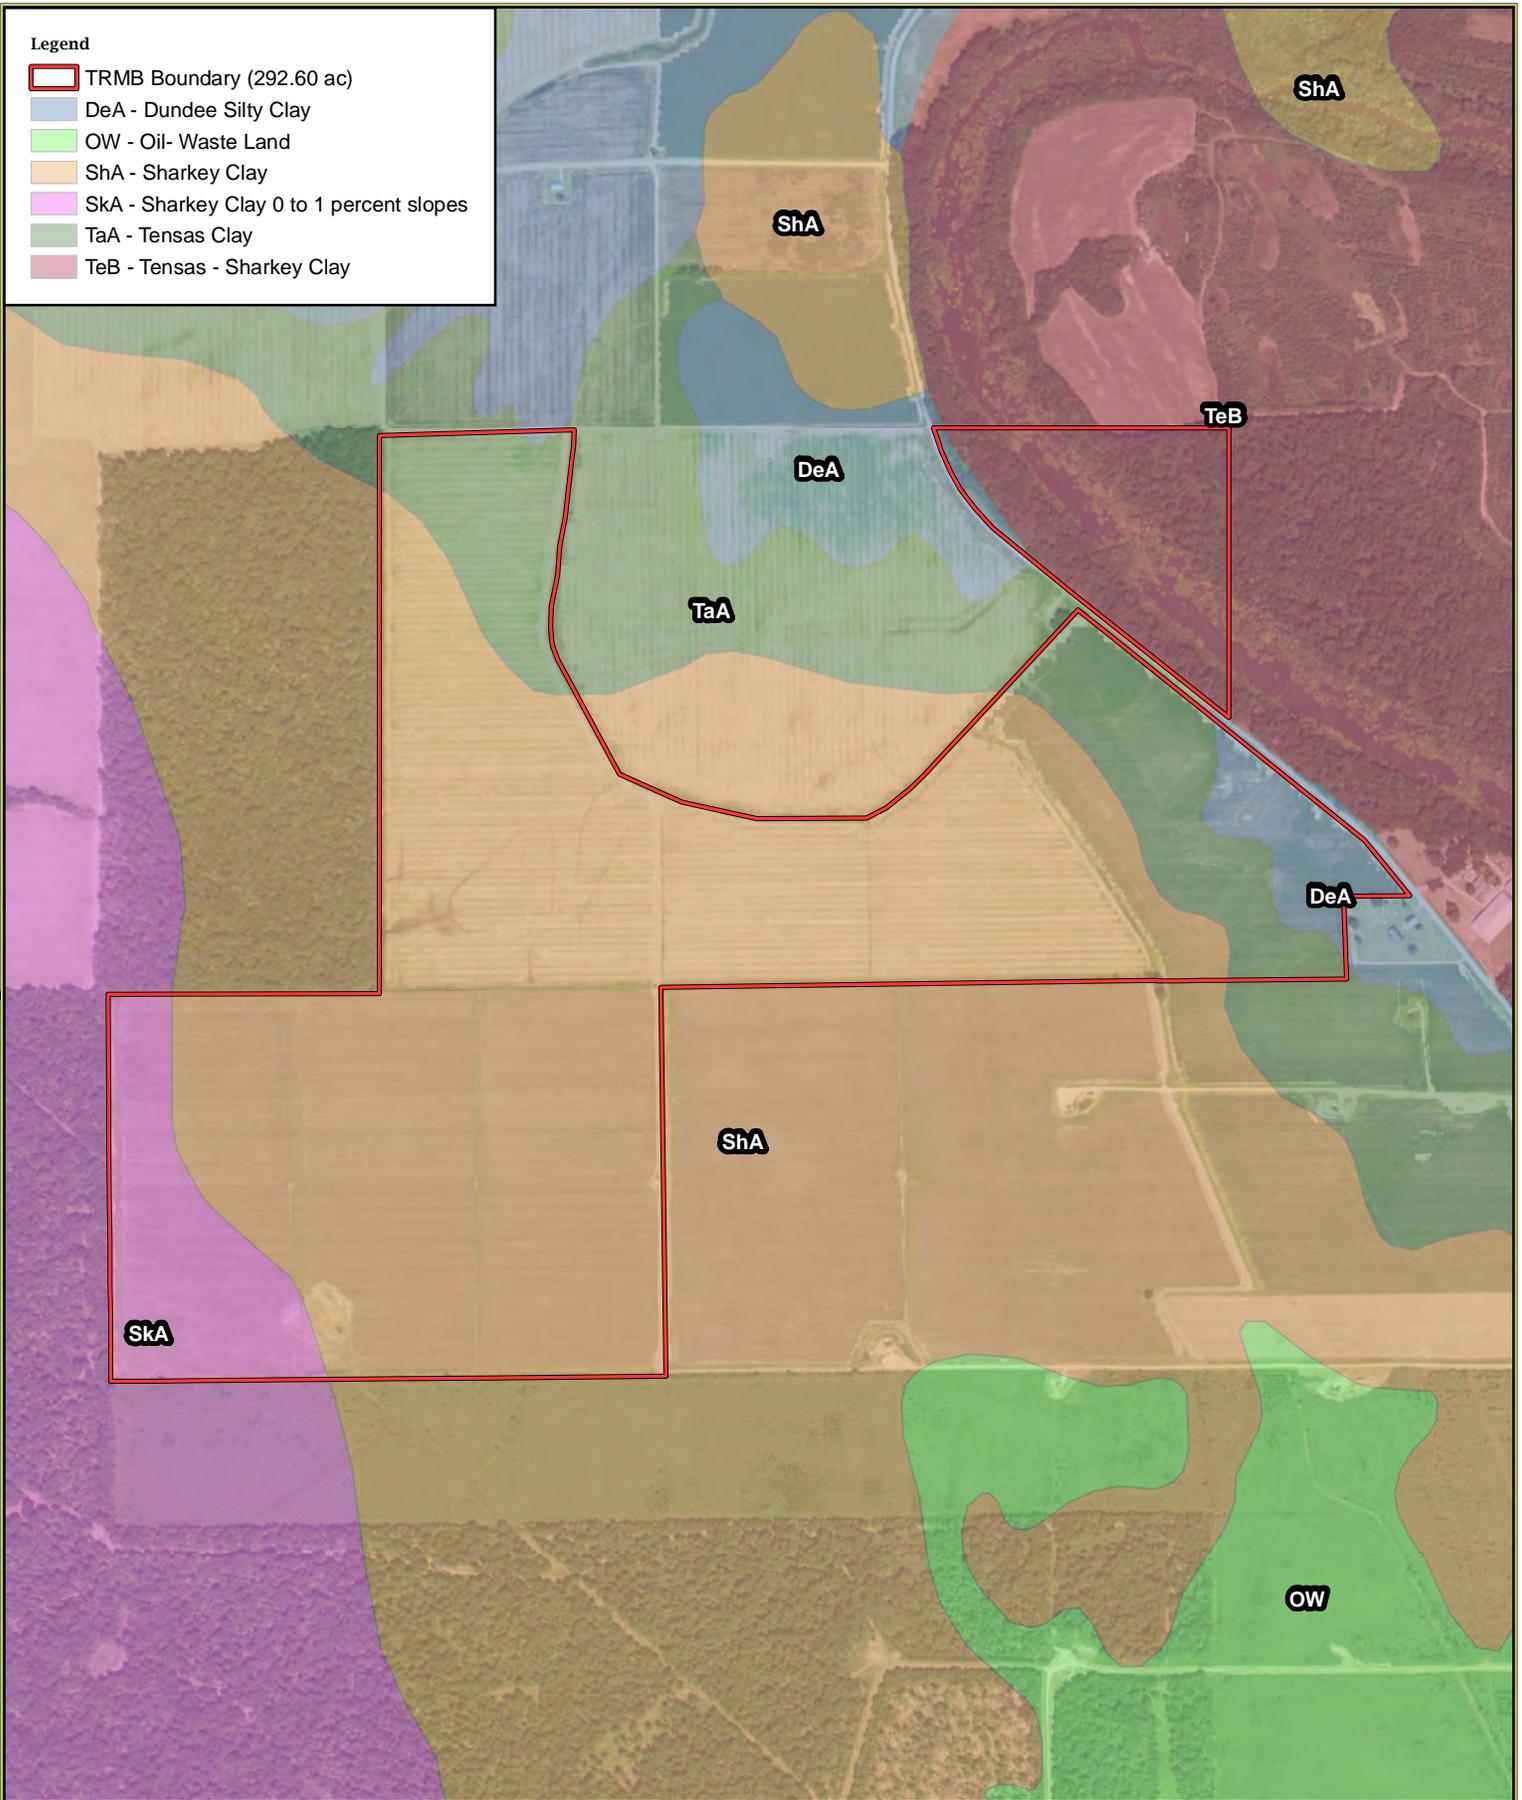
- TRMB Boundary (292.60 ac)
- DeA - Dundee Silty Clay
- OW - Oil- Waste Land
- ShA - Sharkey Clay
- SkA - Sharkey Clay 0 to 1 percent slopes
- TaA - Tensas Clay
- TeB - Tensas - Sharkey Clay

The Dundee silty clay loam series are somewhat poorly drained soils formed in stratified, medium textured and moderately fine textured alluvium deposited by the Mississippi River. They occur on natural levees along the Mississippi River and smaller streams. Typically, the surface layer is brown silt loam or loam. The subsoil is dark grayish-brown clay loam underlain by dark grayish-brown loam. The soil survey for the Bank Property is included as [Figure 9](#).

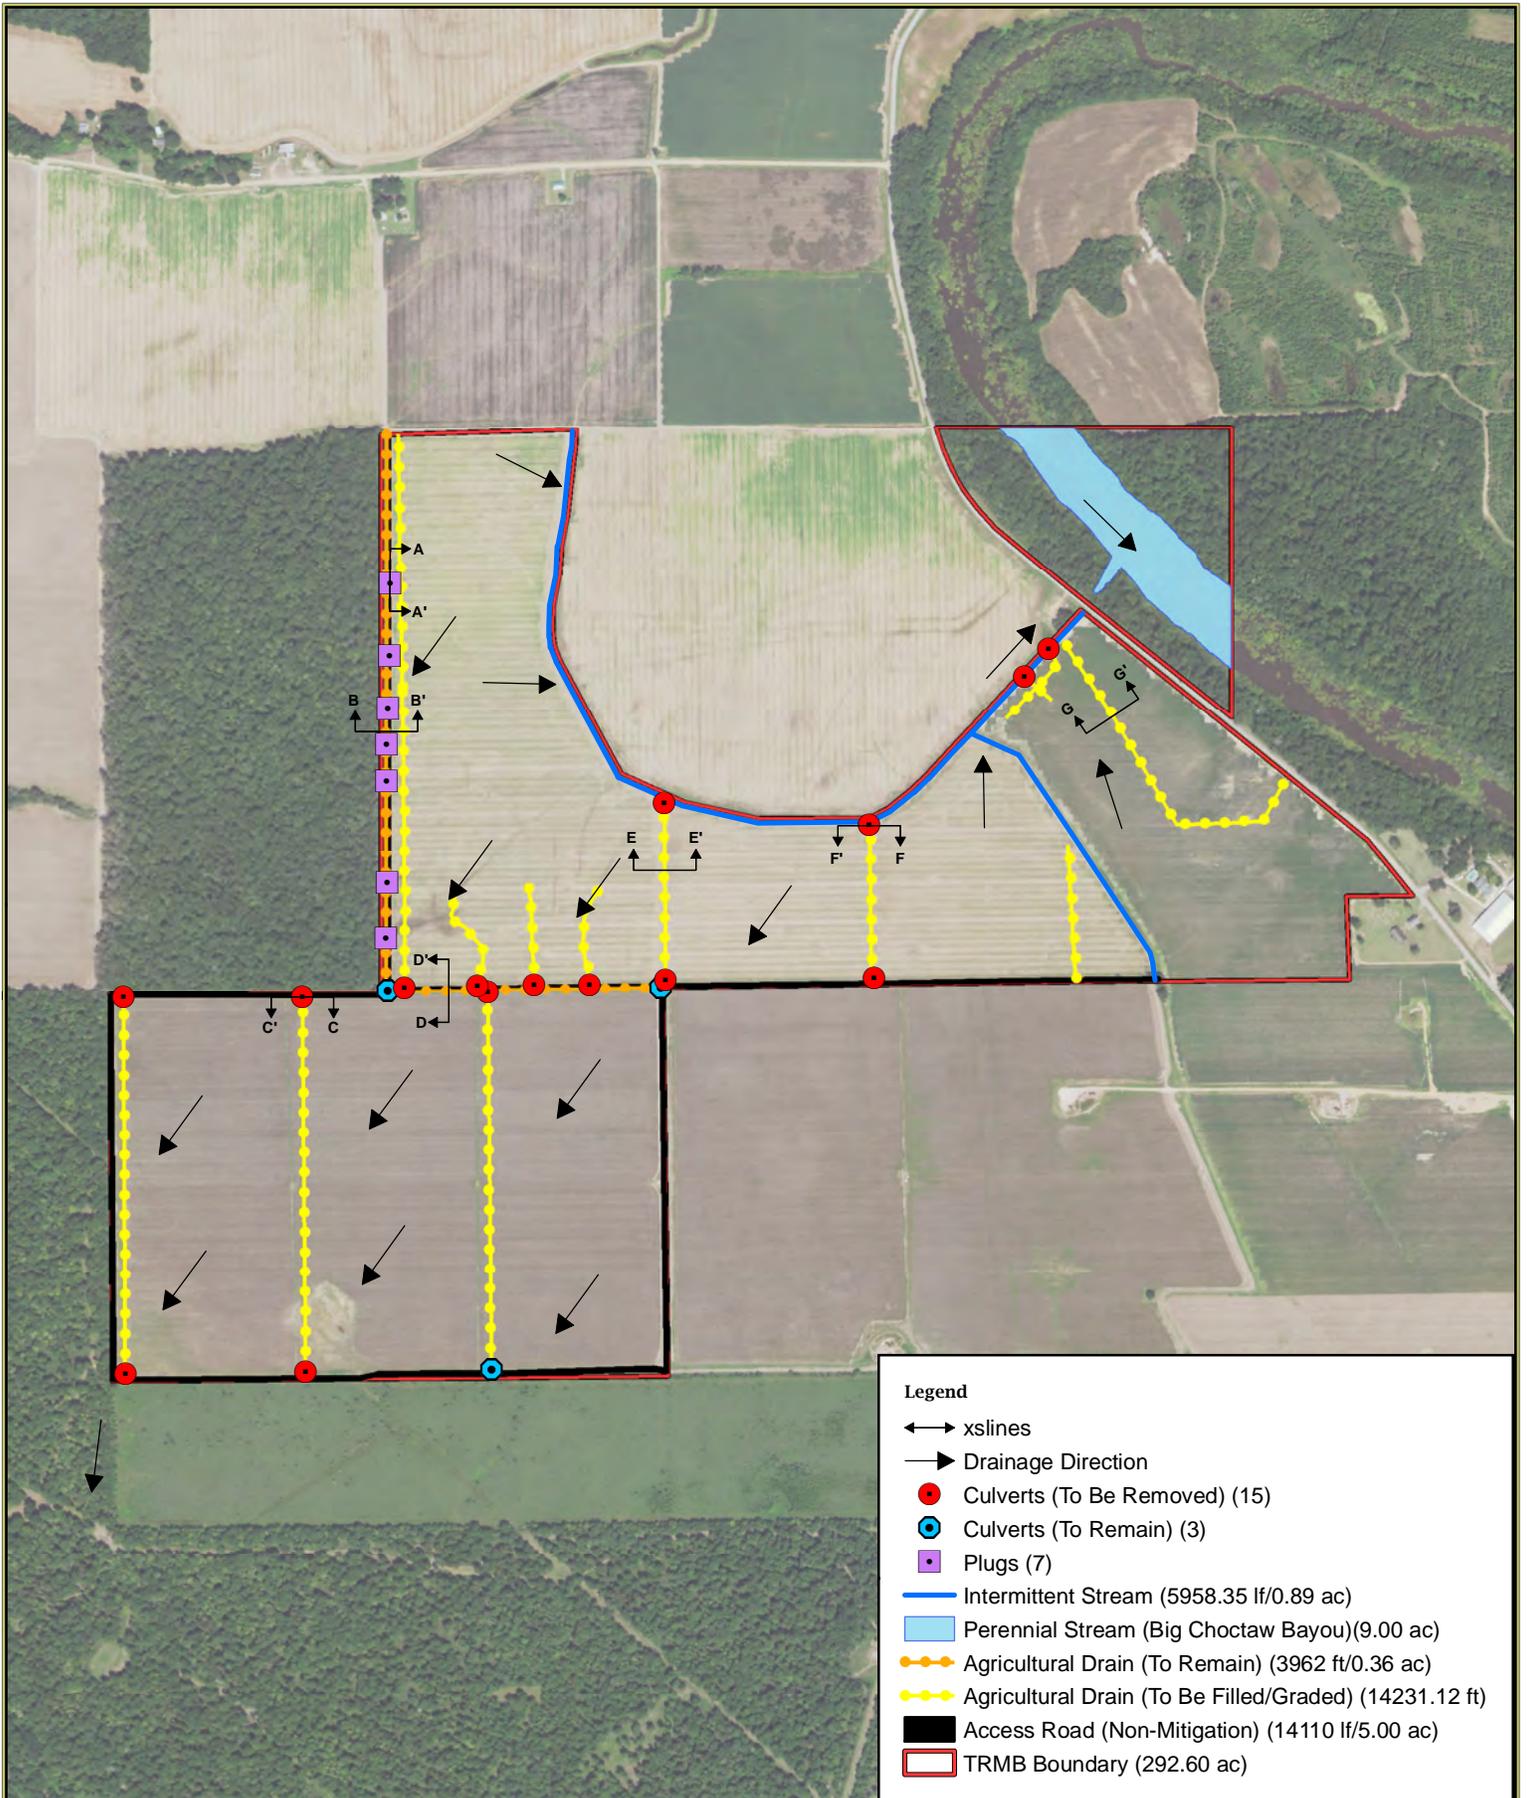
- ↔ xslines
- ➔ Drainage Direction
- Culverts (To Be Removed) (15)
- Culverts (To Remain) (3)
- Plugs (7)
- Intermittent Stream (5958.35 lf/0.89 ac)
- Perennial Stream (Big Choctaw Bayou)(9.00 ac)
- Agricultural Drain (To Remain) (3962 ft/0.36 ac)
- Agricultural Drain (To Be Filled/Graded) (14231.12 ft)
- Access Road (Non-Mitigation) (14110 lf/5.00 ac)
- ▭ TRMB Boundary (292.60 ac)

1. The hydrology restoration work plan will include filling and grading, to as close as practicable natural conditions, of agricultural drains located within the Bank Property. Thirteen (13) agricultural drains, approximately 14,231.12 linear feet in length, are in the Bank Property and will be filled and graded to an elevation comparable to the adjacent open fields and forestlands, restoring the natural sheet flow of storm water runoff. [Figure 11](#) depicts the location of the agricultural drains to be filled and graded as a part of the mitigation work plan. A cross sectional view, representing the agricultural drains, has been prepared and is included within the appendices of this report.

The Hydrologic Work Plan developed for TRMB is depicted as [Figure 11](#).

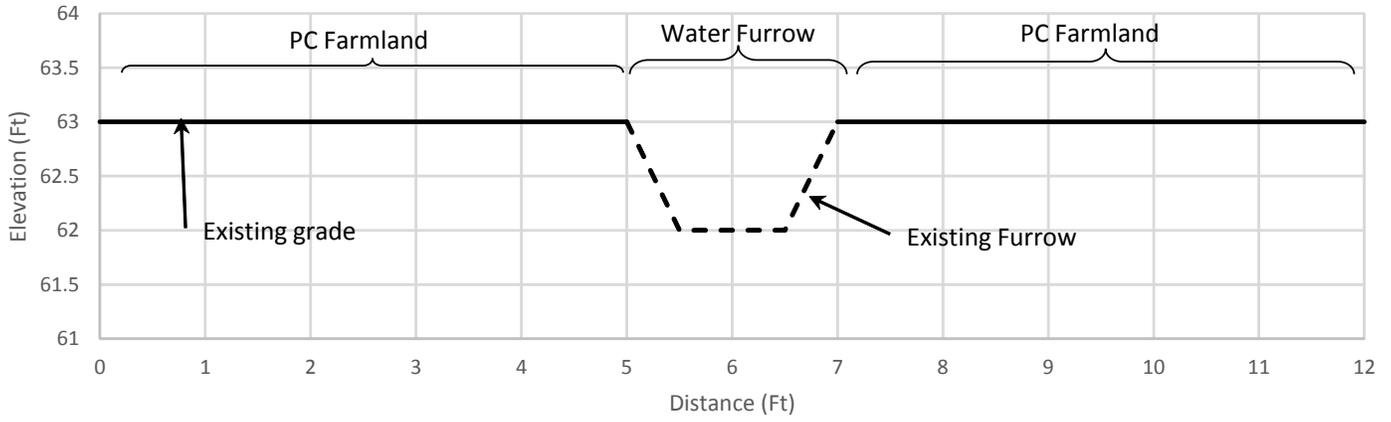
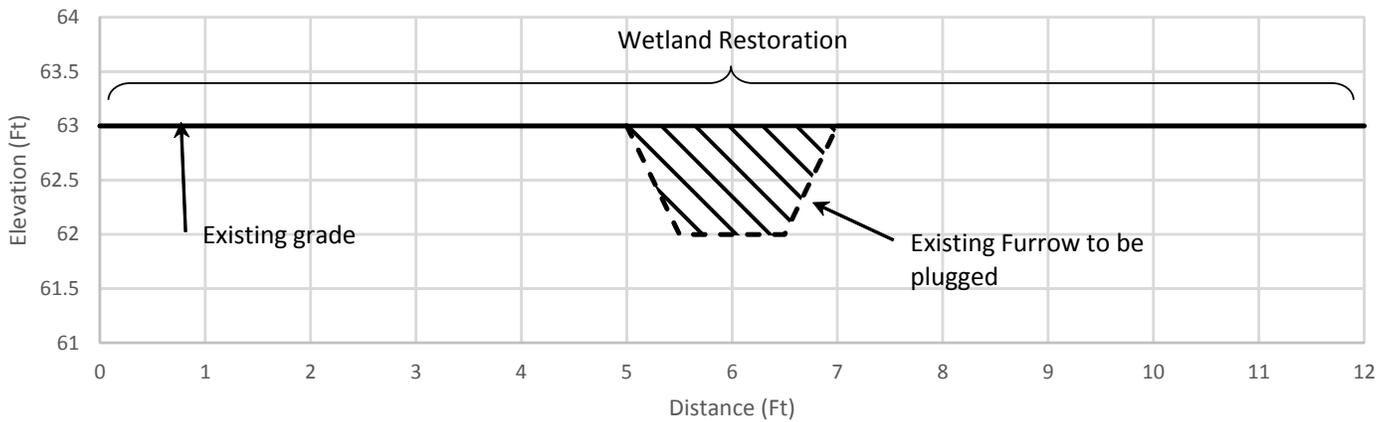
Typical Cross Section A - A' Existing Conditions

Typical Cross Section A - A' Proposed Conditions

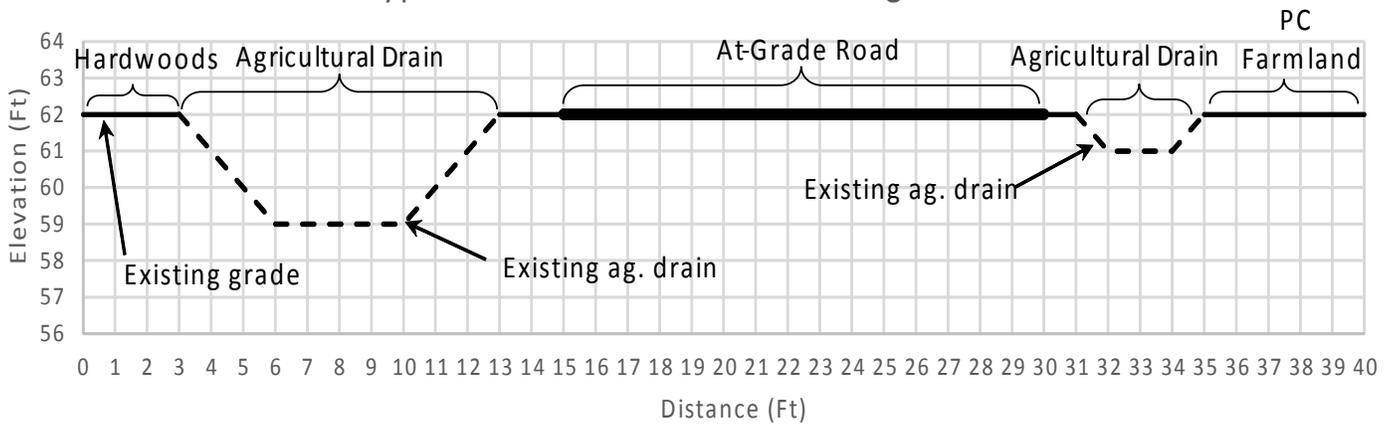
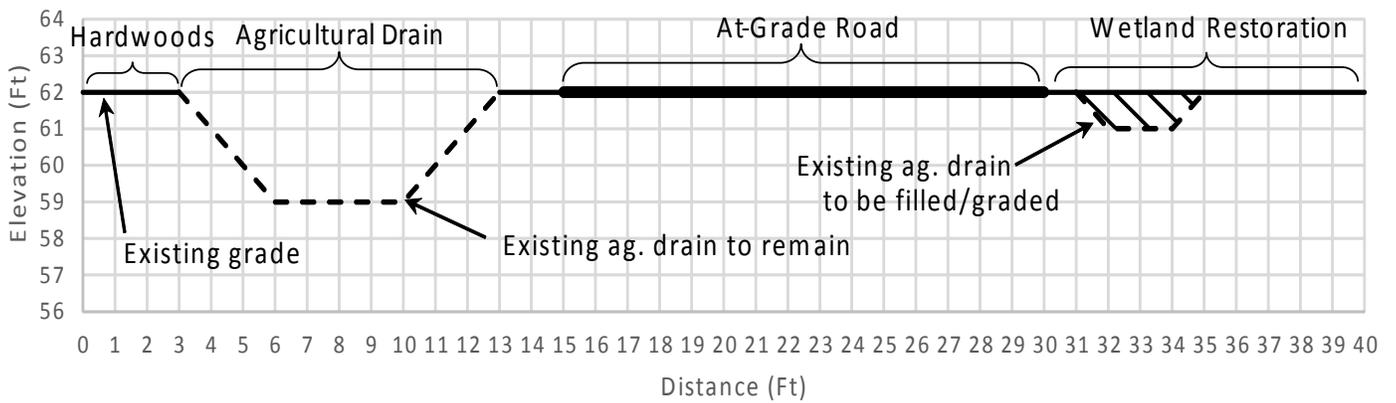
Typical Cross Section B - B' Existing Conditions

Typical Cross Section B - B' Proposed Conditions

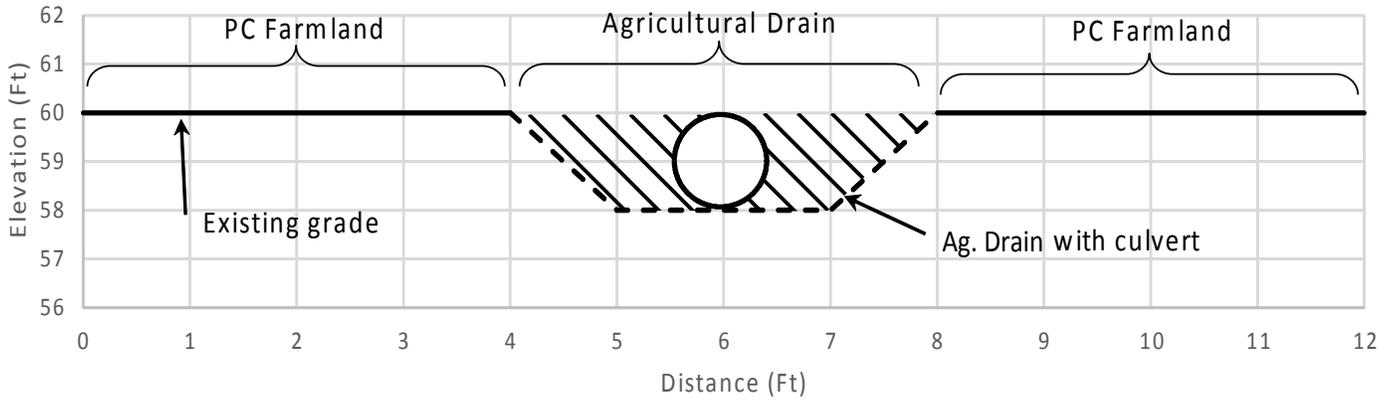
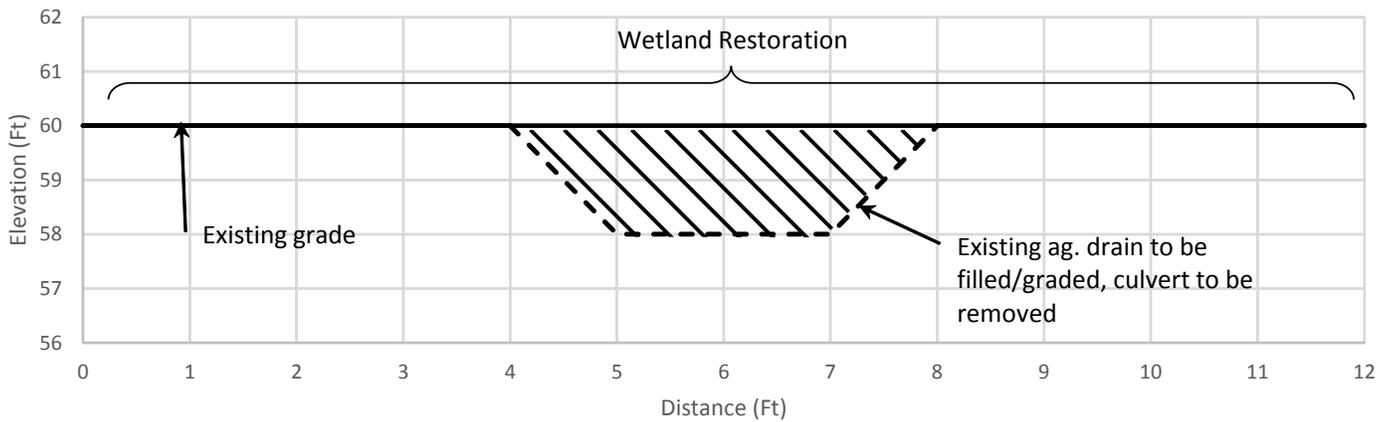
Typical Cross Section C - C' Existing Conditions

Typical Cross Section C - C' Proposed Conditions

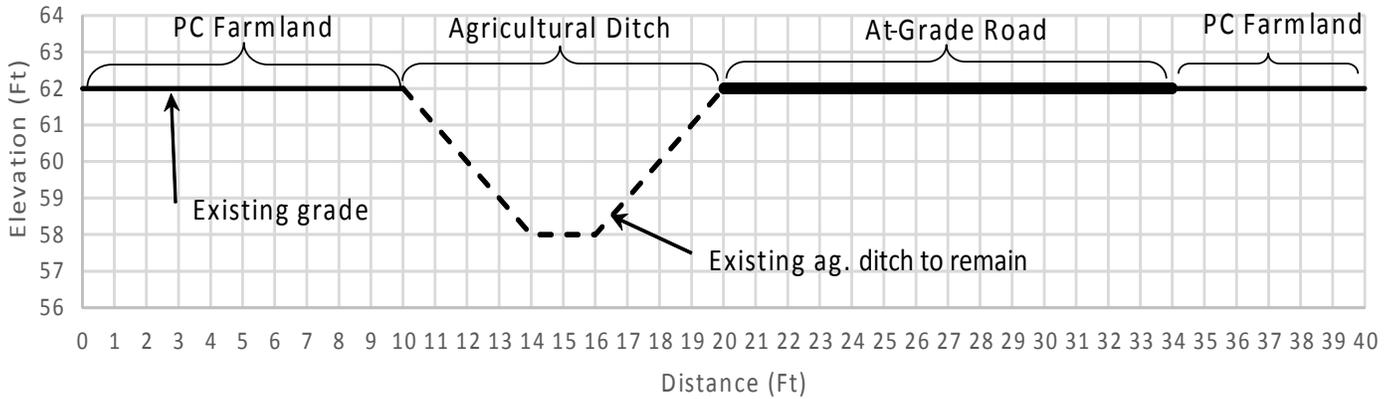
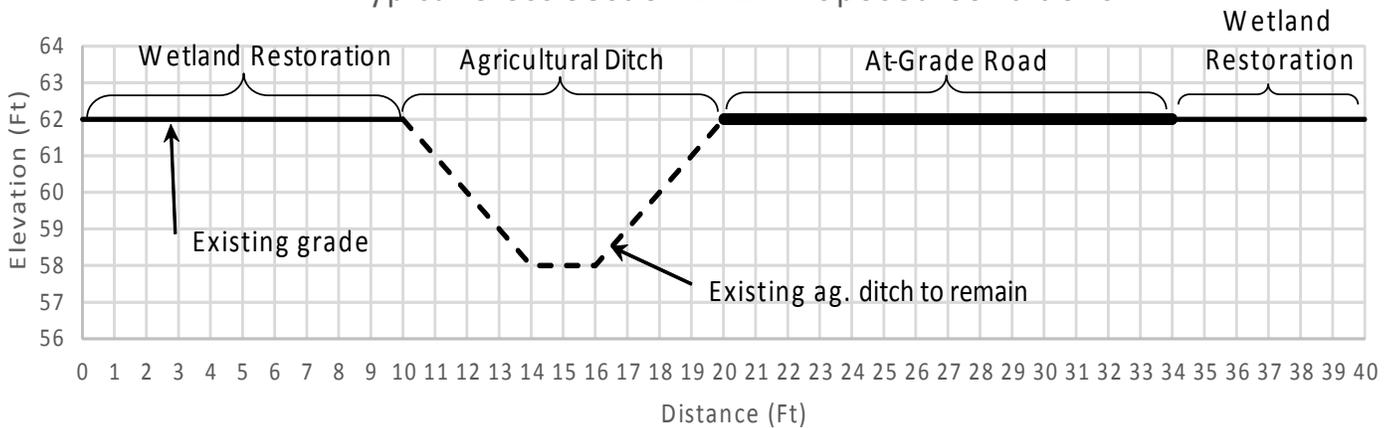
Typical Cross Section D - D' Existing Conditions

Typical Cross Section D - D' Proposed Conditions

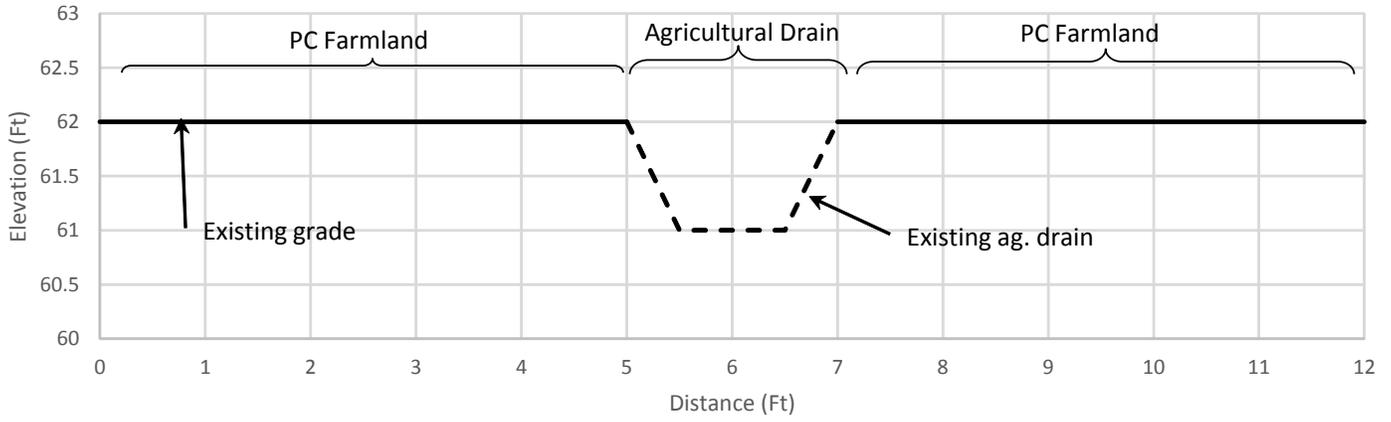
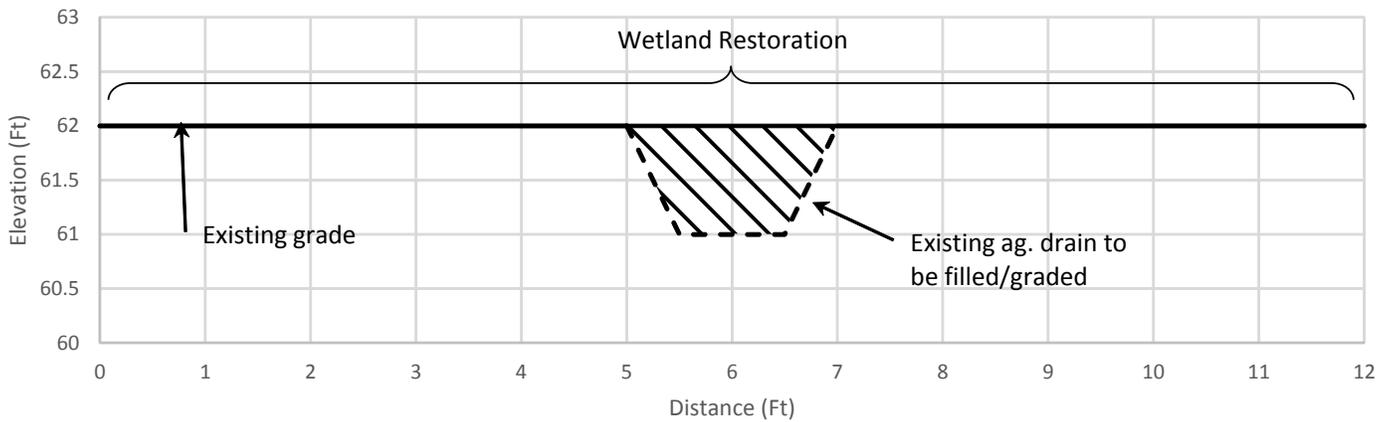
Typical Cross Section E - E' Existing Conditions

Typical Cross Section E - E' Proposed Conditions

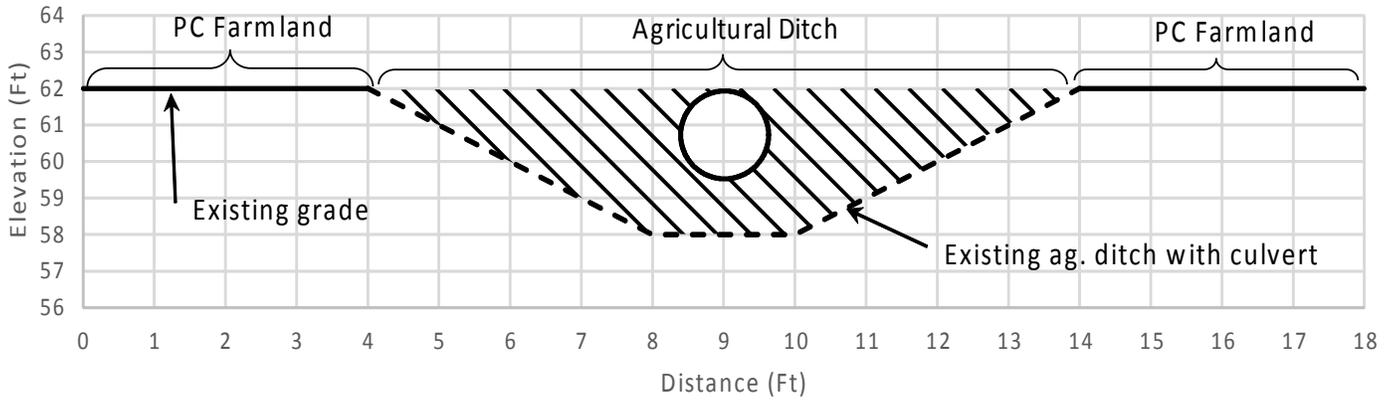
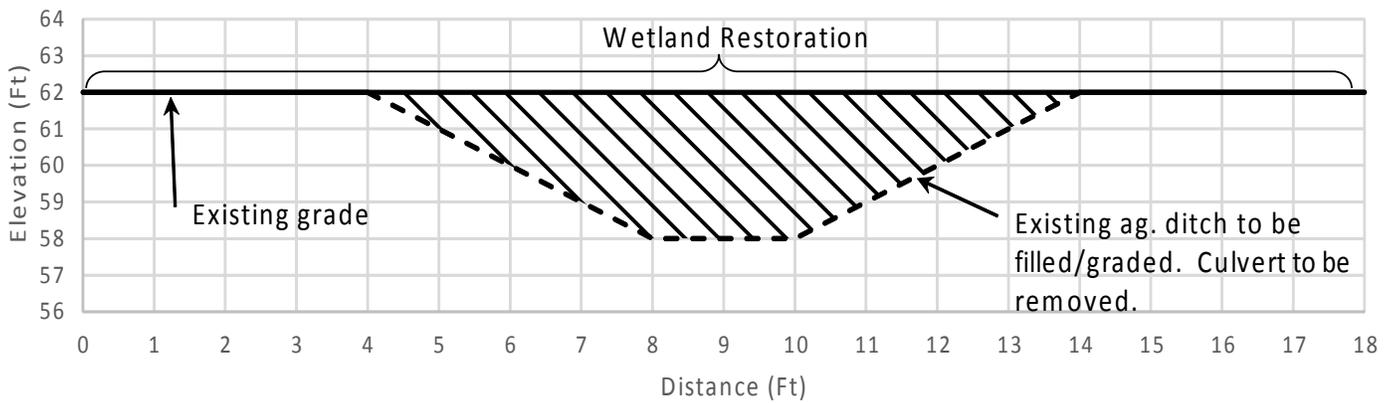
Typical Cross Section F-F' Existing Conditions

Typical Cross Section F - F' Proposed Conditions

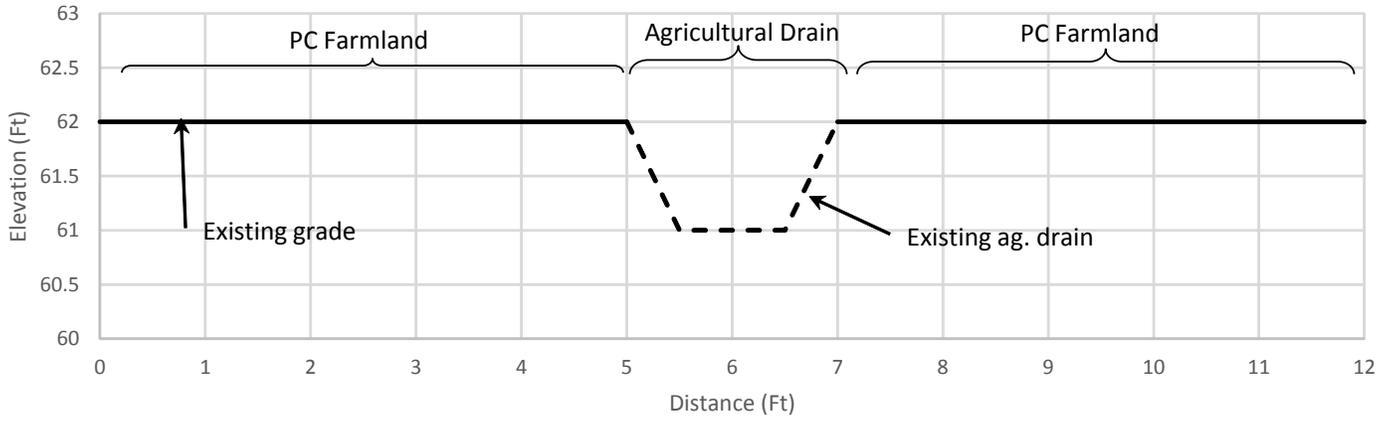
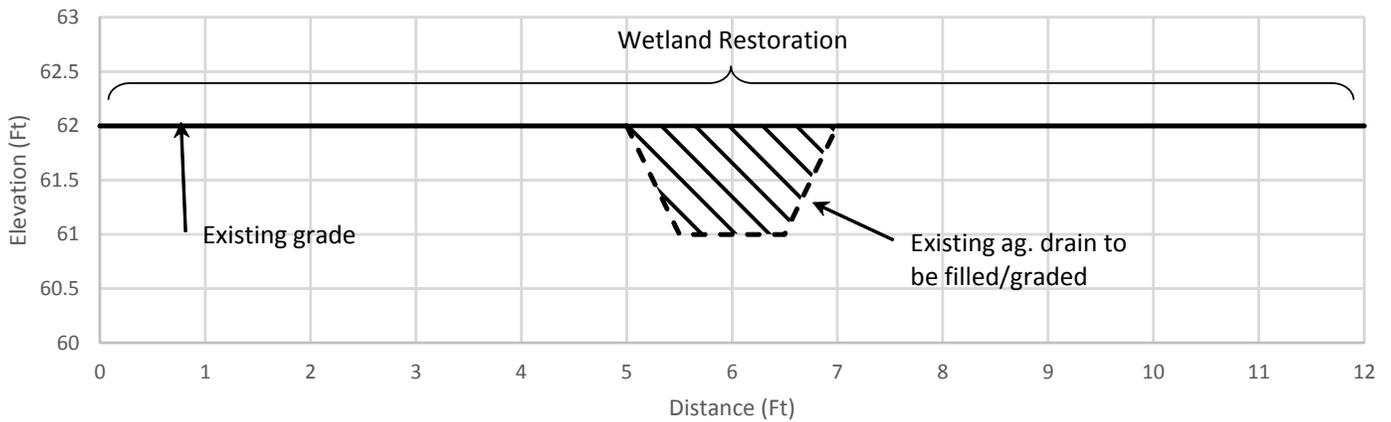
Typical Cross Section G - G' Existing Conditions

Typical Cross Section G - G' Proposed Conditions

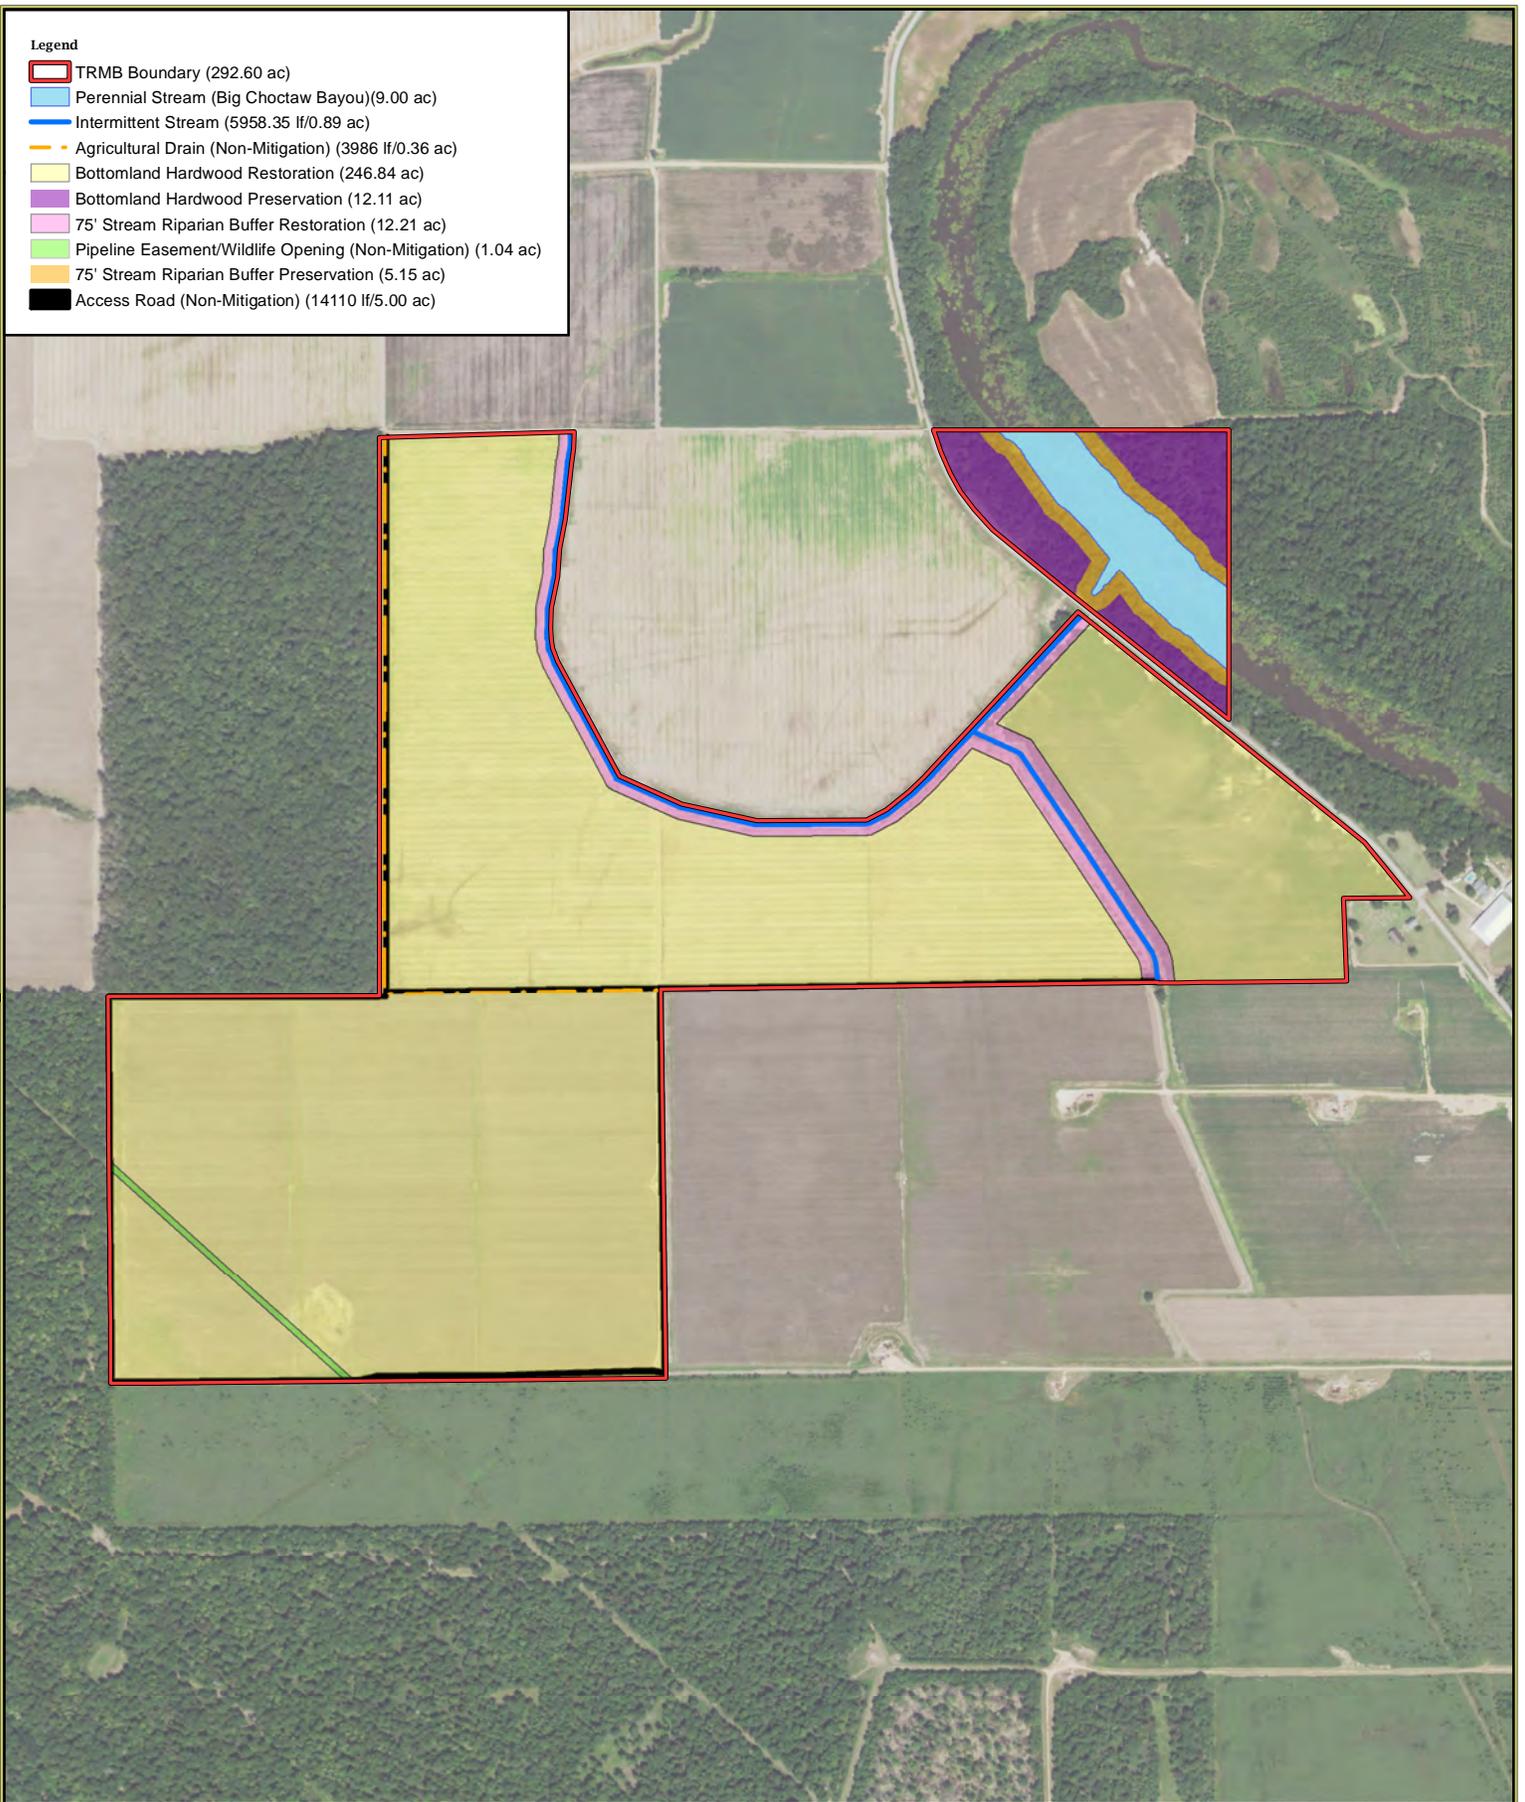
Figure 12 - Mitigation Plan Map

Access Road (Non-Mitigation) (14110 lf/5.00 ac)

Approximately 12.21 acres of stream riparian buffer will be restored along the banks of approximately 5,958.35 feet of stream located along the north and east boundary of the Bank Property. Each stream is considered intermittent but has been improved and maintained for agricultural purposes providing storm water runoff relief for the historic and current land use. The proposal includes the restoration of the native bottomland hardwood component within the riparian buffer areas of each stream reach within the Bank Property. Native bottomland hardwood species will be planted within the designated 75-foot wide buffer on the south side of the north stream. Planting will also occur within a 75-foot wide buffer along either side of the east stream. Currently, agricultural row crop activities extend to the bank of each stream with ongoing maintenance activities in within the stream reaches.

through the northeast corner of the Bank Property. In association with the bottomland hardwood preservation component of this bank proposal, it is intended to preserve a 75-foot wide riparian buffer zone along either bank of the Bayou.
