Mitigation Bank Prospectus Berg Big Black River Mitigation Bank

Berg Mitigation Banks, LLC 4/20/2018

Wetland Delineation Pictures March 2018

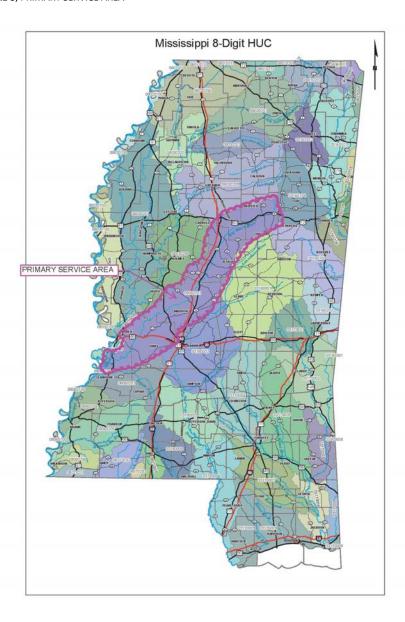
FIGURE 3, PRIMARY SERVICE AREA

The project area and surrounding land use is predominantly a combination of silviculture, agriculture, and low density residential. The establishment of this mitigation bank would eliminate the ongoing impacts associated with silviculture practices and enhance wetland/riparian buffer within the Big Black basin. The proposed primary service area of the mitigation bank is the Upper Big Black and Lower Big Black Watershed (USGS HUC Codes: 08060201 and 08060202 as primary service areas). Mitigation will be allowed outside of the primary service area on a case by case basis.

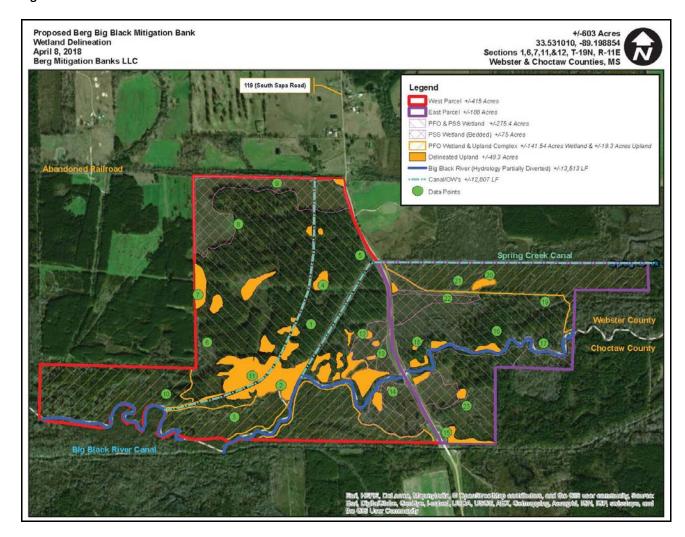
Figure 5. CURENT CONDITIONS

The majority of the property (approximately 400 acres) is currently planted in loblolly pine. The younger stands of loblolly pine (approximately 75 acres) was bedded to improve seedling survival/growth rates. The older stands of the pine plantation was control burned in April of 2018 as part of the scheduled silviculture management. Approximately 160 acres of the site is comprised hardwood species. The majority of this hardwood area is comprised of scattered canopy trees and very dense sapling/shrub. Invasive species (*Ligustrum sinese*) was observed within some locations with coverage less than 5% of total ground cover. One power line ROW transects the site west-east. Existing woods roads provide adequate accessibility to the majority of the site. With pine plantation as the dominant land use and the absence of hardwood canopy, this property has diminished quality food and cover resources for wildlife.

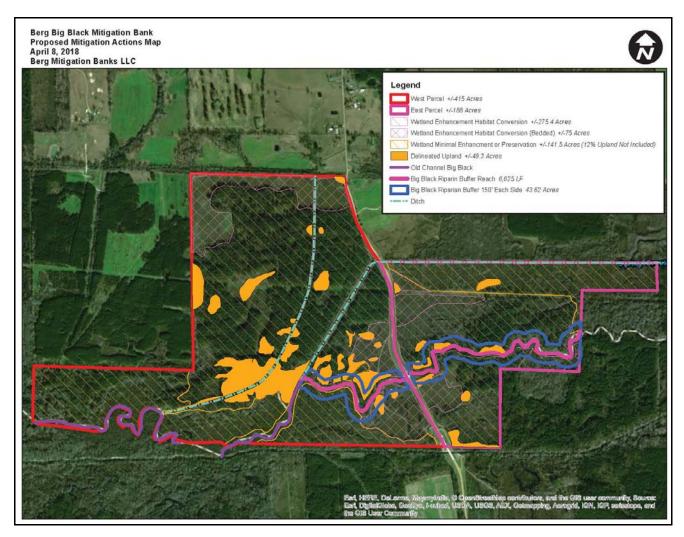
Figure 6. PROPOSED MITIGATION ACTIONS

- Approximately 350 acres of wetland will be enhanced by removal of pine plantation and reforestation with BLH species.
- -Approximately 75 acres of this 350 acres will also require leveling of beds to remove impediments to hydrology.
- -Approximately 141.5 acres of wetland will require minimum enhancement and/or preservation to control invasive species.
- -Approximately 6,625 LF of the original Big Black River Channel will be protected by enhancement of 150' buffers on each side (43.62 acres). Pine plantation removed and invasive species controlled. Portions reforested with BLH species.
- -Approximately 70 acres of upland within the site enhanced by reforestation and included within the protective instrument of the mitigation bank.

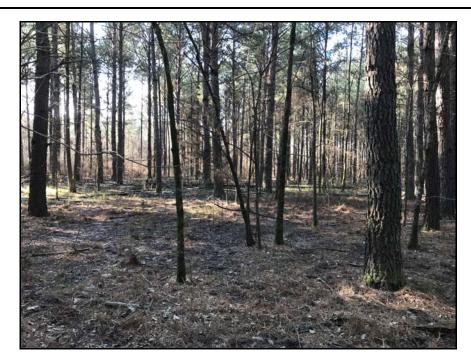
Mature loblolly stand at DP-1

Project/Site: Proposed Mitigation Bank Location City/9	County: Eupora/Webster & Choctaw County Sampling Date: 03/21/2018
Applicant/Owner: Berg Mitigation Banks LLC	State: MS Sampling Point: DP-1
Investigator(s): B. Pittman Sect	ion, Township, Range: Section 12, T-19N, R-11E
	al relief (concave, convex, none): _gently sloping Slope (%): _1-3
Subregion (LRR or MLRA): Lat:	
Soil Map Unit Name: Arkabutla silt loam (Ak)	NWI classification: none
Are climatic / hydrologic conditions on the site typical for this time of year?	Yes No (If no, explain in Remarks.)
Are Vegetation, Soil, or Hydrology significantly distu	rrbed? Are "Normal Circumstances" present? Yes No
Are Vegetation, Soil, or Hydrology naturally problem	natic? (If needed, explain any answers in Remarks.)
SUMMARY OF FINDINGS – Attach site map showing sar	mpling point locations, transects, important features, etc.
Hydrophytic Vegetation Present? Hydric Soil Present? Wetland Hydrology Present? Yes ✓ No No No Remarks:	Is the Sampled Area within a Wetland? Yes No

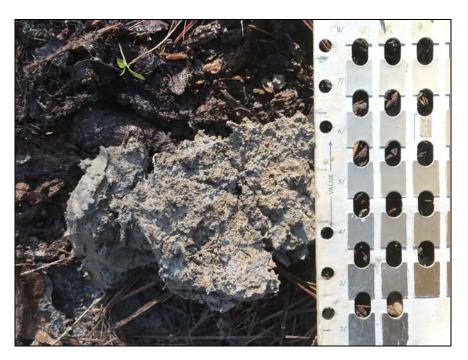
Hydric soil at DP-1

Profile Des	cription: (Describe	to the dept	h needed to docui	ment the i	indicator	or confir	m the absence	of indicators.)
Depth						_		
(inches)	Color (moist)	%	Color (moist)	%	Type ¹	Loc ²	<u>Texture</u>	Remarks
0-17	10 YR 6/1	55%	10 YR 6/2	30%	KIVI	IVI	Silt Loam	
			10 YR 6/8	15%				
					. —			
		:						
1Type: C=C	oncentration, D=Dep	oletion PM-	Peduced Matrix M	S-Macker	d Sand G	aine	2l ocation:	PL=Pore Lining, M=Matrix.
	Indicators: (Applic					aiiis.		for Problematic Hydric Soils ³ :
		abio to all i				DD C T		-
Histoso			Polyvalue Be				· —	Muck (A9) (LRR O)
1	pipedon (A2)		Thin Dark Su					Muck (A10) (LRR S)
_	istic (A3)		Loamy Muck			(0)		ed Vertic (F18) (outside MLRA 150A,B)
	en Sulfide (A4)		Loamy Gleye		(۲۷)			ont Floodplain Soils (F19) (LRR P, S, T)
_	d Layers (A5)	T 11\	✓ Depleted Ma		E6)			alous Bright Loamy Soils (F20) RA 153B)
	: Bodies (A6) (LRR F		Redox Dark	,	,		•	•
I —	ucky Mineral (A7) (L l resence (A8) (LRR L		Depleted Da Redox Depre					arent Material (TF2) Shallow Dark Surface (TF12)

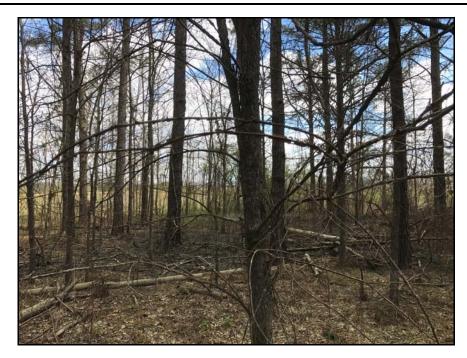
Loblolly Stand, facing road from DP-5

Project/Site: Proposed Mitigation Bank Location City/0	County: Eupora/Webster & Choctaw County Sampling Date: 03/21/2018
Applicant/Owner: Berg Mitigation Banks LLC	State: MS Sampling Point: DP-5
	ion, Township, Range: Section 1, T-19N, R-11E
	I relief (concave, convex, none): gently sloping Slope (%): 1-2
Subregion (LRR or MLRA): Lat: 33.534653	
Soil Map Unit Name: Bonn silt loam (Bo)	NWI classification: none
Are climatic / hydrologic conditions on the site typical for this time of year?	res _ ✓ No (If no, explain in Remarks.)
Are Vegetation, Soil, or Hydrology significantly distu	rbed? Are "Normal Circumstances" present? Yes <u>√</u> No
Are Vegetation, Soil, or Hydrology naturally problem	
	npling point locations, transects, important features, etc.
Hydrophytic Vegetation Present? Hydric Soil Present? Wetland Hydrology Present? Remarks: Site recently control burned	Is the Sampled Area within a Wetland? Yes No

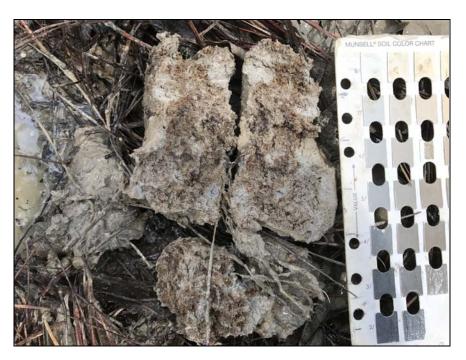
Hydric soil at DP-5

Profile Desc	cription: (Describe	to the dep	th needed to docu	ment the	indicator	or confir	m the absence	of indicators.)
Depth	Matrix			x Feature	es		_	
(inches)	Color (moist)	%	Color (moist)	%	Type ¹	<u>Loc²</u> _	<u>Texture</u>	Remarks
0-6	10 YR 6/1	70%	10 YR 5/8	30%	<u> </u>	IVI	Silt Loam	
6-18	10 YR 6/1	60%	10 YR 5/6	40%		IVI		
1Tumps: C=C	encentration D-Day	nletien DM-		C-Maaka	d Cand C	- ———	2l postion:	PL=Pore Lining, M=Matrix.
			LRRs, unless othe			I all 15.		for Problematic Hydric Soils ³ :
Histosol		cable to all	Polyvalue Be			IDDCT		fuck (A9) (LRR O)
l —	pipedon (A2)		Thin Dark St					Muck (A3) (LRR S)
I — ·	istic (A3)		Loamy Muck	•	, ,			ed Vertic (F18) (outside MLRA 150A,B)
l —	en Sulfide (A4)		Loamy Gley			ι Ο,		ont Floodplain Soils (F19) (LRR P, S, T)
1 —	d Layers (A5)		✓ Depleted Ma		(1 2)			lous Bright Loamy Soils (F20)
	Bodies (A6) (LRR I	P, T, U)	Redox Dark		F6)			RA 153B)
	ucky Mineral (A7) (L			,			•	arent Material (TF2)

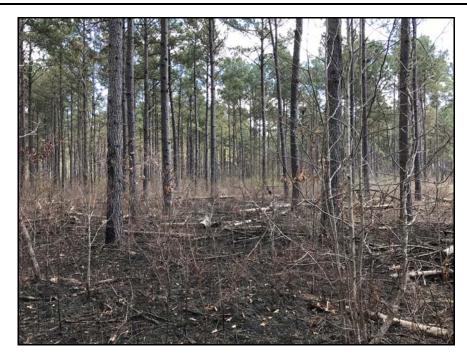
Loblolly Stand, facing north from DP-6

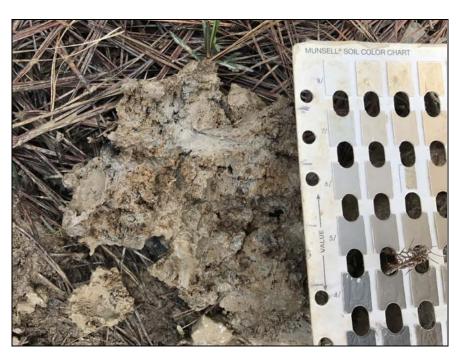
Hydric soil at DP-6

Profile Desc	ription: (Describe	to the dept	th needed to docu	ment the	indicator	or confirm	n the absence o	of indicators.)
Depth Matrix Redox Features								
(inches)	Color (moist)	%	Color (moist)	%	Type ¹	<u>Loc²</u>	<u>Texture</u>	Remarks
0-17	10 YR 5/1	70%	10 YR 5/6	30%	<u></u>	IVI	Silt Loam

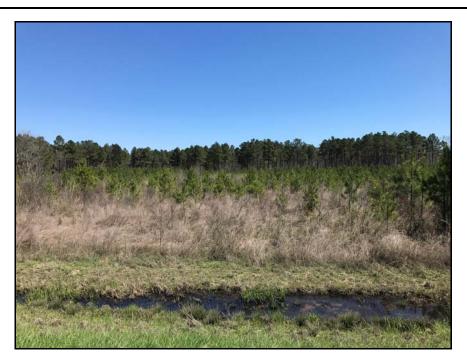
Young/bedded loblolly stand, facing east from South Sapa Road

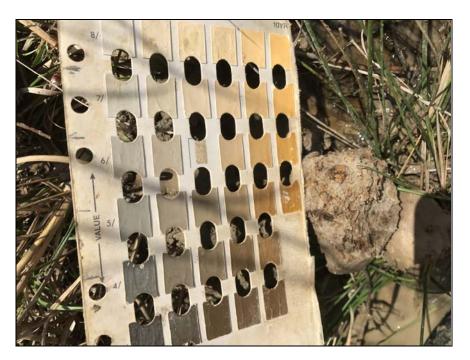
Hydric soil at DP-9

Profile Des	cription: (Describe	to the depth	needed to docum	nent the i	ndicator	or confir	m the absence	of indicators.)
Depth	Matrix		Redo	x Features	s		_	
(inches)	Color (moist)	%	Color (moist)	%	Type ¹	Loc ²	<u>Texture</u>	Remarks
0-17	10 YR 6/1	50%	10 YR 4/2	30%	U	IVI	Silt Loam	
			10 YR 5/6	20%	U	IVI		
			10 11(0/0					
l ———								
1							2	
	oncentration, D=Dep		<u></u>			rains.		PL=Pore Lining, M=Matrix.
Hydric Soil	Indicators: (Applic	able to all L	RRs, unless other	rwise note	ed.)		Indicators	for Problematic Hydric Soils ³ :
Histoso	(A1)		Polyvalue Be				· —	Muck (A9) (LRR O)
Histic E	pipedon (A2)		Thin Dark Su	ırface (S9)	(LRR S	, T, U)	2 cm M	/luck (A10) (LRR S)
Black H	istic (A3)		Loamy Muck	y Mineral	(F1) (LR I	R O)	Reduc	ed Vertic (F18) (outside MLRA 150A,B)
Hydroge	en Sulfide (A4)		Loamy Gleye	ed Matrix (F2)		Piedm	ont Floodplain Soils (F19) (LRR P, S, T)
Stratifie	d Layers (A5)		✓ Depleted Mat	trix (F3)			Anoma	alous Bright Loamy Soils (F20)

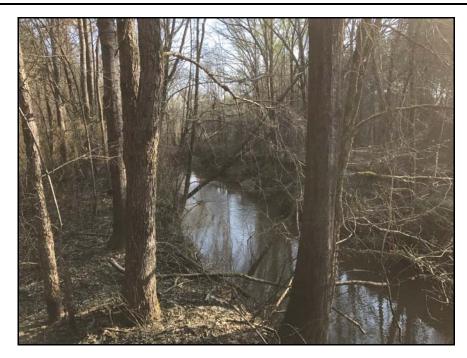
Spring Creek Canal

The property is located within the 100-year floodplain of the Big Black River. One unnamed canal/ditch and the Spring Creek Canal transect the proposed site. These features were historically constructed for flood control. The original Big Black River channel transects/borders the site for approximately 13,513 linear feet. The majority of the hydrology from the original channel was diverted to the Big Black River Canal that is located adjacent to the south of the site. The Big Black River (Water Body ID: 100111) is listed by the MS DEQ as an impaired 303(d) stream from the headwaters to the MWS 1003 boundary.

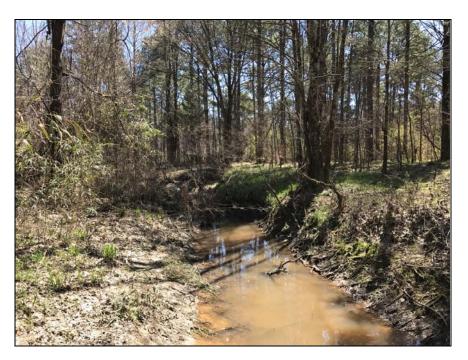
Original Channel of Big Black River, east of Sapa Road

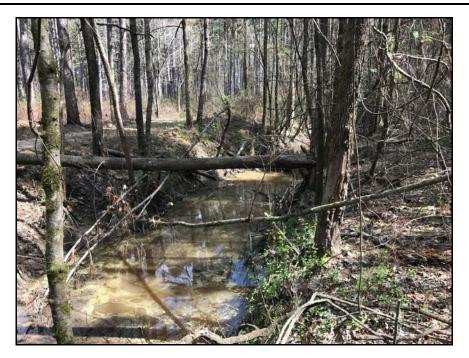
Unnamed/smaller canal, near DP-4

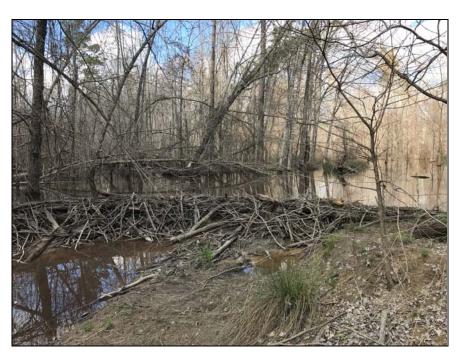
Beaver dam and ponded area near DP-10

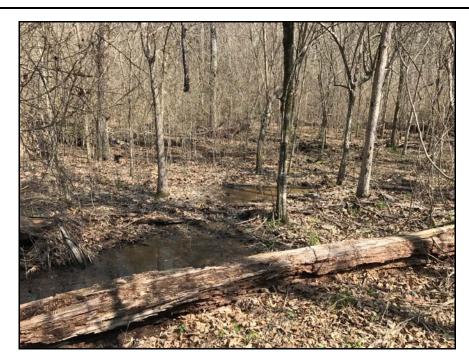
Hardwood regeneration near DP-3

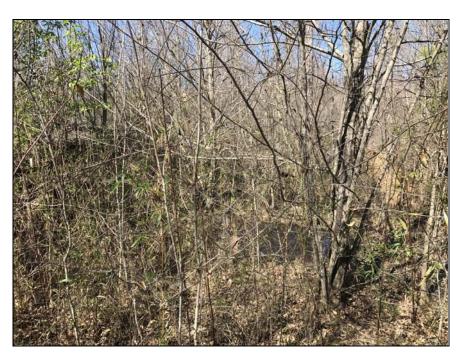
Dense shrub hardwood at DP-20

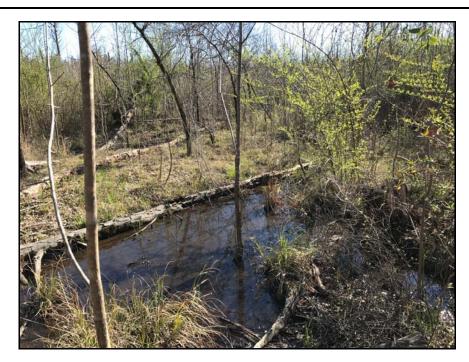
Hardwood regeneration at DP-23, Chinese privet present

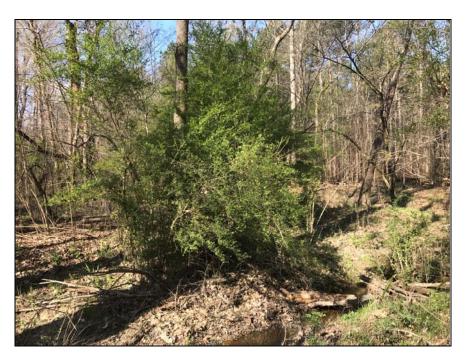
Large privet along old Big Black River Channel

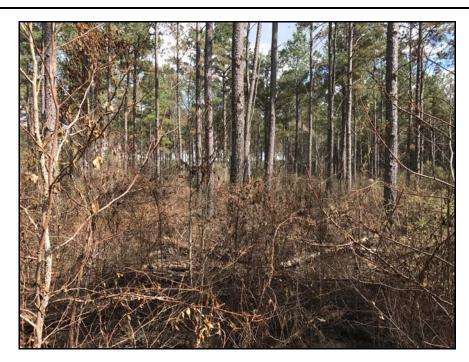
Delineated upland at DP-11

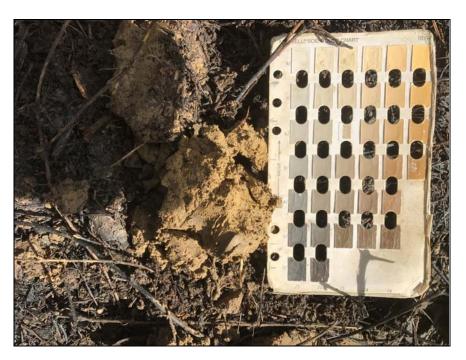
Non-hydric soil at DP-11

Profile Desc	ription: (Describe	to the depti	n needed to docum	nent the i	ndicator	or confirm	n the absence	of indicators.)
Depth	Matrix		Redo	x Features	6			
(inches)	Color (moist)	%	Color (moist)	%	Type ¹	Loc ²	Texture	Remarks
0-17	10 YR 5/4	100%					Silt Loam	
¹ Type: C=Co	oncentration, D=Dep	oletion, RM=I	Reduced Matrix, MS	S=Masked	Sand Gr	ains.	² Location:	PL=Pore Lining, M=Matrix.
Hydric Soil I	ndicators: (Applic	able to all L	RRs, unless other	wise note	ed.)		Indicators	for Problematic Hydric Soils ³ :
Histosol	(A1)		Polyvalue Be	low Surfac	ce (S8) (L	RR S. T. I	J) 1 cm N	fluck (A9) (LRR O)
	ipedon (A2)		Thin Dark Su					fluck (A10) (LRR S)
Black Hi			Loamy Muck	, ,	, ,			ed Vertic (F18) (outside MLRA 150A,B)
	n Sulfide (A4)		Loamy Gleye			,		ont Floodplain Soils (F19) (LRR P, S, T)
	I Layers (A5)		Depleted Mai		· -/			llous Bright Loamy Soils (F20)
	Bodies (A6) (LRR F	T 111	Redox Dark		6)			RA 153B)
