**Re: Pelican Foster Mitigation Bank Addendum Prospectus
MVK-2012-00197
Pelican Mitigation, LLC
Ashley County, Arkansas
Matrix Project No. 19-043**

**PELICAN FOSTER MITIGATION BANK
ADDENDUM PROSPECTUS
MVK-2012-00197
ASHLEY COUNTY, ARKANSAS**

Matrix Project No. 19-043

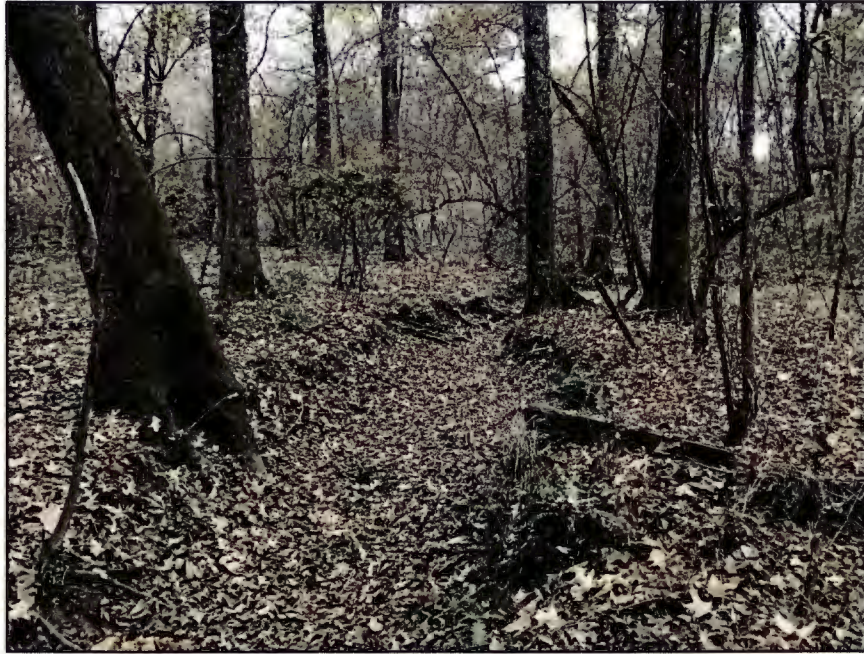
Photo #1: RC-01 facing downstream showing a stable E6 stream with leaf litter during the dry month of November.

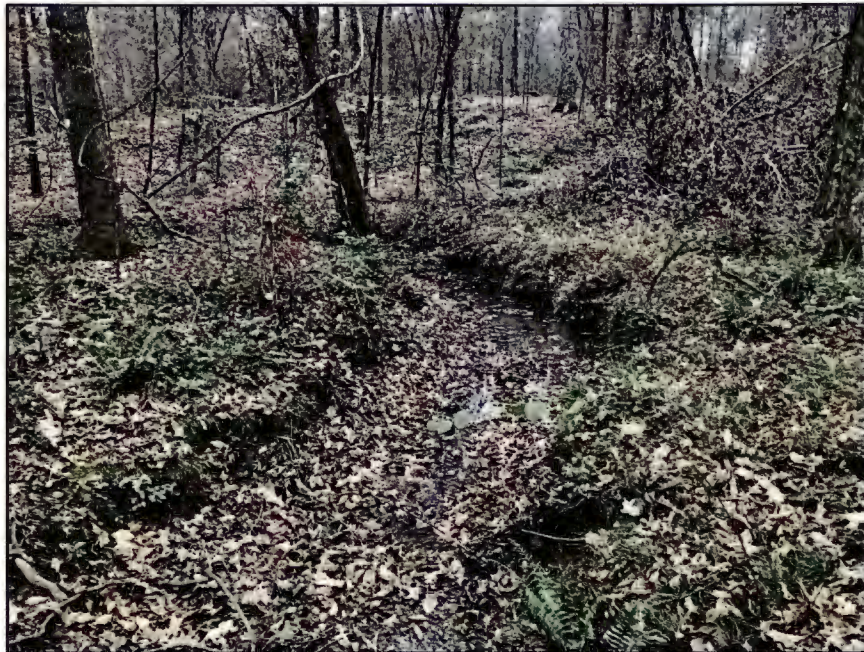
Photo #2: RC-02 facing upstream showing a stable E4/6 stream with good floodplain connectivity.

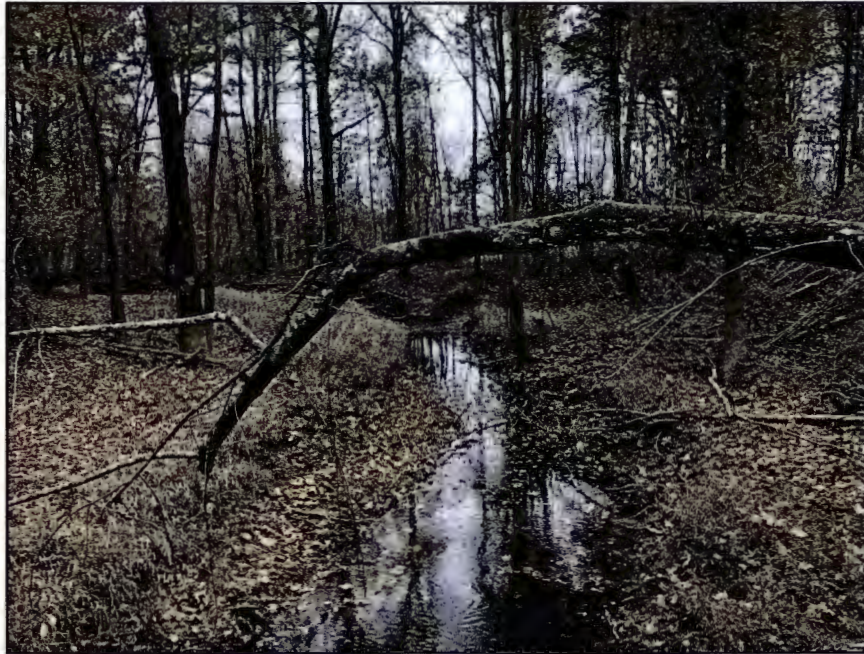
Photo #3: RC-03 facing downstream showing a larger perennial stream channel with stable channel geometry.

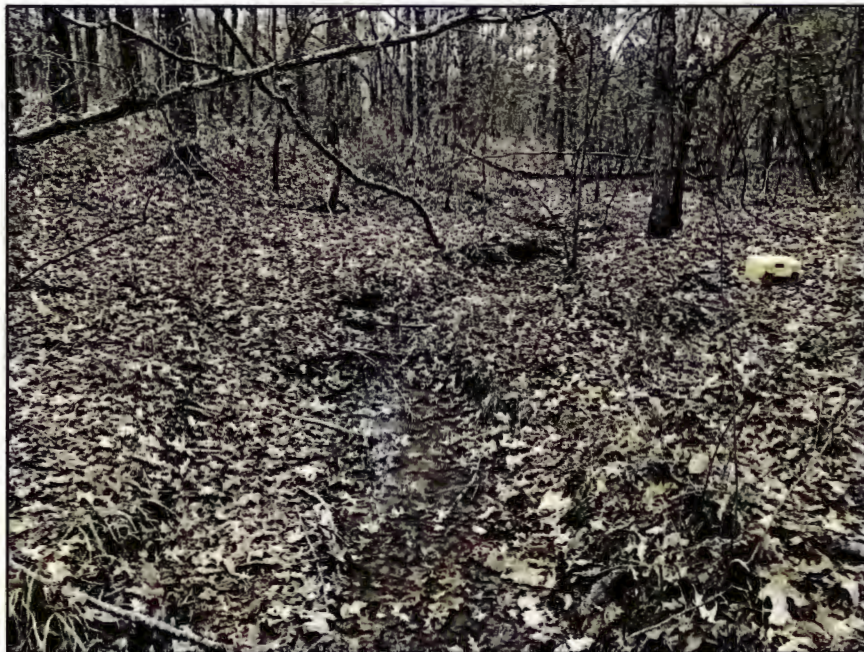
Photo #4: RC-04 facing upstream on a small headwater stream channel which stable channel form.

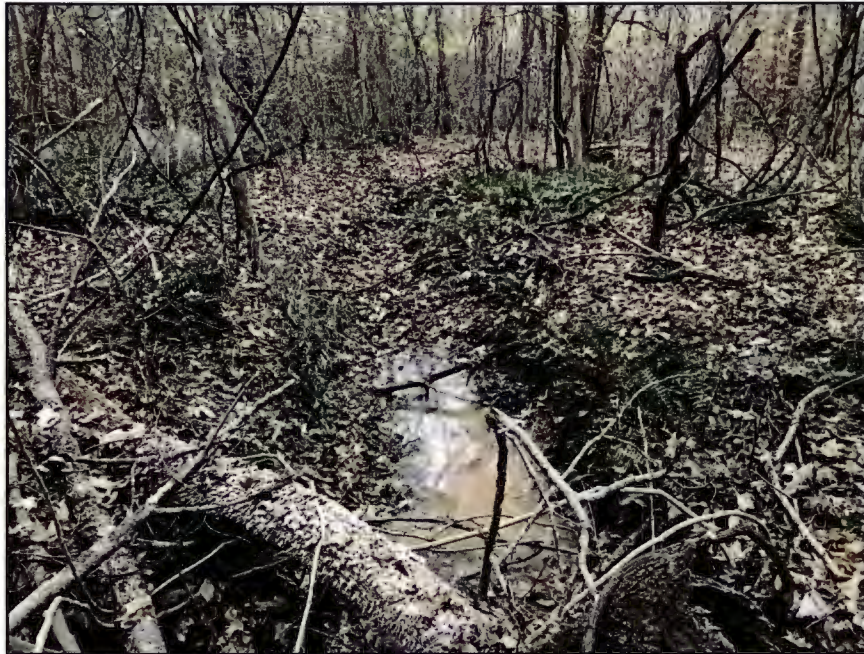
Photo #5: RC-05 facing downstream on the project's reference reach with little flow, mostly in pool features.

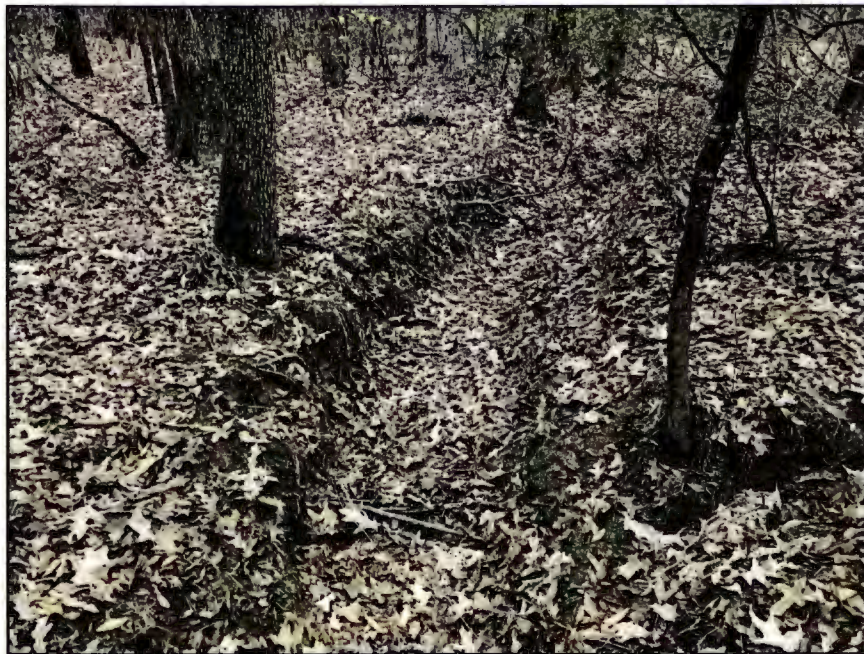
Photo #6: RC-06 facing upstream showing a stable E6 stream with leaf litter during the dry month of November.

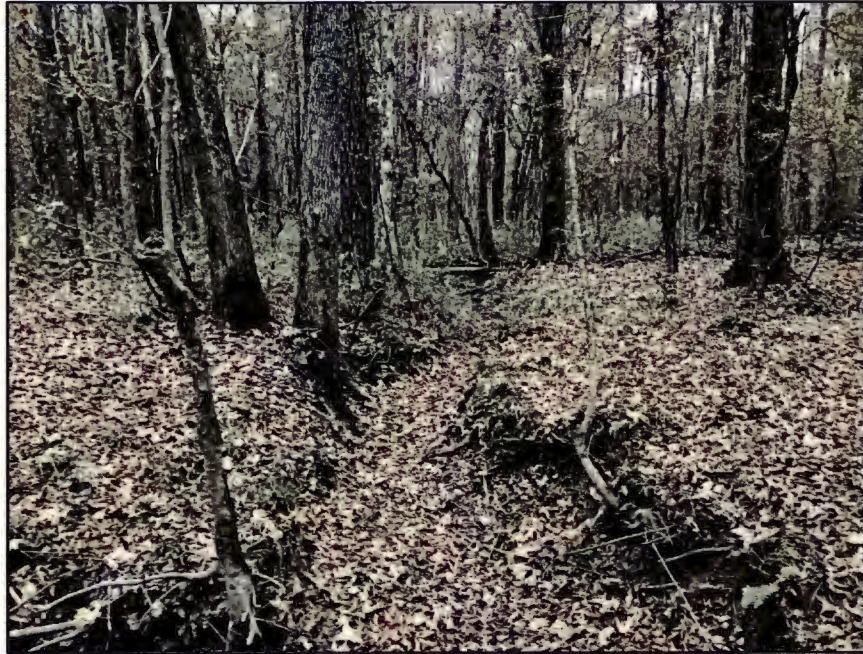
Photo #7: RC-07 facing downstream showing a stable E6 channel with good floodplain connectivity.

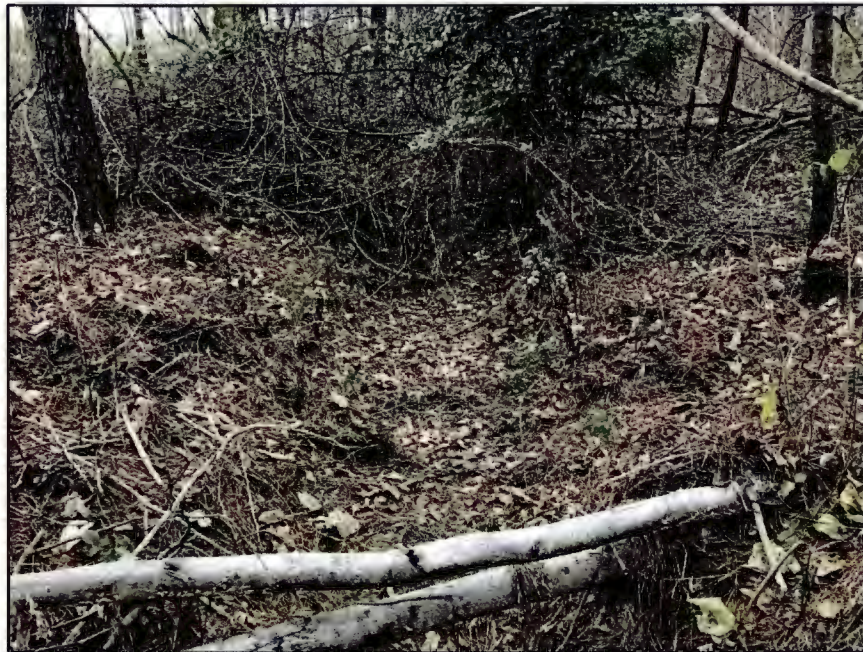
Photo #8: RC-08 facing upstream showing a small headwater E6 channel with little bedform diversity but stable channel form.

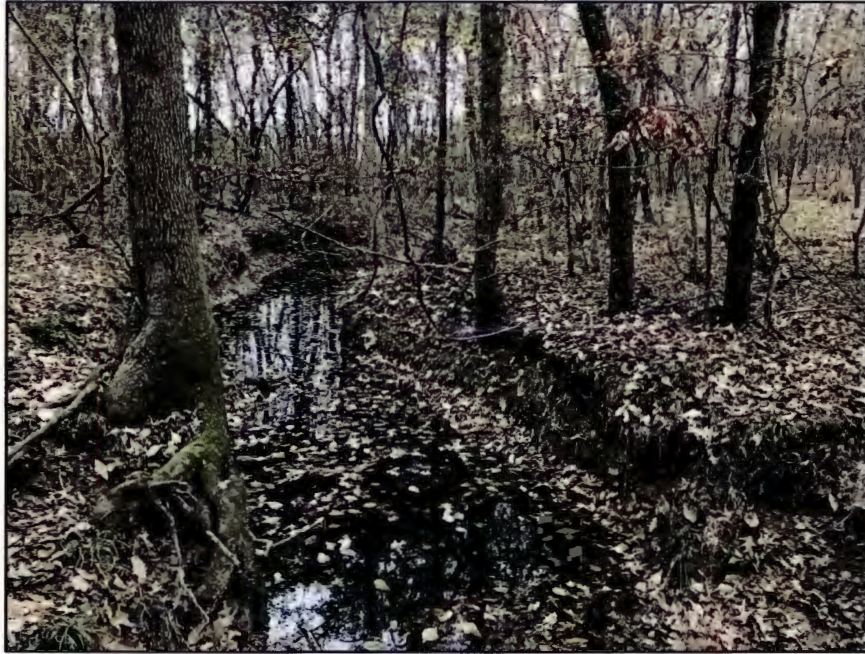
Photo #9: RC-09 facing upstream showing a large stream that has downcut slightly but had bankfull indicators that were useful in developing the RC.

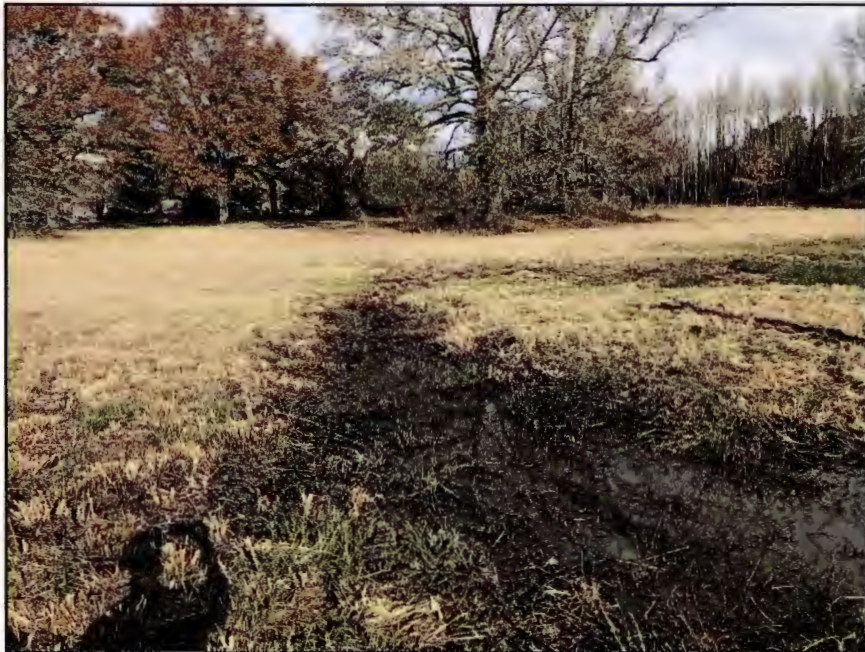
Photo #10: UT1 Reach 1 area in the pasture where the stream channel has been impaired by cattle operation and a lack of buffer.

the upstream-most reach to become filled from cattle impacts and aggradated conditions which allowed pasture grasses to grow into the channel forming unnatural swale-like conditions.

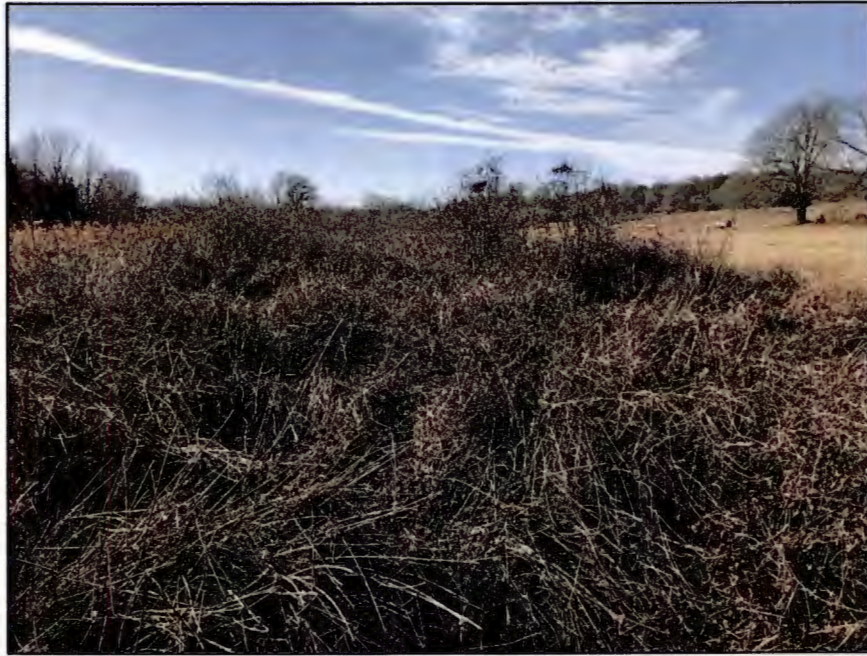
Photo #11: UT1 Reach 2 where a grassy stream wetland complex exists and is linear in nature.

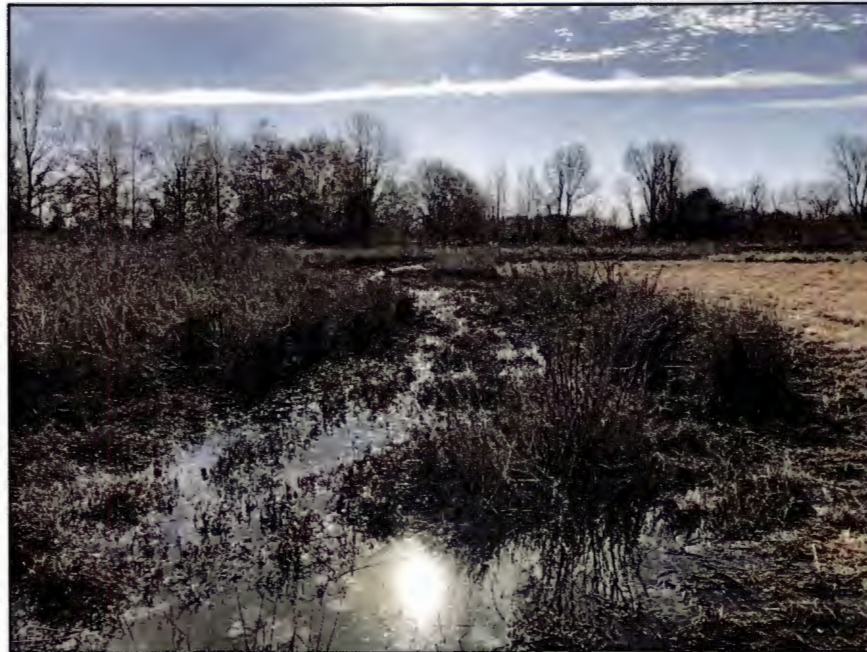
Photo #12: UT1 Reach 3 beginning where stream wetland complex ends and transitions into a single-thread channel.

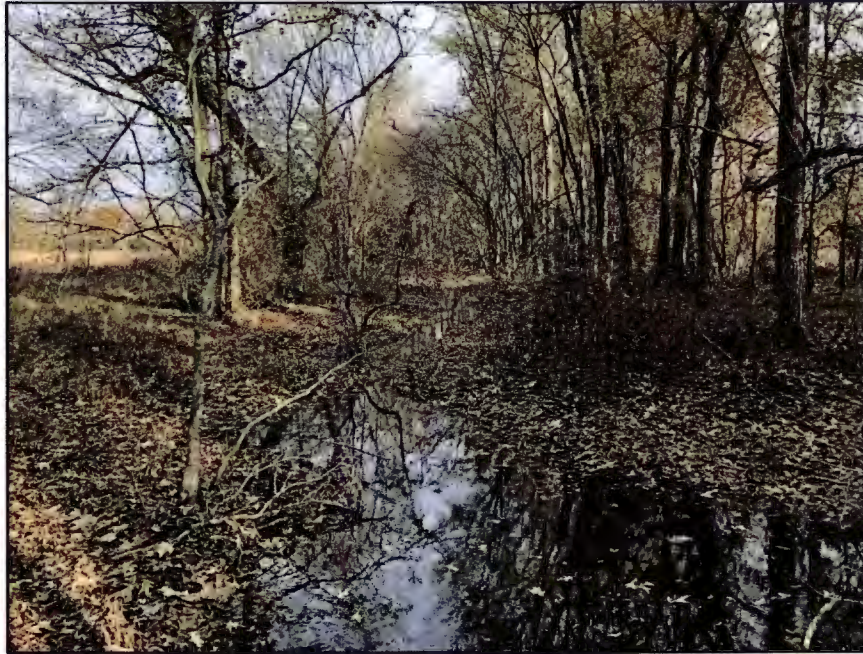
Photo #13: UT1 Reach 2 where the channel has an existing buffer and has maintained its channel.

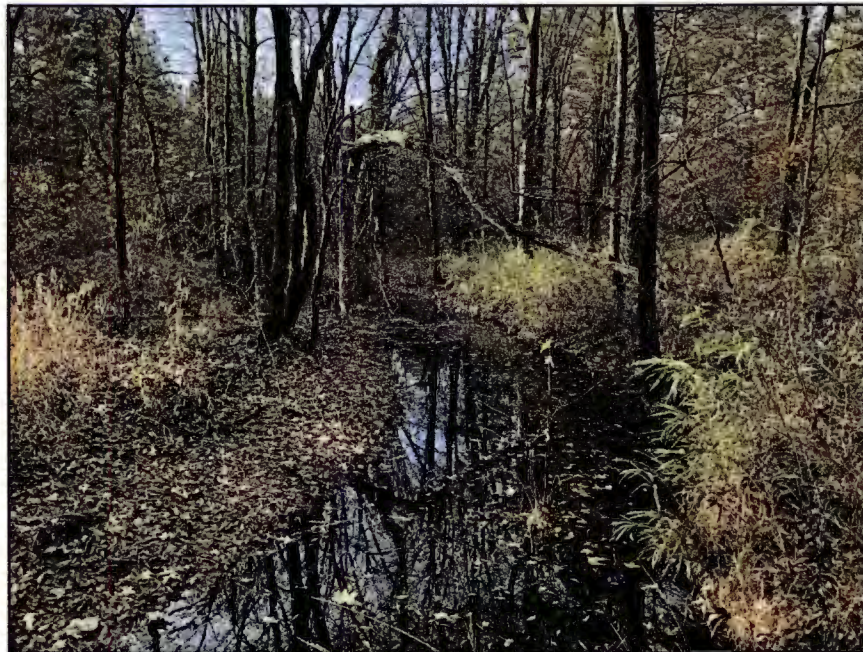
Photo #14: UT1 downstream of the project boundary showing a stable stream channel flowing towards Overflow Creek.
