## **APPENDIX F-4: HAZARDOUS, TOXIC, AND RADIOACTIVE WASTE (HTRW)**

### UPDATE MEMORANDUM HAZARDOUS, TOXIC, AND RADIOACTIVE WASTE (HTRW) EVALUATION SUPPLEMENT NO. 2 TO THE 1982 YAZOO AREA PUMP PROJECT FINAL ENVIRONMENTAL IMPACT STATEMENT

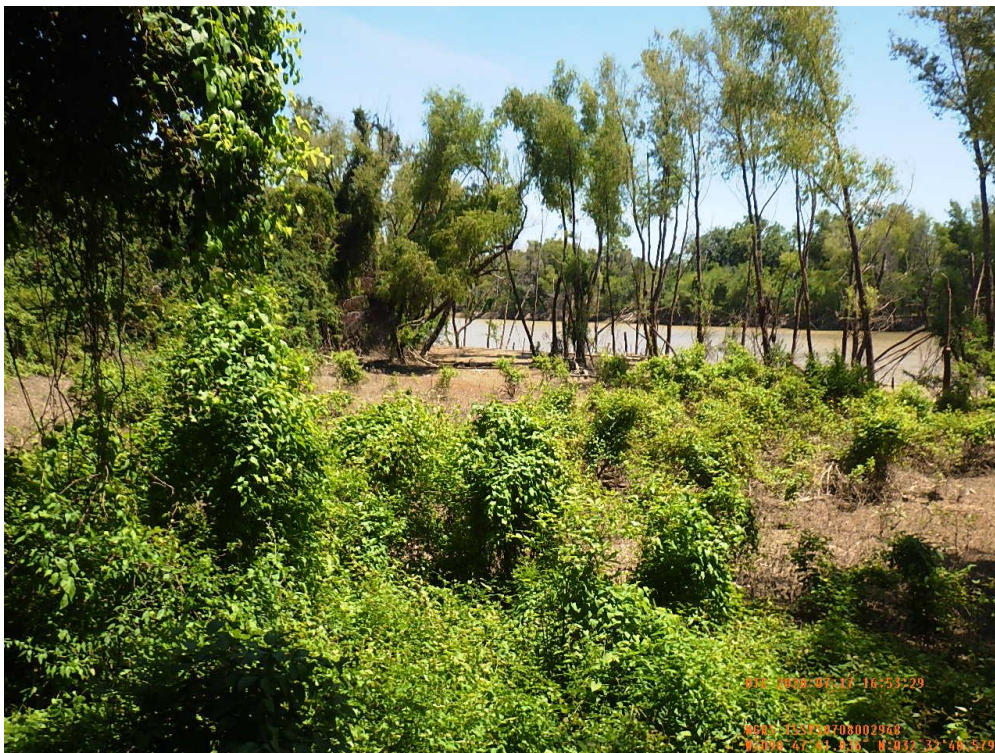
**Figure 12. Typical picture of the right descending bank of the Yazoo River located within the footprint of the pump station ROW.**

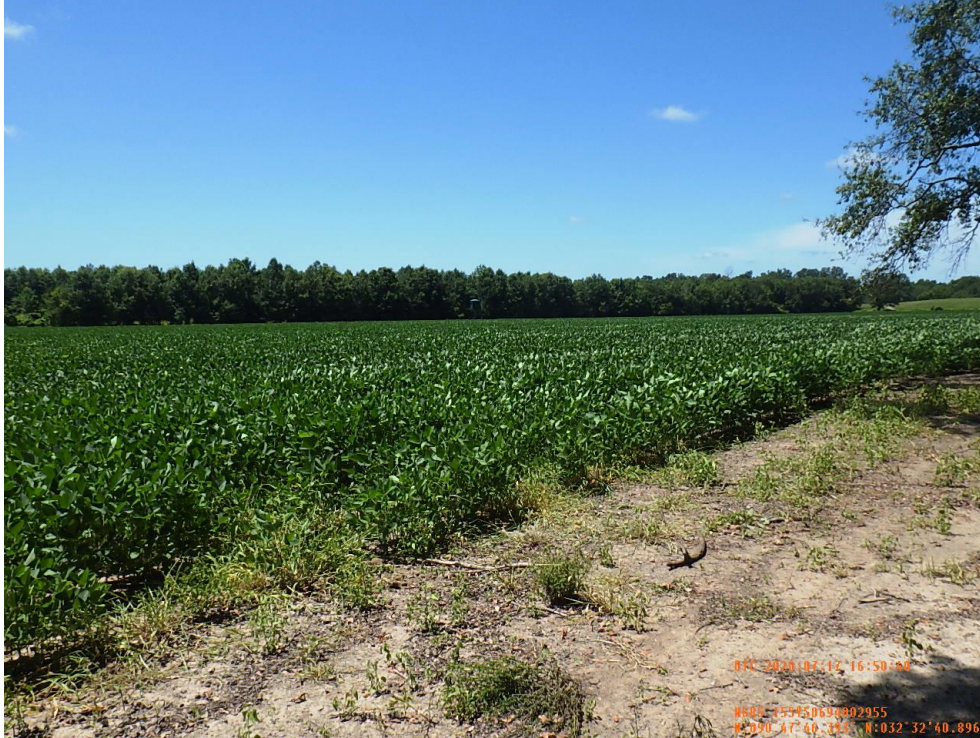
**Figure 13. Typical picture of agricultural field located within the footprint of the pump station ROW.**

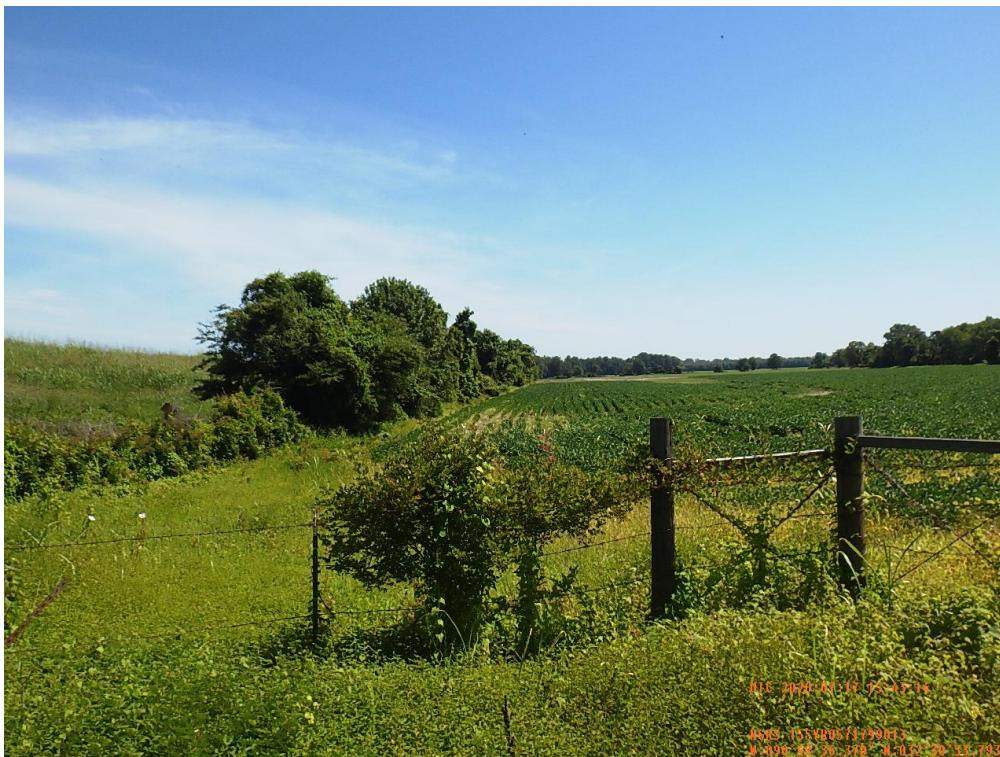
**Figure 14. Typical picture of agricultural field along the eastern toe of the Yazoo Backwater Levee facing northeast from Highway 61 located within the footprint of the pump station utility access.**

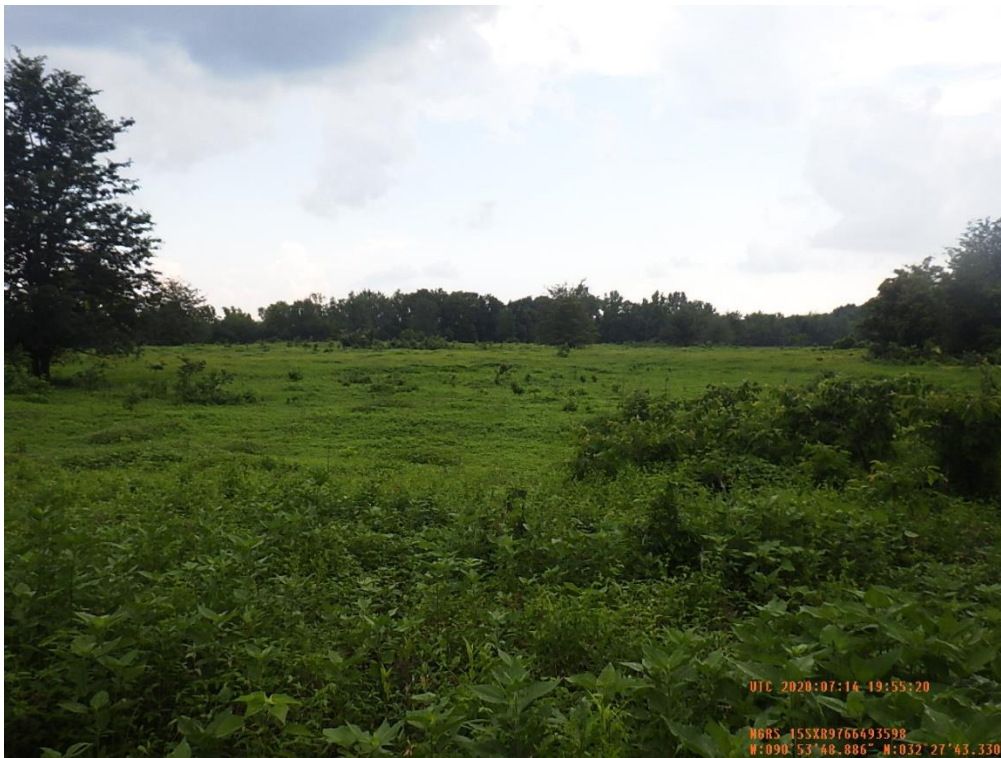
The borrow area along with the previously constructed coffer dams and the proposed access roads located along the Yazoo Backwater Levee south of the Steele Bayou water control structure were visited on 14 July 2020. The area appeared to be utilized for cattle farming and recreational deer hunting. Tractors, agricultural implements, catch pens, and fencing were observed throughout the site. One irregularly shaped object which contained five partially filled hydraulic oil buckets (5-gallon) was observed on the northeast quadrant of the borrow area (Figures 15-19). Figure 20 shows the typical landscape of the proposed borrow area.

**Figure 20. Typical picture of borrow area facing southwest.**

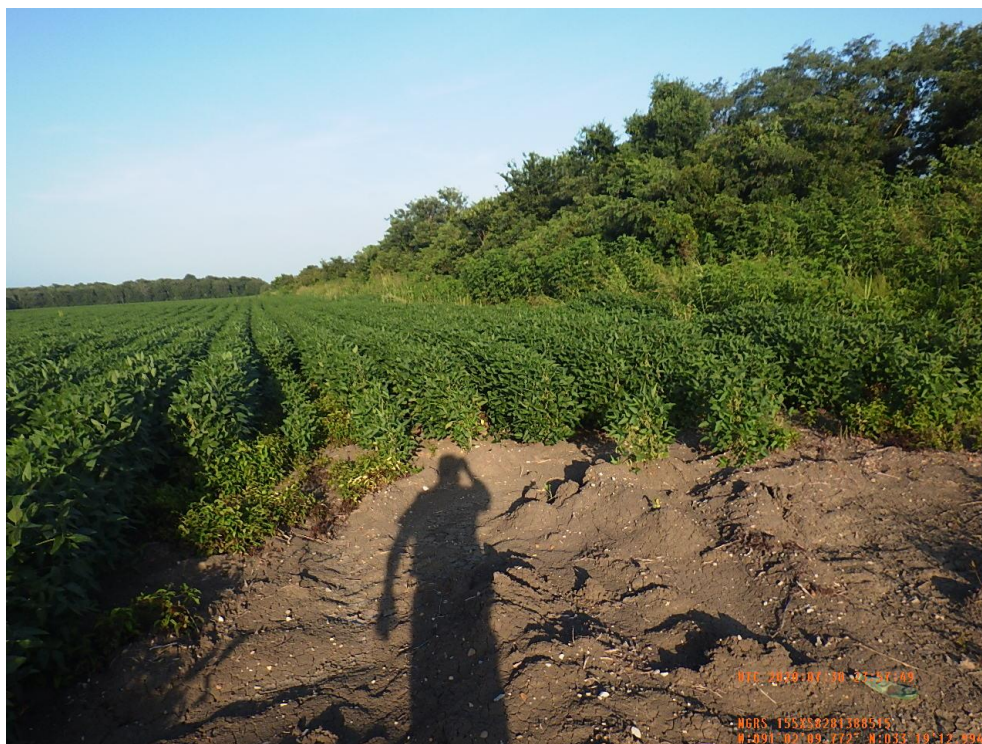
None of the aforementioned indicators of HTRW were found during the ROW site visits to any of the other structural features. Figures 22-54 show the typical landscape for each of the remaining 33 well sites.

**Figure 22. East facing picture from Tate Road of typical area showing well site, YBP-MC-No6-44 (Ditch No6).**

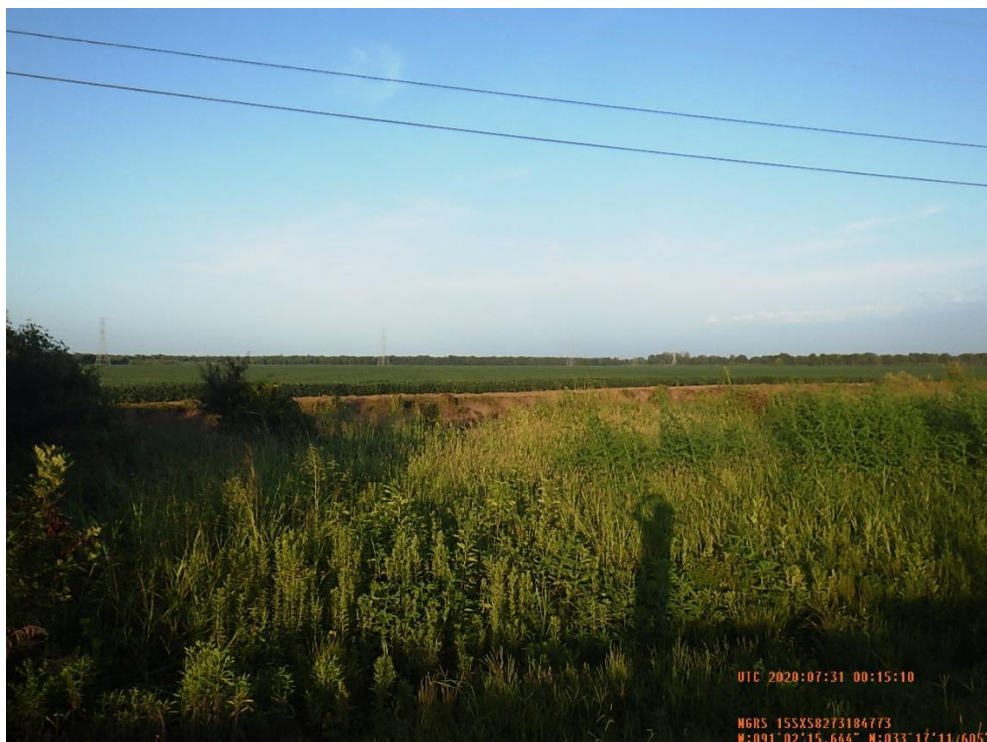
**Figure 23. East facing picture from Highway 1 of typical area showing well site, YBP-MC-No9-43 (Ditch No9).**

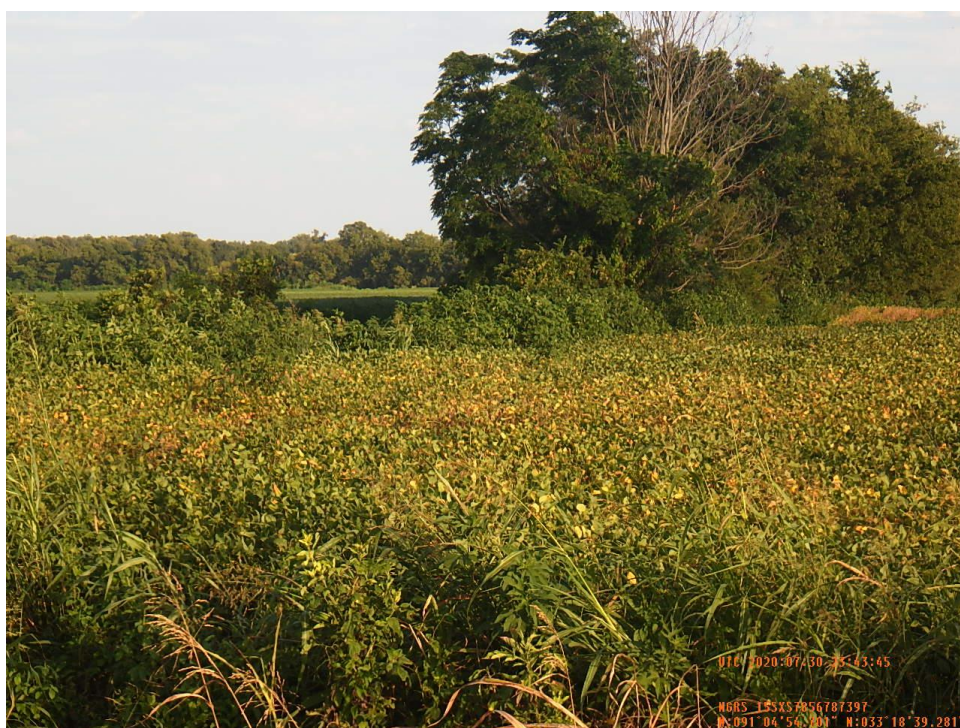
**Figure 24. South facing picture from Highway 454 of typical area showing well site, YBP-MC-No8-41 (Ditch No8).**

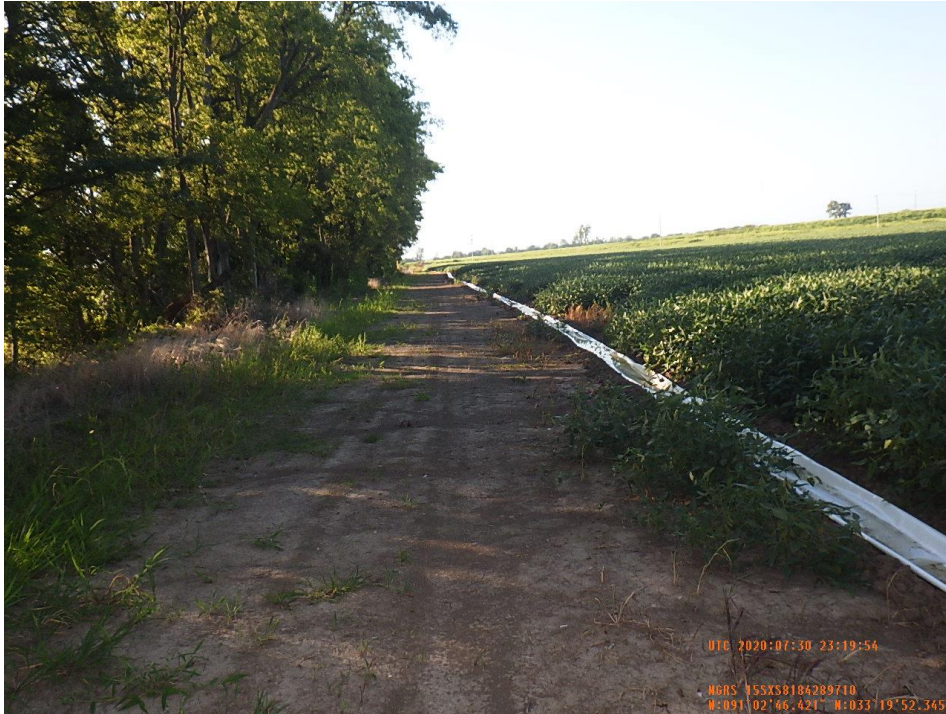
**Figure 25. North facing picture from access road of typical area showing well site, YBP-MC-No6-40 (Ditch No6).**

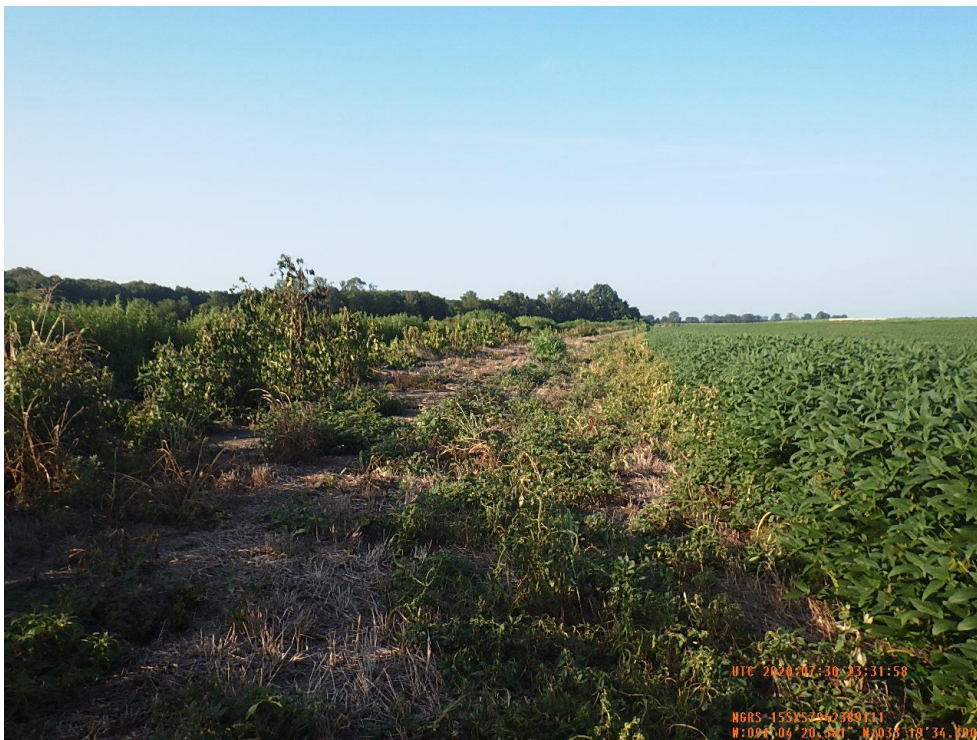
**Figure 26. Northeast facing picture from southwest corner of agricultural field of typical area showing well site, YBP-MC-No8-39 (Ditch No8).**

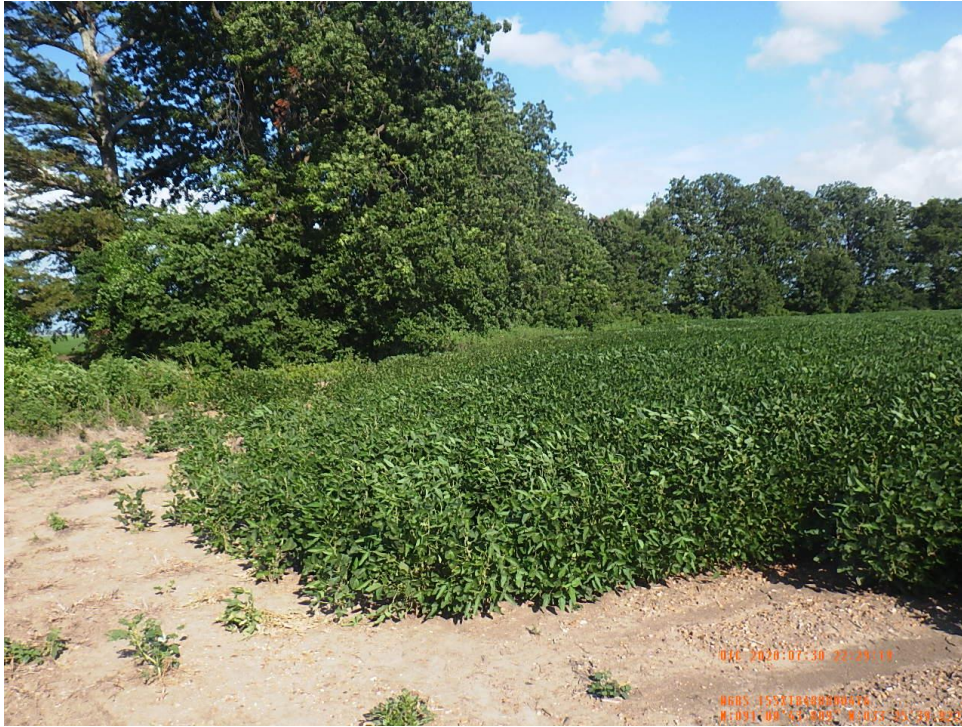
**Figure 27. Southwest facing picture from Horseshoe Bayou Road of typical area showing well site, YBP-BB-HB-35 (Horseshoe Bayou).**

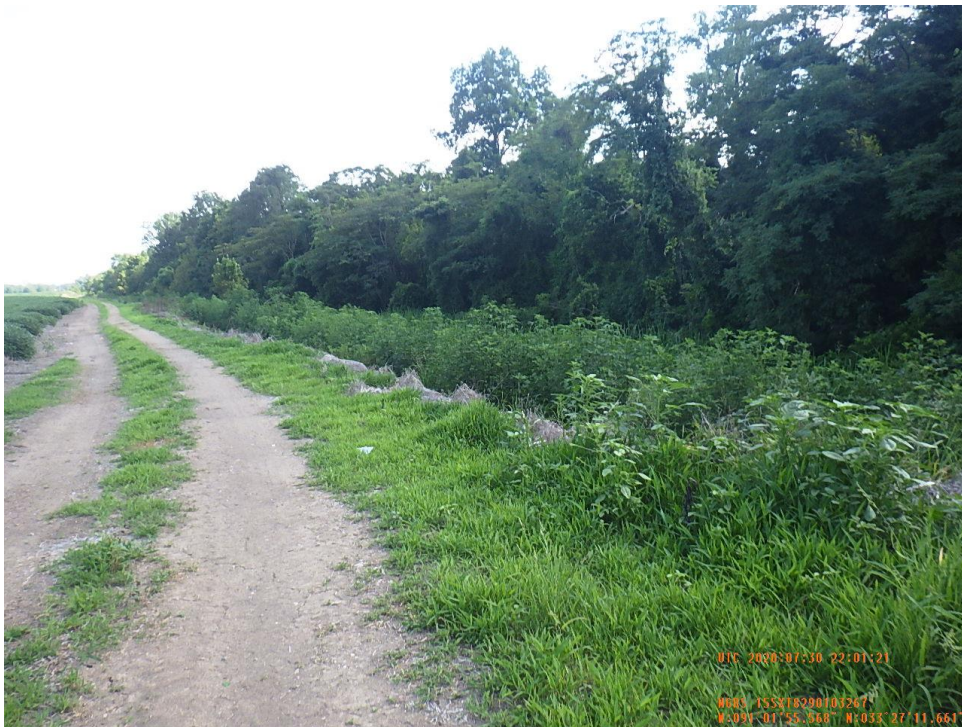
**Figure 28. South facing picture from Metcalf Road of typical area showing well site, YBP-MC-MC-33b (Main Canal).**

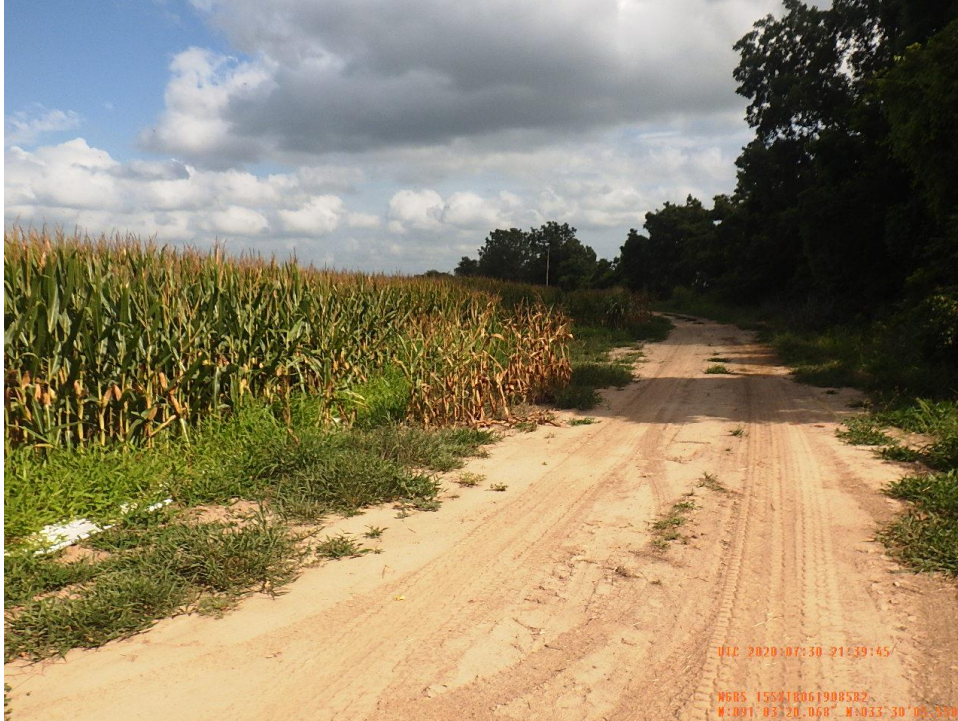
**Figure 29. South facing picture from Hwy 384 of typical area showing well site, YBP-DC-WB-32 (Williams Bayou).**

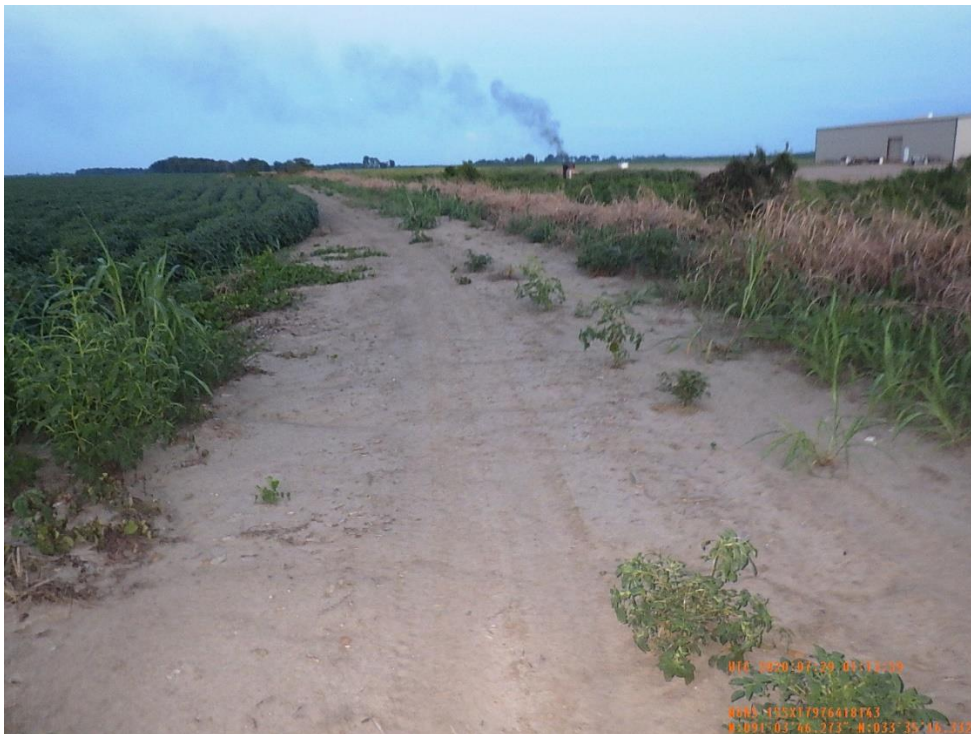
**Figure 30. East facing picture from Pine Road of typical area showing well site, YBP-DC-DC-30 (Deer Creek).**

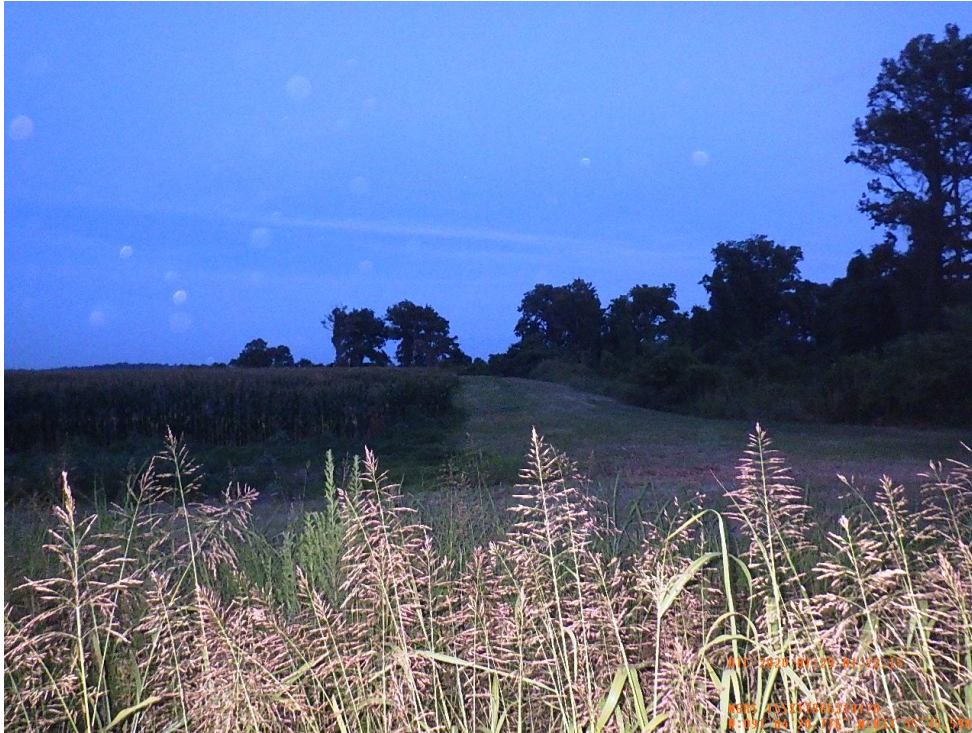
**Figure 31. South facing picture from western corner of agricultural field of typical area showing well site, YBP-DC-DC-29 (Deer Creek).**

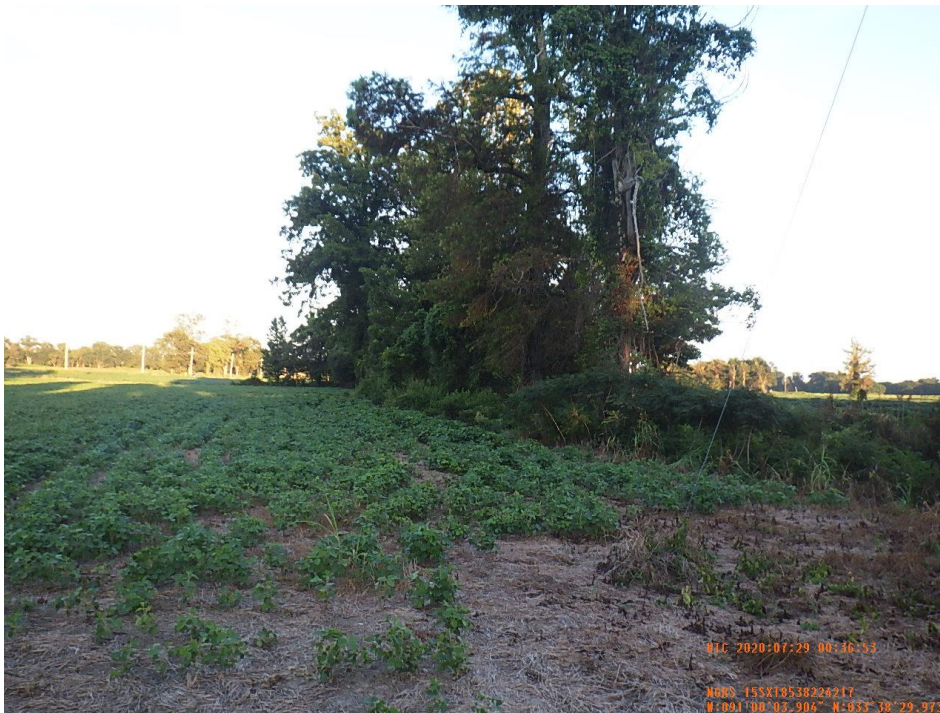
**Figure 32. Southeast facing picture from Burrus Road of typical area showing well site, YBP-DC-BB-28 (Browns Bayou).**

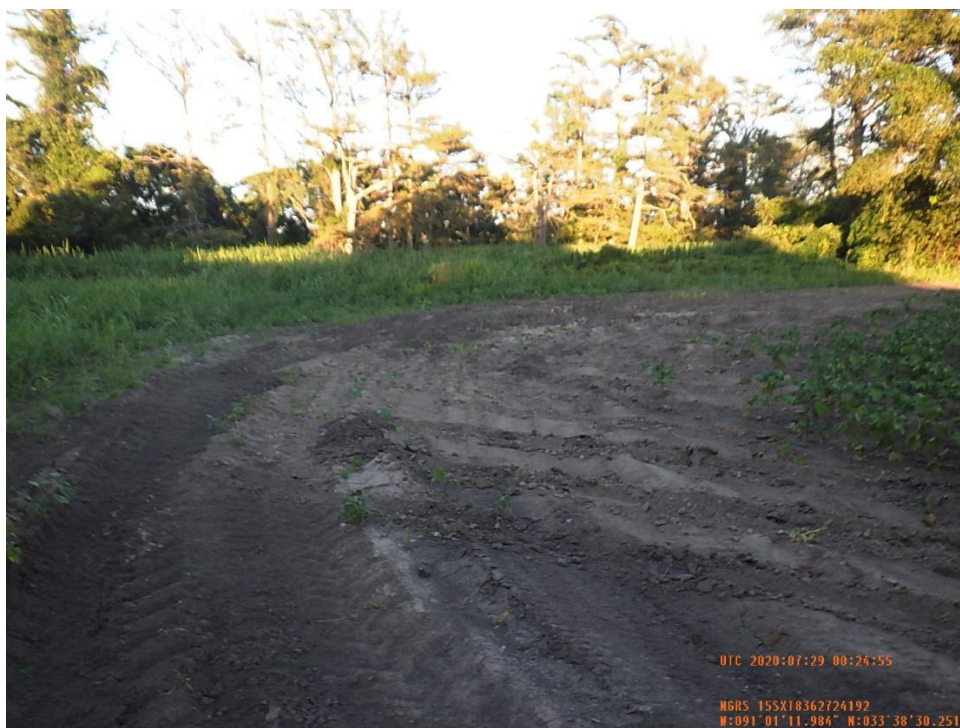
**Figure 33. Southeast facing picture from northern corner of agricultural field of typical area showing well site, YBP-DC-SB-27 (Straight Bayou).**

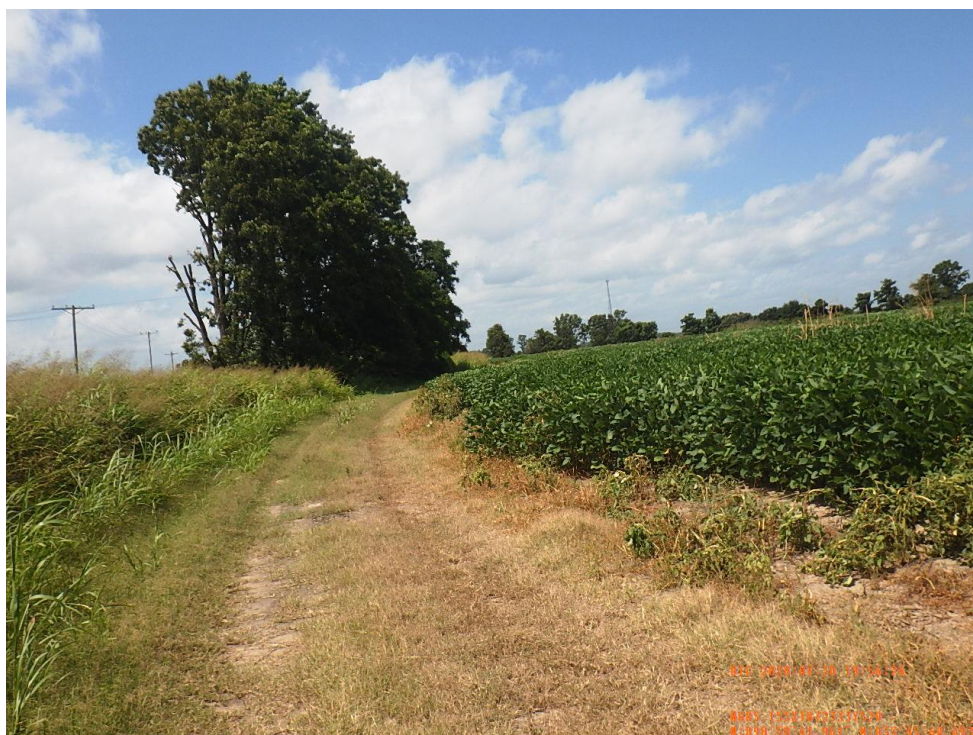
**Figure 34. North facing picture from western edge of cemetery of typical area showing well site, YBP-BP-SB-26 (Lower Stokes Bayou).**

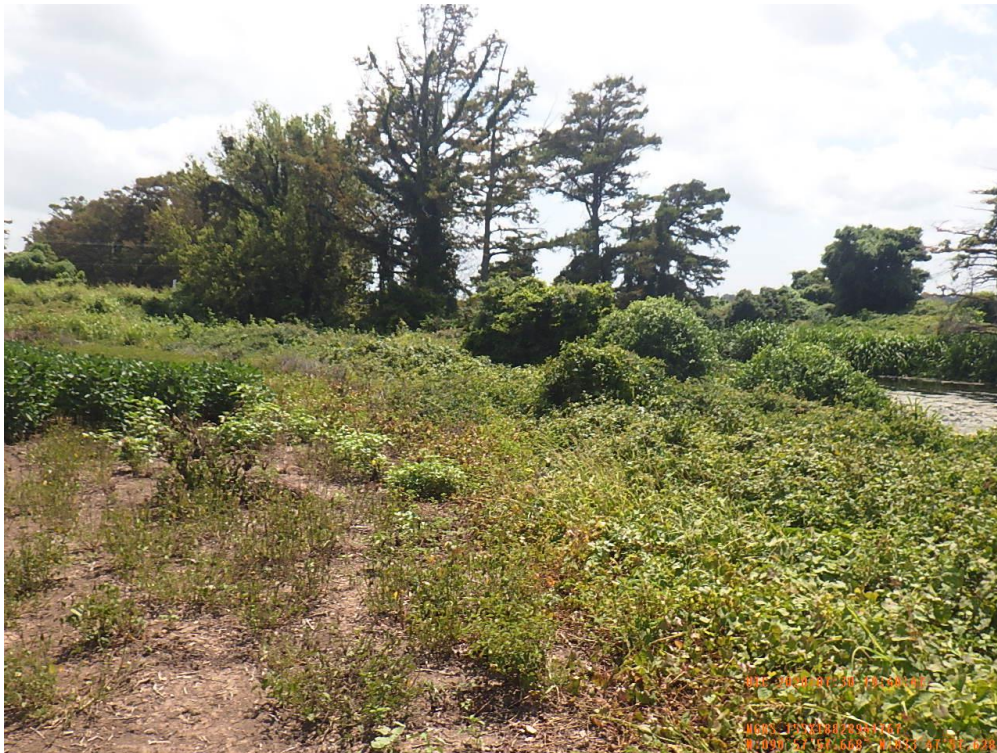
**Figure 35. North facing picture from Beulah Road of typical area showing well site, YBP-BP-LB-24 (Laban Bayou).**

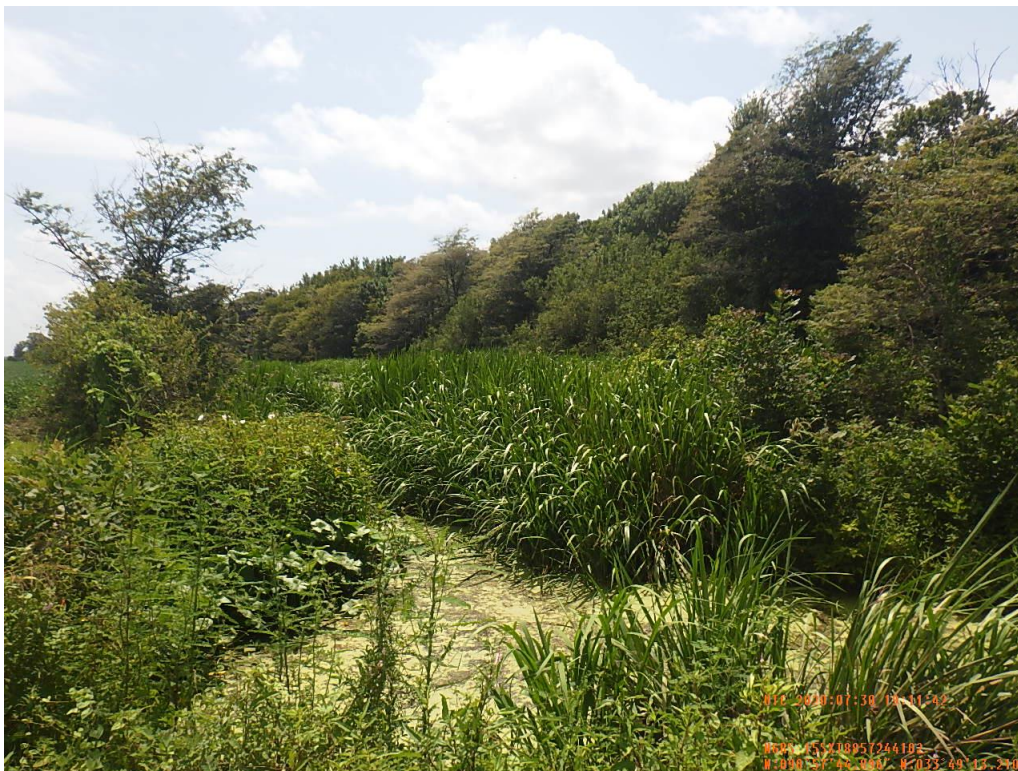
**Figure 36. South facing picture from northwest corner of agricultural field of typical area showing well site, YBP-BP-LB-23 (Laban Bayou).**

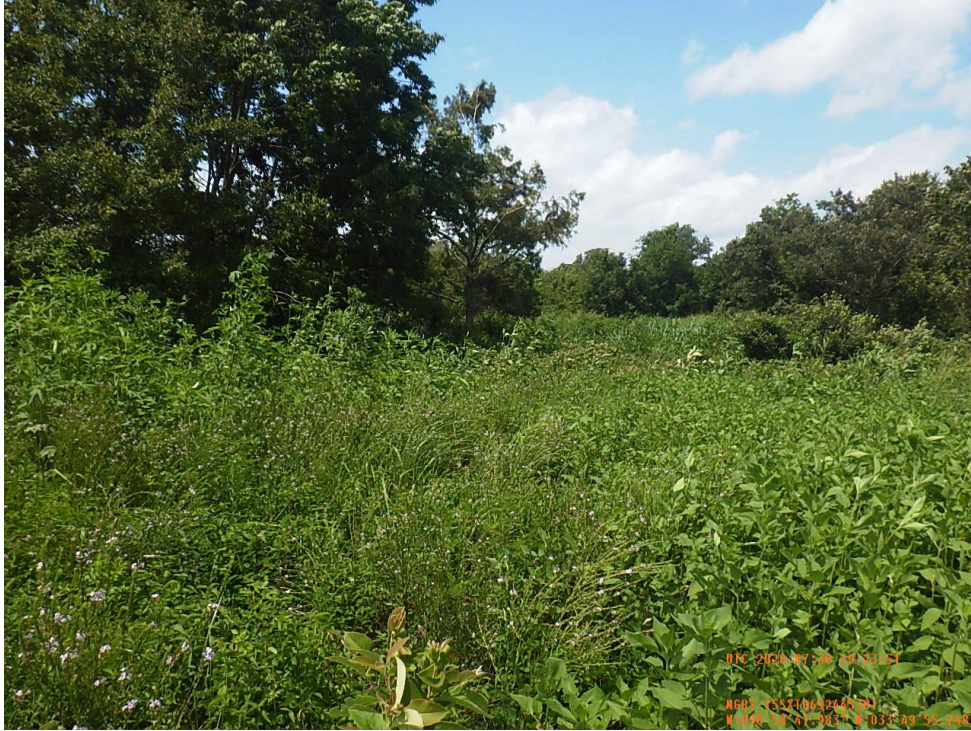
**Figure 37. North facing picture toward Laban Bayou of typical area showing well site, YBP-BP-LB-22 (Laban Bayou).**

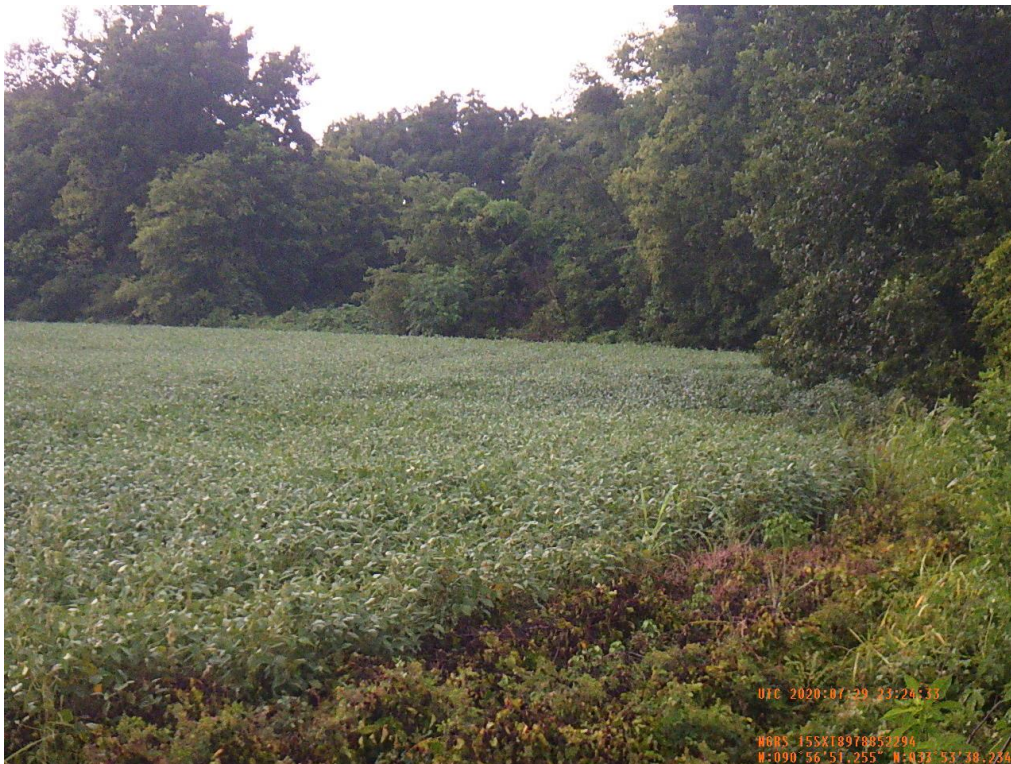
**Figure 38. Northwest facing picture from Gibson Swamp Road of typical area showing well site, YBP-BP-LB-20 (Lane Bayou).**

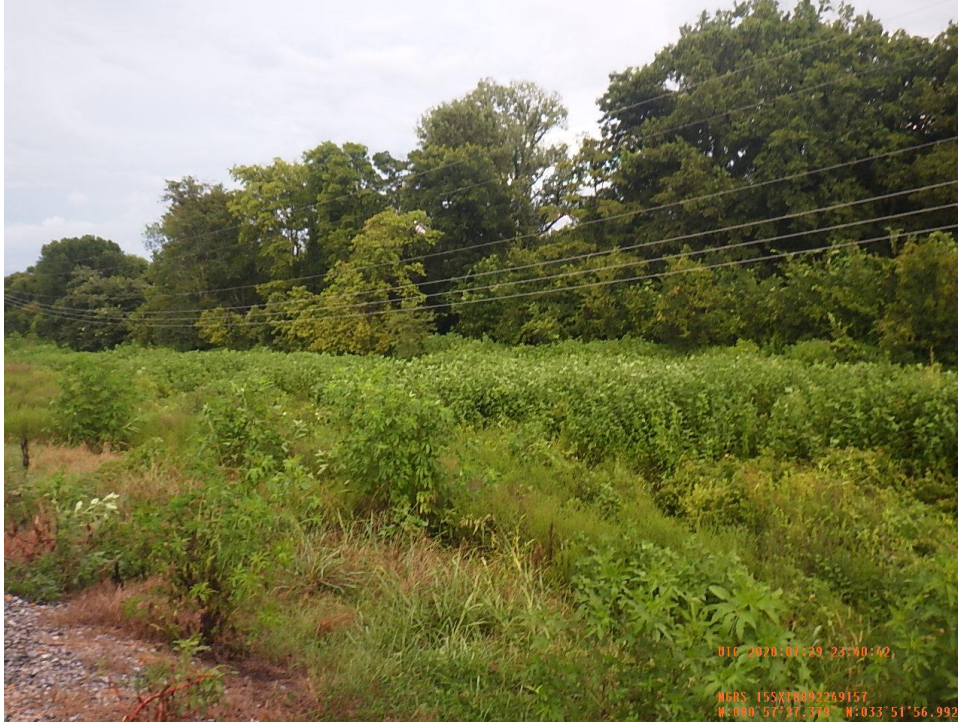
**Figure 39. Southeast facing picture from gravel road of typical area showing well site, YBP-BP-LB-19 (Lane Bayou, Charlie Capp WMA).**

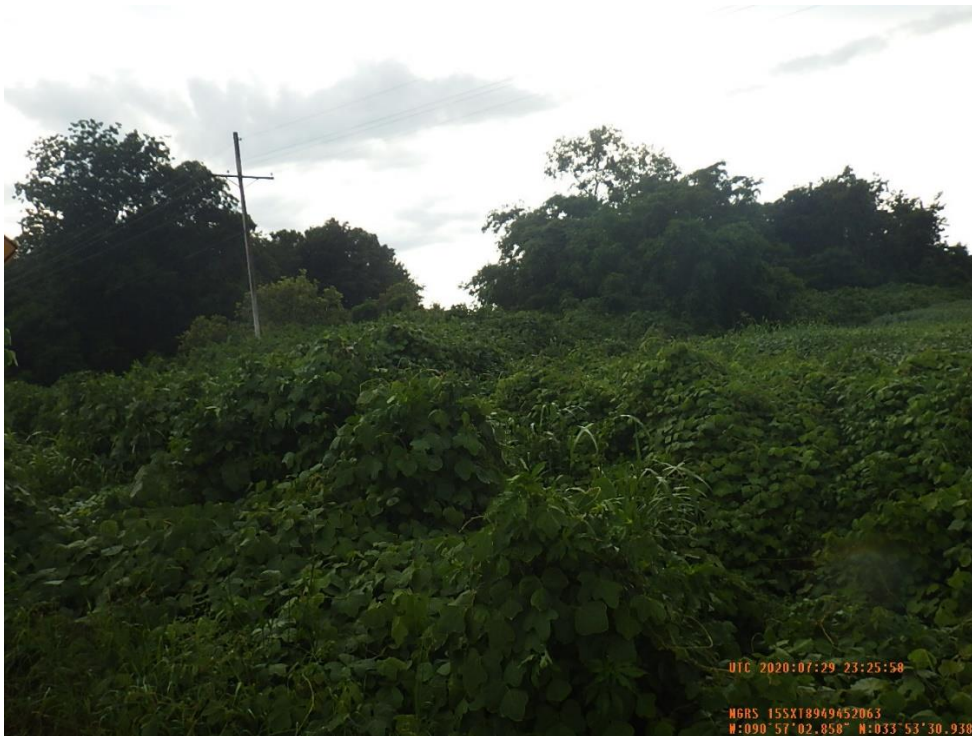
**Figure 40. Northwest facing picture from Gibson Swamp Road of typical area showing well site, YBP-BP-LB-18 (Lane Bayou).**

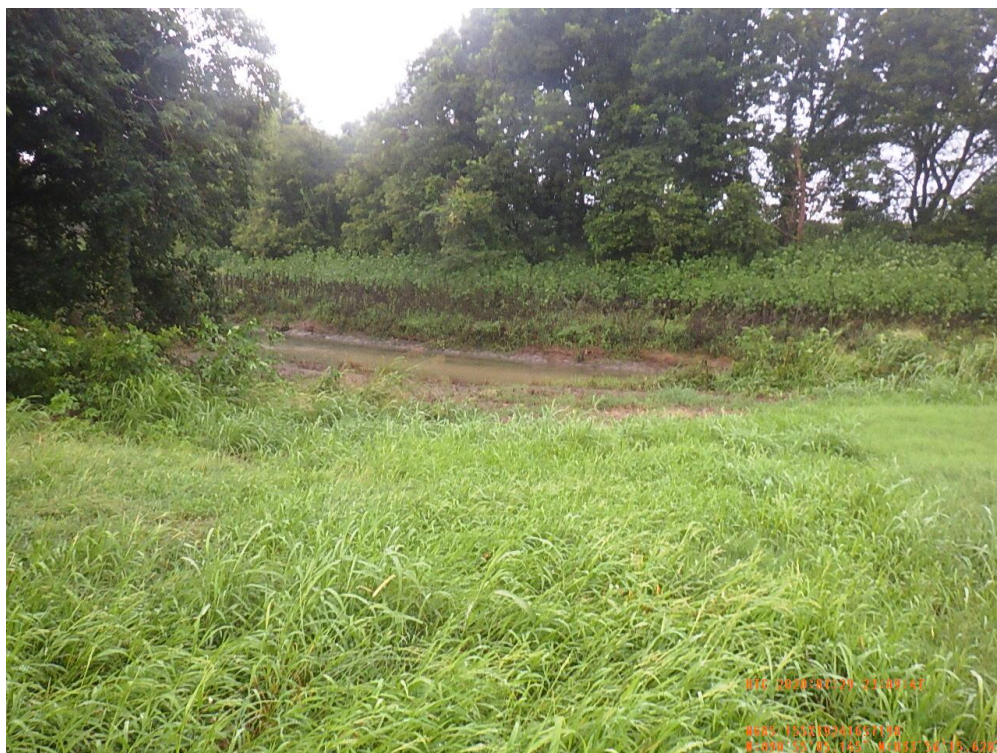
**Figure 41. Northeast facing picture towards Bogue Phalia River of typical area showing well site, YBP-BP-BP-16 (Bogue Phalia).**

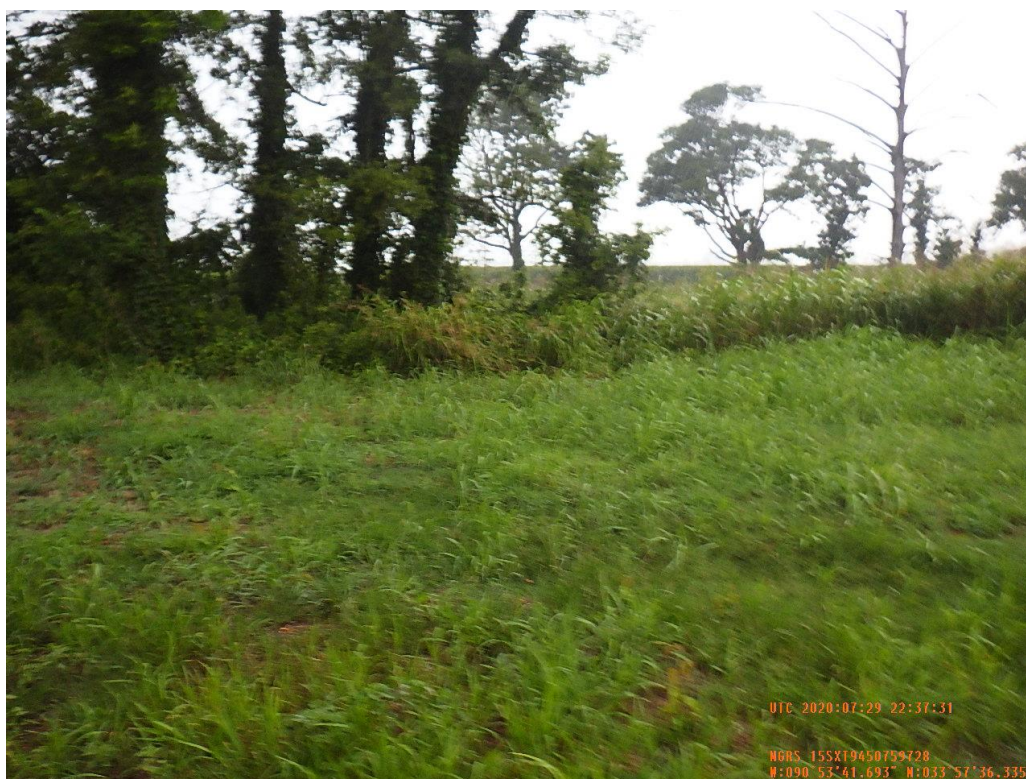
**Figure 42. West facing picture from Stafford Road of typical area showing well site, YBP-BP-BP-15 (Bogue Phalia).**

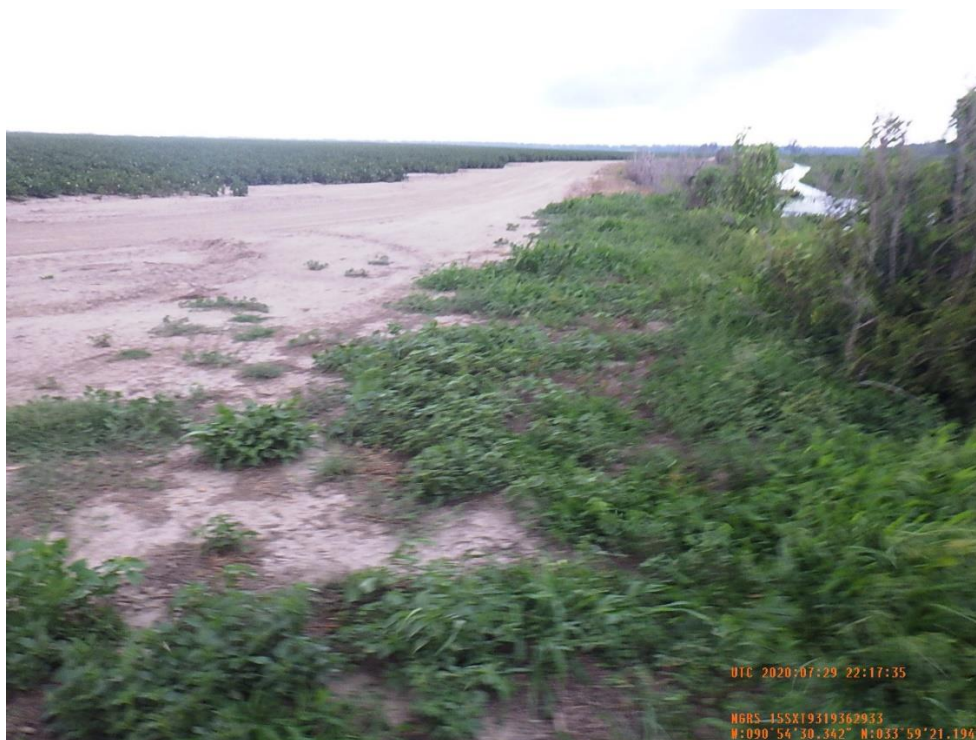
**Figure 43. Northwest facing picture of typical area showing well site, YBP-BP-BP-14 (Bogue Phalia).**

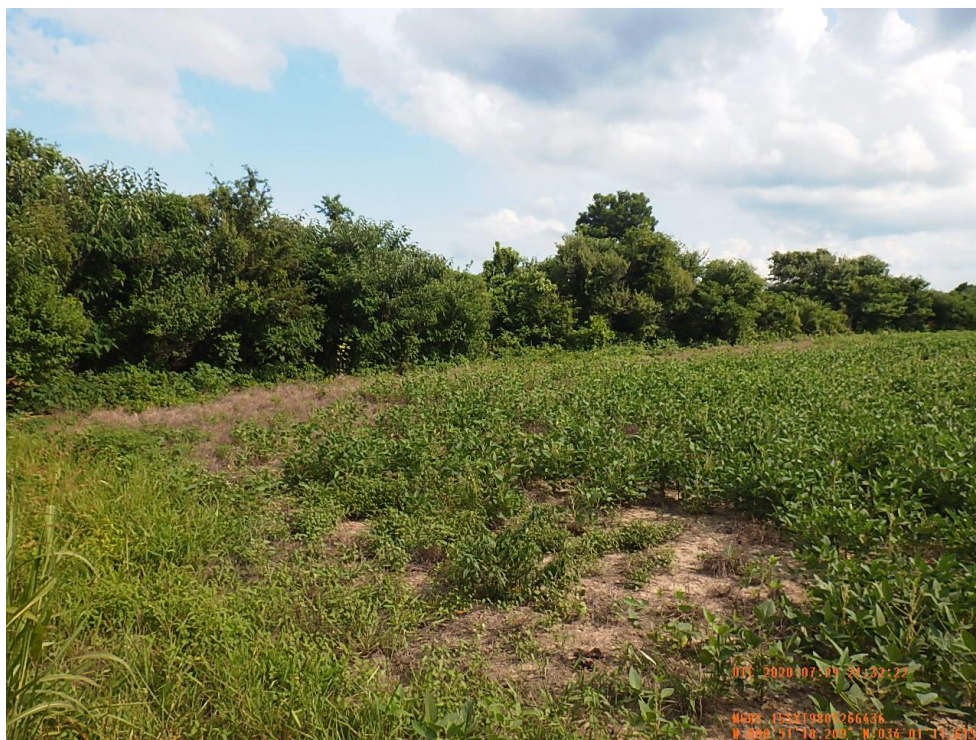
**Figure 44. South facing picture from Sugar Hill Road of typical area showing well site, YBP-HP-EB-13 (Edwards Bayou).**

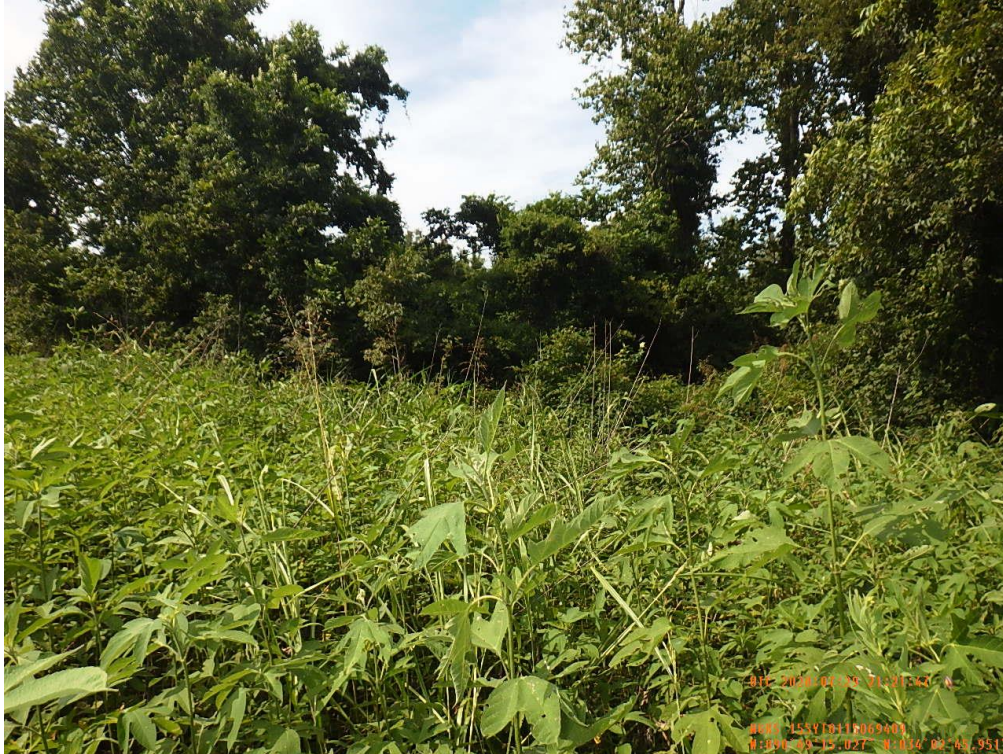
**Figure 45. East facing picture towards Stokes Bayou of typical area showing well site, YBP-HP-SB-12 (Upper Stokes Bayou).**

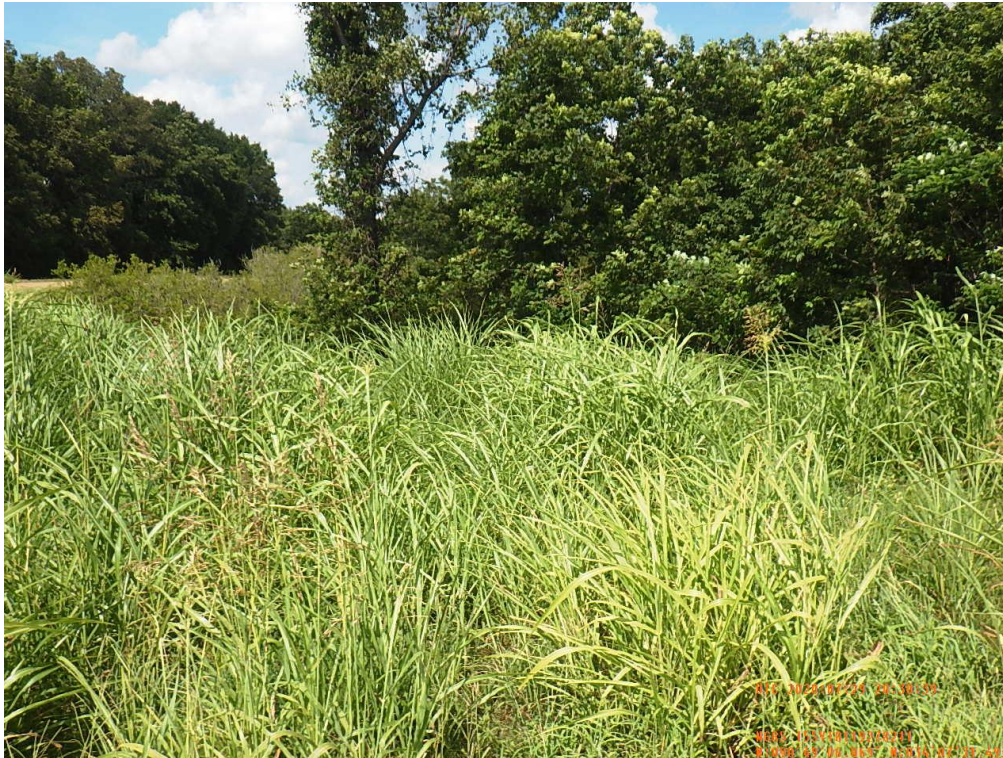
**Figure 46. Northeast facing picture from Alligator Hillhouse Road of typical area showing well site, YBP-HP-MS-10 (McNeil Slough).**

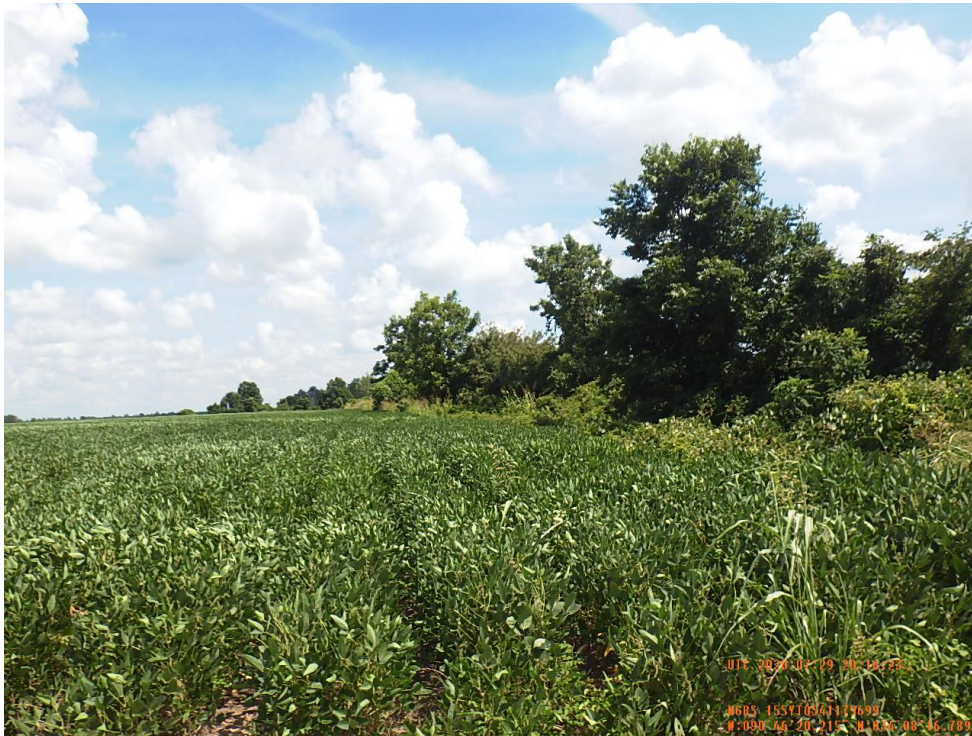
**Figure 47. Southeast facing picture from Long Road of typical area showing well site, YBP-HP-HP-8 (Hushpuckena River).**
