## **APPENDIX F-4: HAZARDOUS, TOXIC, AND RADIOACTIVE WASTE (HTRW)**

### UPDATE MEMORANDUM HAZARDOUS, TOXIC, AND RADIOACTIVE WASTE (HTRW) EVALUATION SUPPLEMENT NO. 2 TO THE 1982 YAZOO AREA PUMP PROJECT FINAL ENVIRONMENTAL IMPACT STATEMENT

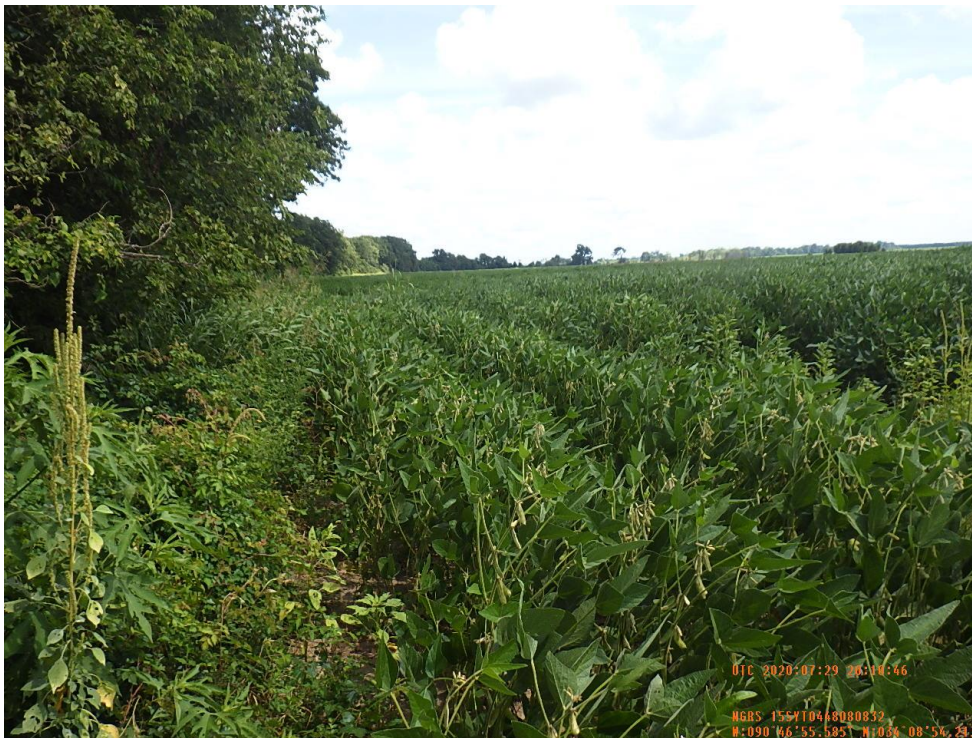
**Figure 48. Southeast facing picture from Hwy 1 of typical area showing well site, YBP-HP-HP-7 (Hushpuckena River).**

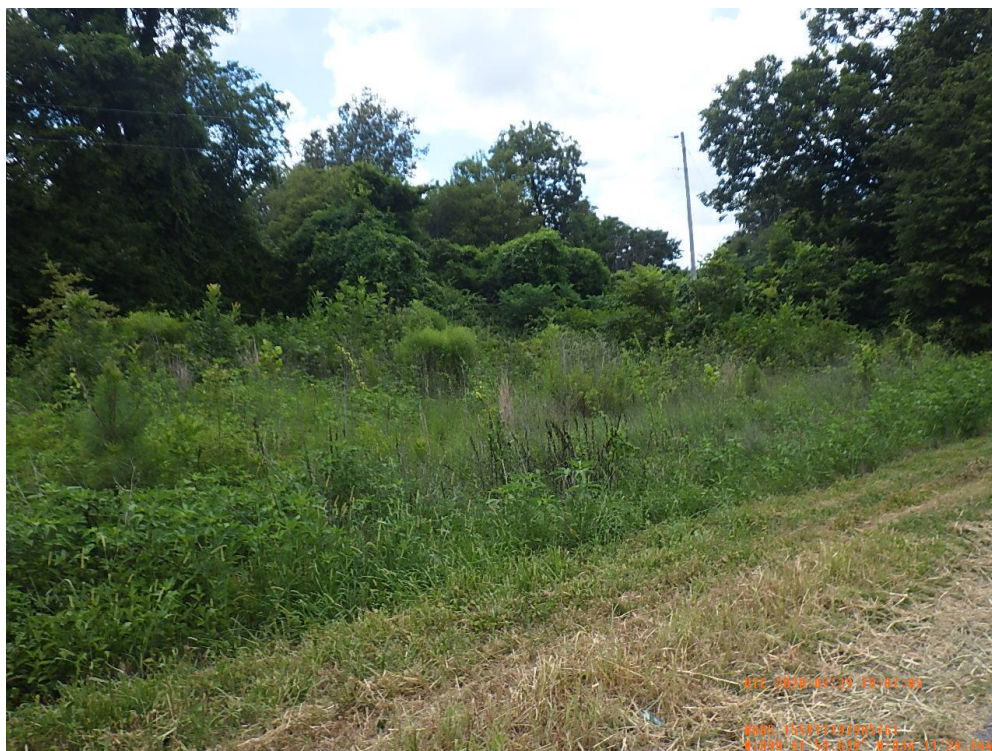
**Figure 49. West facing picture from Bobo Sherard Road of typical area showing well site, YBP-HB-HB-6 (Harris Bayou).**

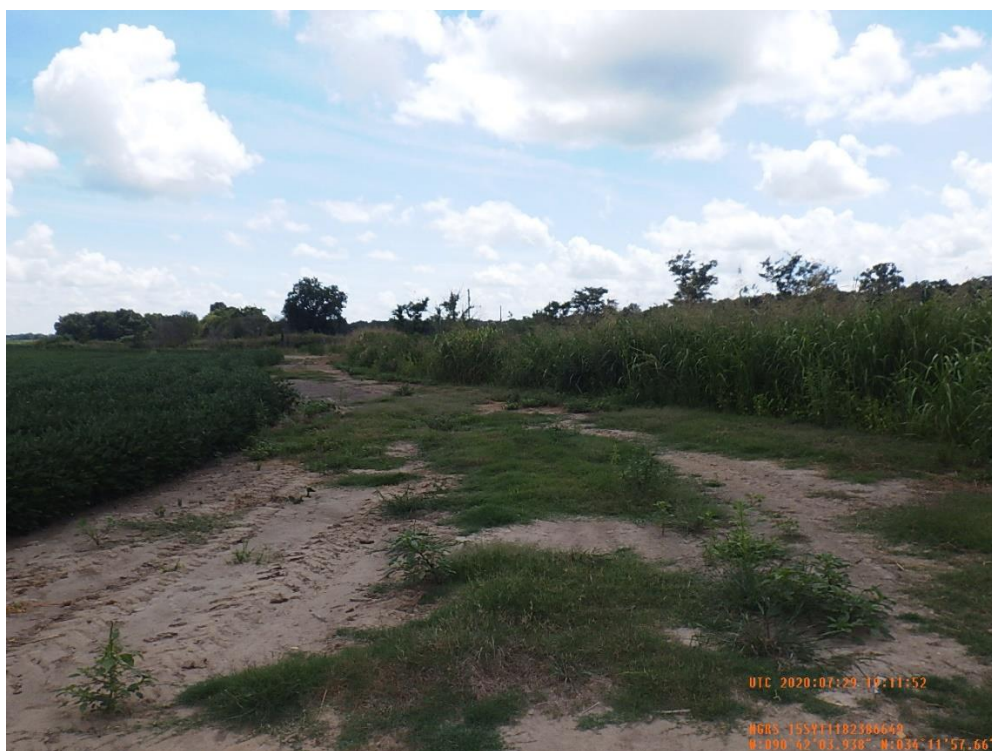
**Figure 50. South facing picture from Sherard Road of typical area showing well site, YBP-HB-HB-5 (Harris Bayou).**

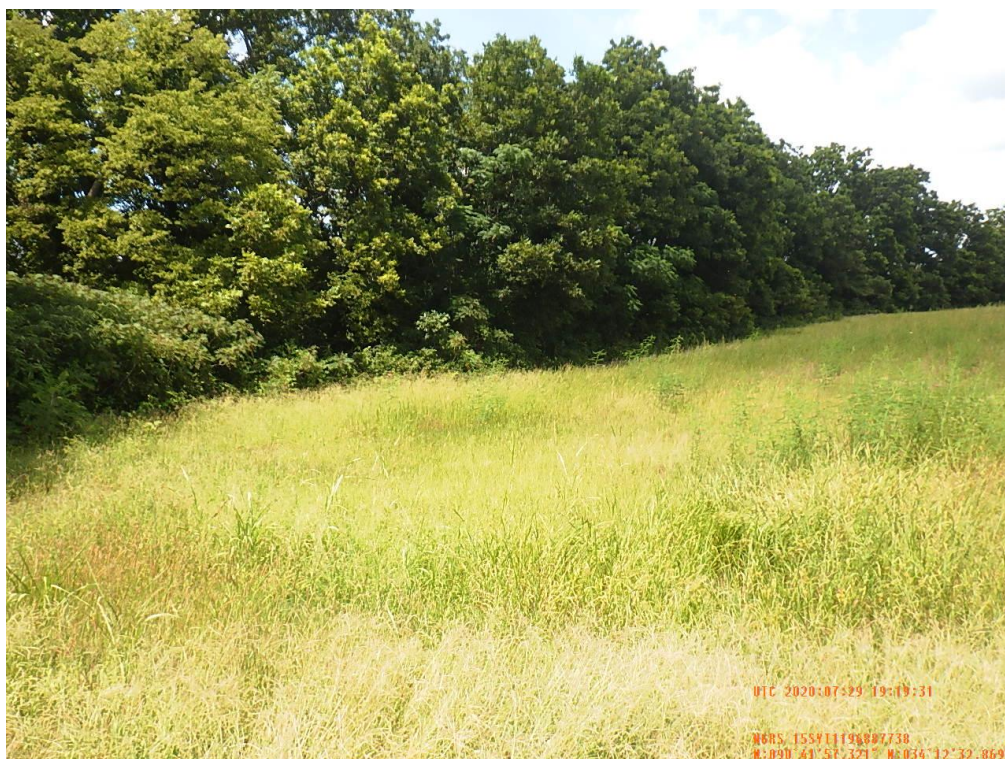
**Figure 51. North facing picture from Highway 322 of typical area showing well site, YBP-HB-HB-4 (Harris Bayou).**

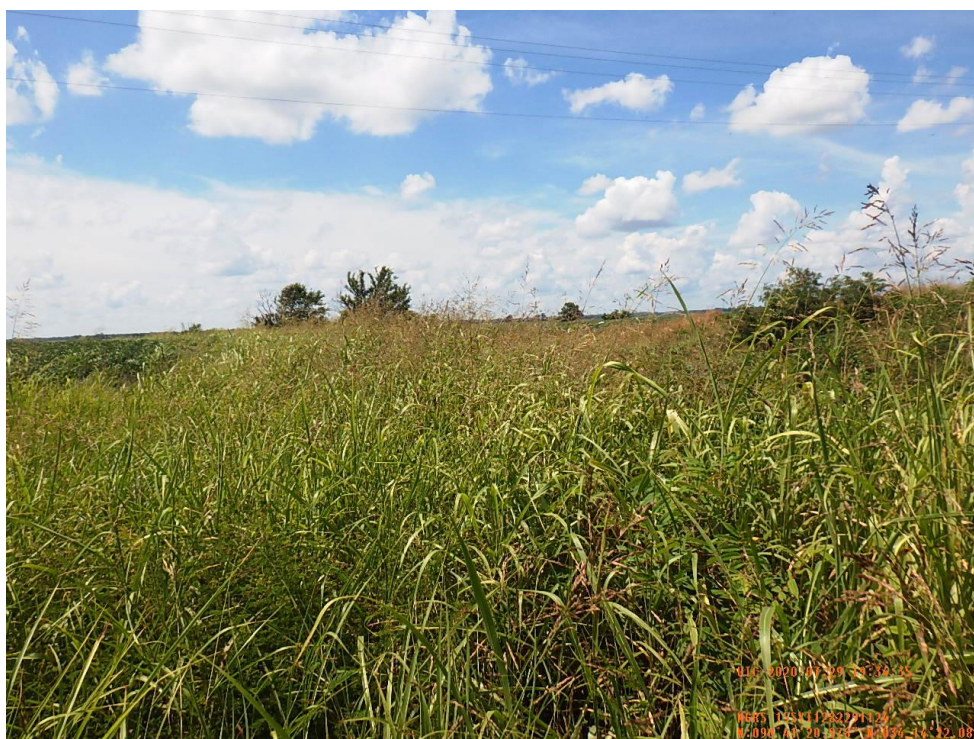
**Figure 52. Northwest facing picture from Highway 1 of typical area showing well site, YBP-HB-RB-3 (Ritchies Bayou).**

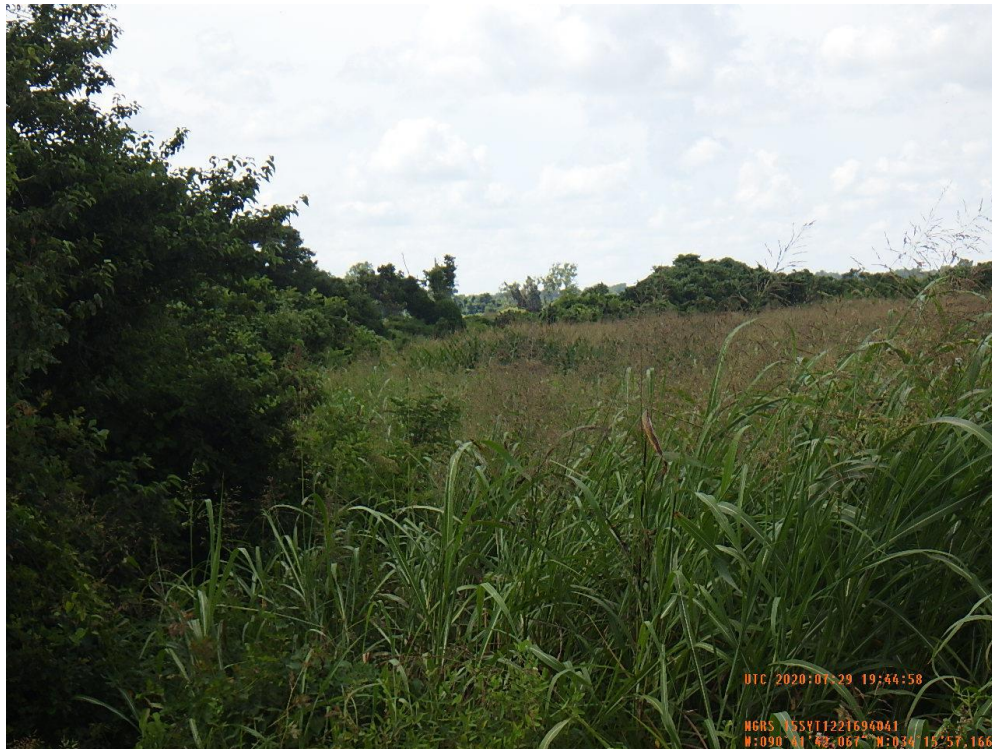
**Figure 53. Northwest facing picture from Farrell Road of typical area showing well site, YBP-HB-RB-2 (Ritchies Bayou).**

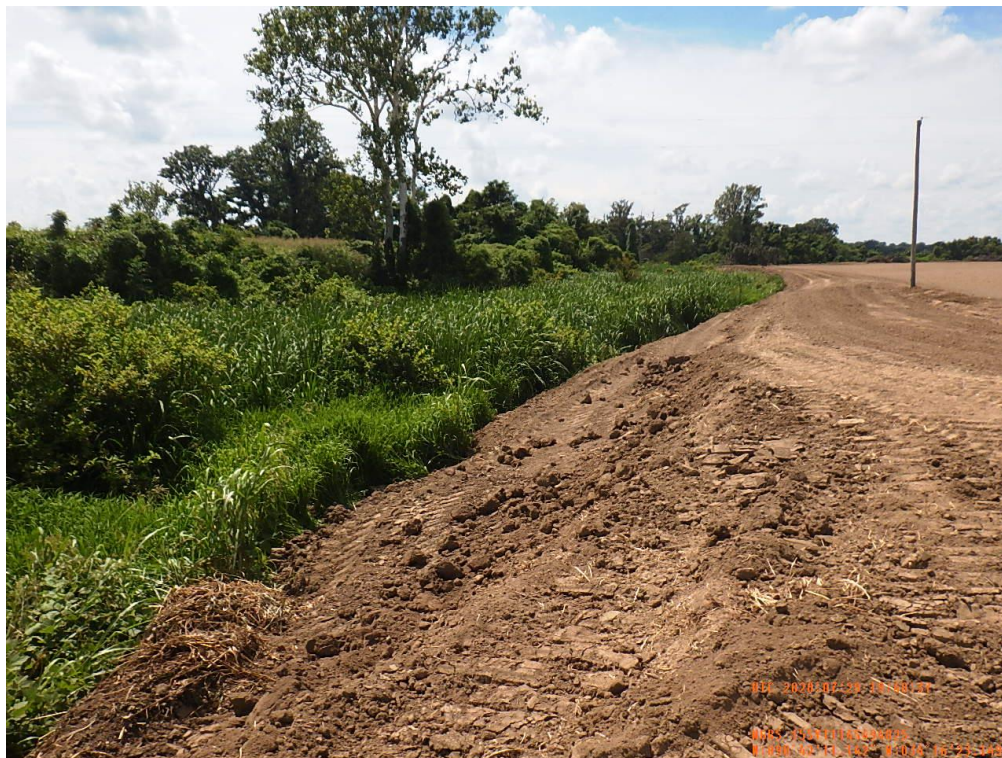
**Figure 54. West facing picture from McWilliams Road of typical area showing well site, YBP-HB-RB-1 (Ritchies Bayou).**
