CHAPTER 4

ARCHAEOLOGY OF THE *EASTPORT* AND THE *ED F. DIX*

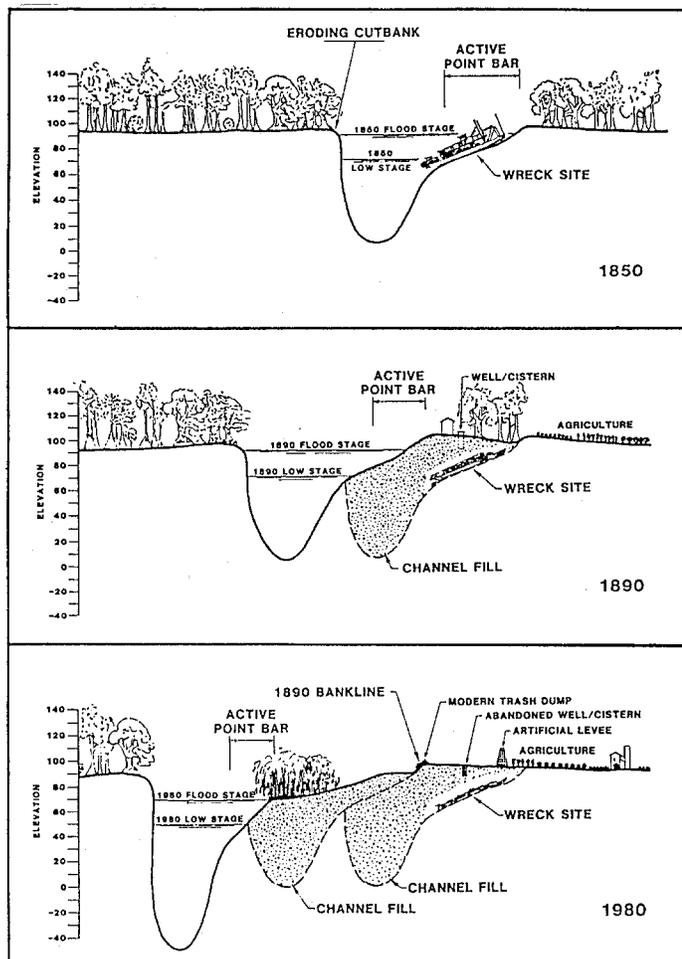
Figure 4-1. Model of processes of boat loss and preservation on Red River (source: Pearson et al. 1981).

Relying on this information about the probable location of the *Eastport*, a first step was to determine the position(s) of the channel of the Red River in this area when the two boats were lost. As noted, the Red River is characterized by frequent changes and shifts in its course. As depicted in the model presented as Figure 4-1, the preservation of the *Eastport* and *Dix* as archaeological sites relied on the assumption that the Red River had shifted course in the area where the sinkings had occurred. Assessing these course changes is, generally, considered a prerequisite to most archaeological research along Red River, because it can lead to the identification of the relative ages of various river valley landforms and, as in the present instance, can often be used to identify the locations of former courses of the river. For over 30 years, archaeologists and geologists working in the Red River valley have recognized the active nature of the river and numerous studies have been undertaken that rely on geological, archaeological and cartographic sources to as-

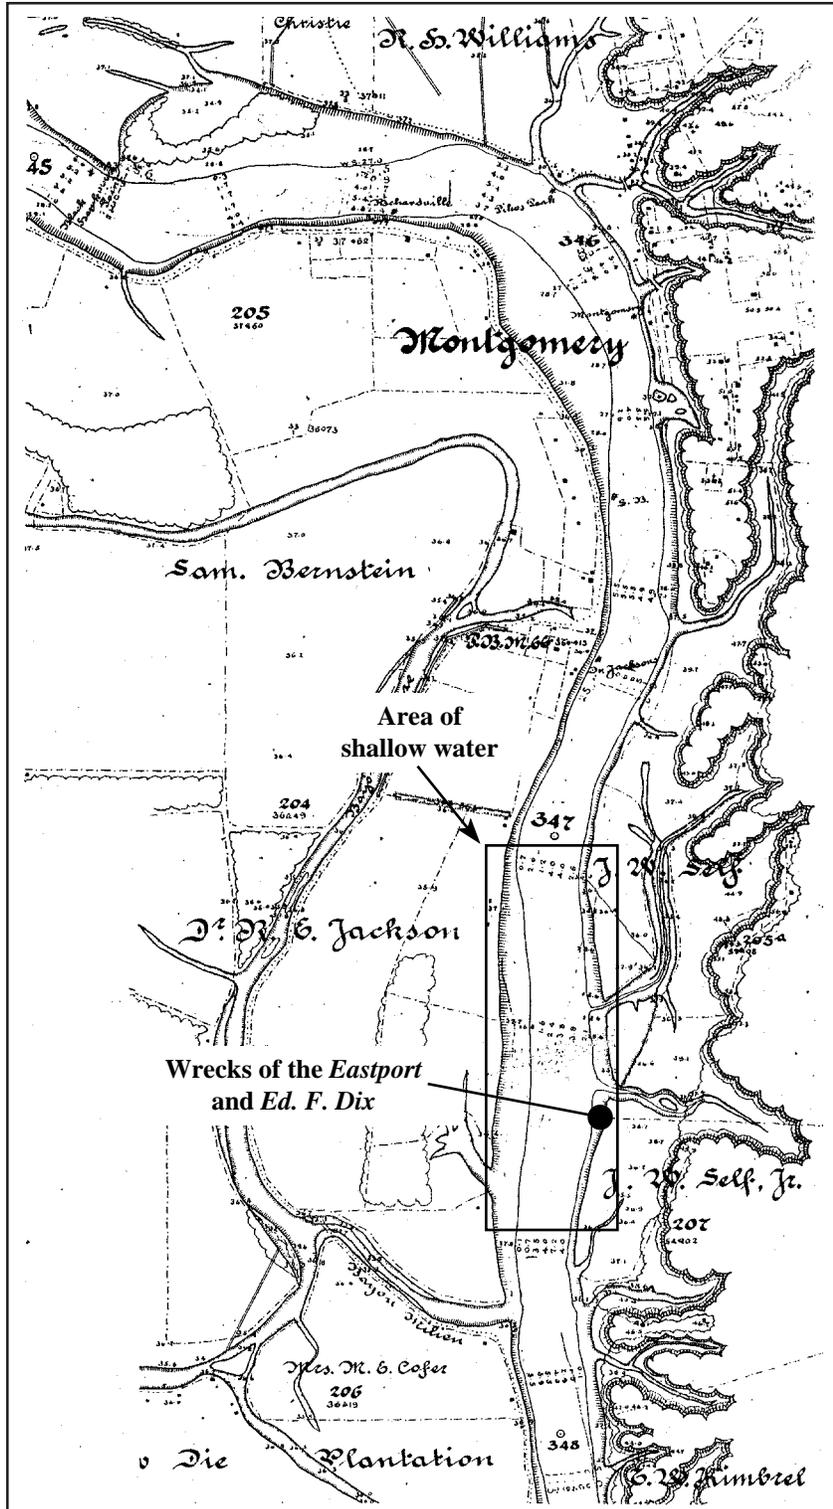
Figure 4-2. Detail of 1889-1890 U.S. Army Engineer map of the Red River below Montgomery, Louisiana. The area of shallow water is outlined and the location where the wrecks of the *Eastport* and *Ed. F. Dix* were ultimately found is shown (source: U.S. Engineer Department 1892:Sheet 38).

be seen, plus, in places the floodplain surface is cut by gullies produced by runoff from the uplands. These features are particularly evident in Figure 4-2.

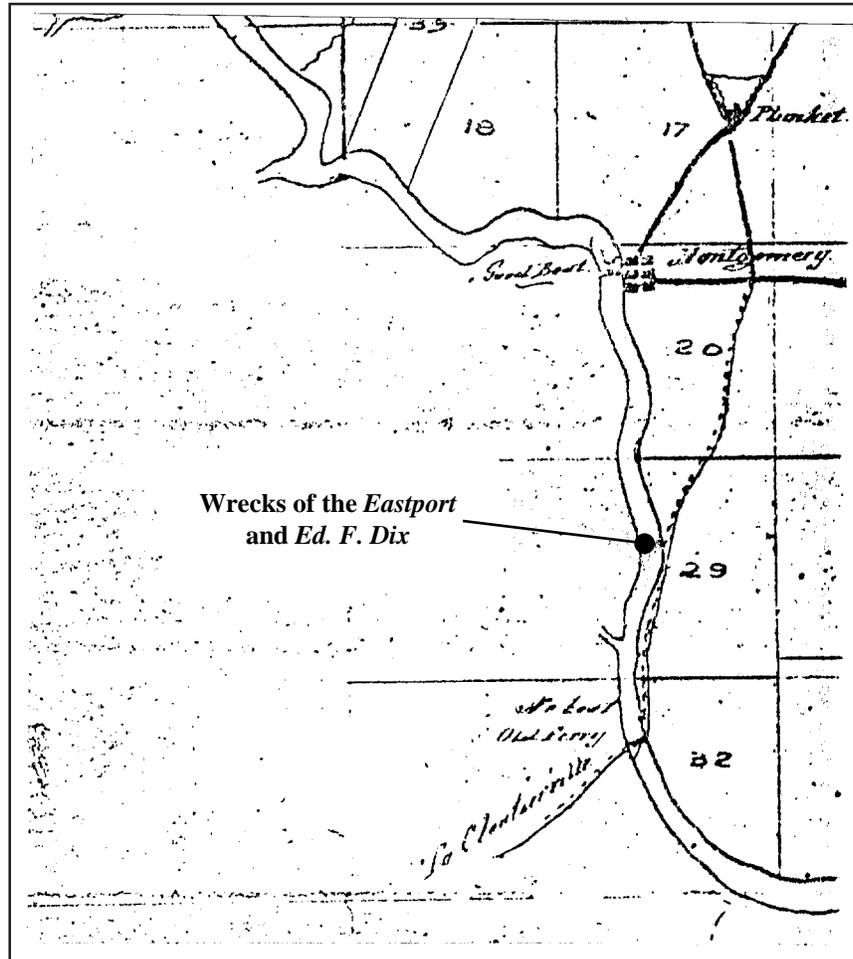
Figure 4-3. Detail of 1865 “Captured Confederate Map” of Winn Parish, Louisiana, showing the Red River near Montgomery. The river course is taken from the circa 1829 federal land survey plat map of Winn Parish. The location of the wrecks of the *Eastport* and *Ed. F. Dix* is shown (source: National Archives 1865).

is certainly derived from earlier plat maps and probably portrays the channel position of about 1829-1830. Today, the channel of the river is almost one-quarter of a mile away from (west of) the edge of the uplands in this same area. Even though there are likely to be inaccuracies in this map, it did appear that the river had shifted to the west in the area a mile or so south of Montgomery, the same area that historic accounts report the *Eastport* was abandoned and scuttled.

As is evident, this map lacks the detail of the later Army Engineer maps, but the land section information can be correlated with features found on

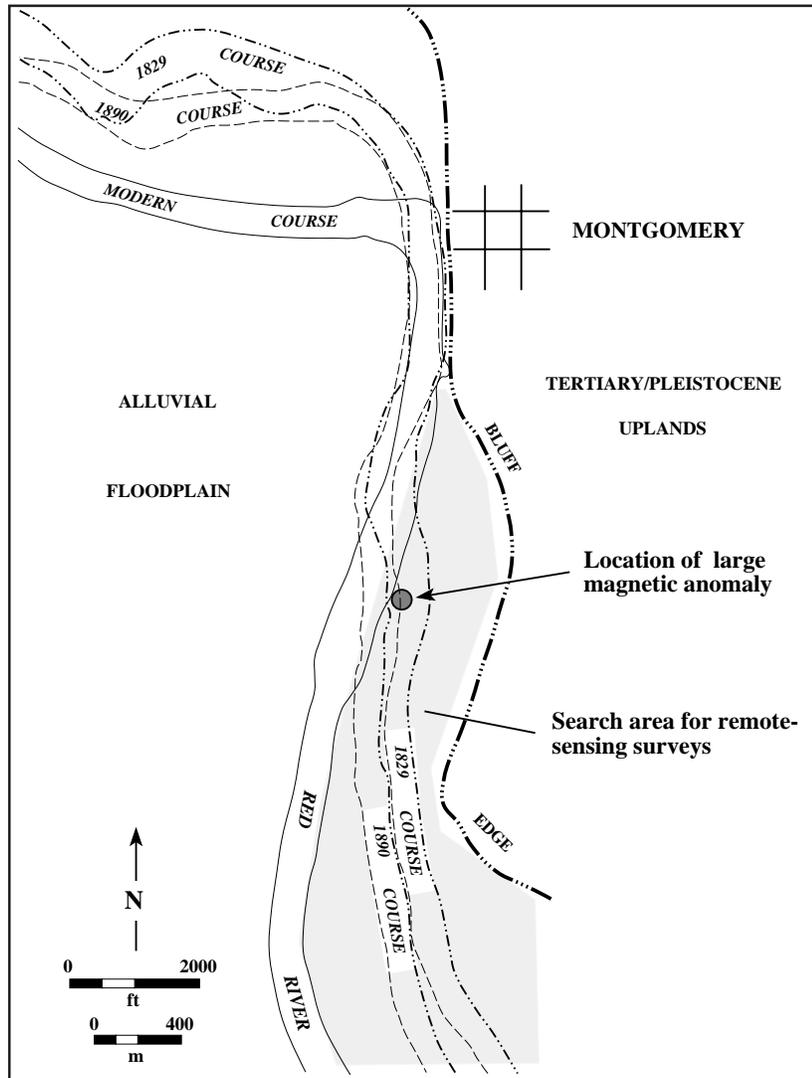
Figure 4-4. Reconstructed historic Red River channel courses near Montgomery. The area within which the search for the *Eastport* and *Ed. F. Dix* was conducted is shaded and the location of the large magnetic anomaly recorded during the search is shown.

shows the area where the search for the two wrecks was conducted and the location of the large magnetic anomaly that proved to be the remains of the *Eastport* and *Ed. F. Dix*. As can be seen in Figure 4-4, where the river impinges upon the Tertiary and Pleistocene uplands immediately adjacent to the town of Montgomery it has occupied almost the same position for the past 170 years or so. However, beginning about 1.5 miles below Montgomery, the river has shifted to the west, and this shift increases with distance down river. The *Eastport* is reported to have been abandoned between 1 and 2 miles below Montgomery in the main channel of the Red, in fact, the hulk supposedly blocked a major portion of the 1864 river channel. This means that the remains of the *Eastport*, and those of the *Ed. F. Dix* that sank on top of it, if they existed, would be on the eastern side of the present course of the river. Relying on the model of preservation portrayed in Figure 4-1, it was hypothesized that as the Red moved to the west it would have deposited large quantities of silt, sand, and clay over the wreck sites, eventually covering the remains of the two boats and, possibly, preserving them.

The channel reconstructions and the historical information on the sinkings of the two vessels allowed the delineation of a relatively small area within which to initiate a search for the wrecks. This area consisted of the modern floodplain on the east side of the Red River below Montgomery between the present channel of the river and the Pleistocene and Tertiary age uplands that border the river valley (Figure 4-4). Upriver of what was eventually identified as the site of the two wrecks, at what is known as

In 1989, one of the authors, Tommy Birchett, at the time an archaeologist with the Vicksburg District, initiated a remote-sensing survey of the selected search area using a magnetometer. As shown in Figure 4-4, this search area extended from the bluffs just below Montgomery south for a distance of about 3 miles and included all of the floodplain between the modern course of the Red and the edge of the uplands to the east. The initial phase of the search involved the examination of selected locales in areas encompassed by the projected circa 1864 channel course. This selection was made on the basis of the configuration of the Red River channel as reconstructed from various historic maps.

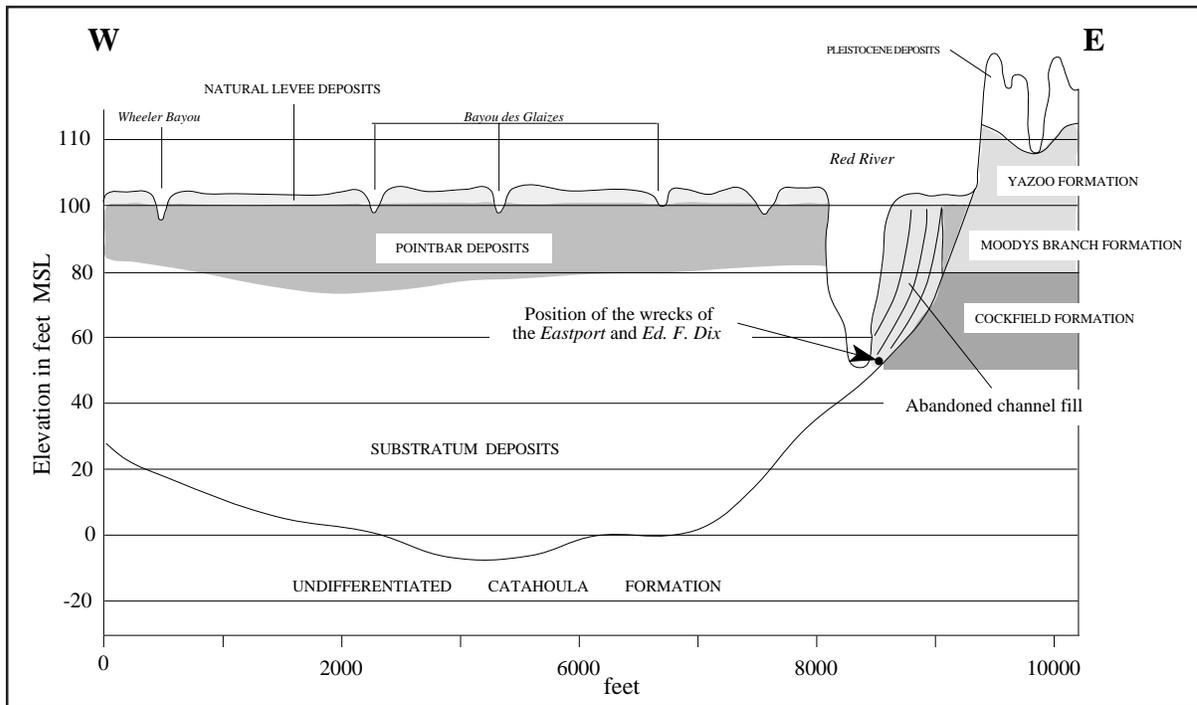
Figure 4-5. Geologic cross section of the Red River valley just below Montgomery. The position of the wrecks of the *Eastport* and *Ed. F. Dix* relative to geological features is shown (after: Albertson and Hennington 1992; Smith and Russ 1974).

Formation, the lower parts of which are covered by river mud during low water (Figure 4-5). Above the lignitic clays is a fossiliferous, glauconitic marl bed (the Moodys Branch Formation), topped by a thin calcareous ledge. Above this calcareous bed are a series of beds consisting of greenish-gray clays, known as the Yazoo Formation, which, in places is very fossiliferous (Schiebout and van den Bold 1982). These deposits are highest at, and just below, the town of Montgomery, where they form the immediate river bank. The deposits slope downward to the south (i.e., downstream) such that they disappear and are covered by modern alluvium less than 2 miles below Montgomery. The Cockfield Formation consists of relatively hard and durable sediments and produces “shallows” in the Red River below Montgomery (Albertson and Hennington 1992). These are almost certainly the shallows on which the *Eastport* lodged in late April 1864.

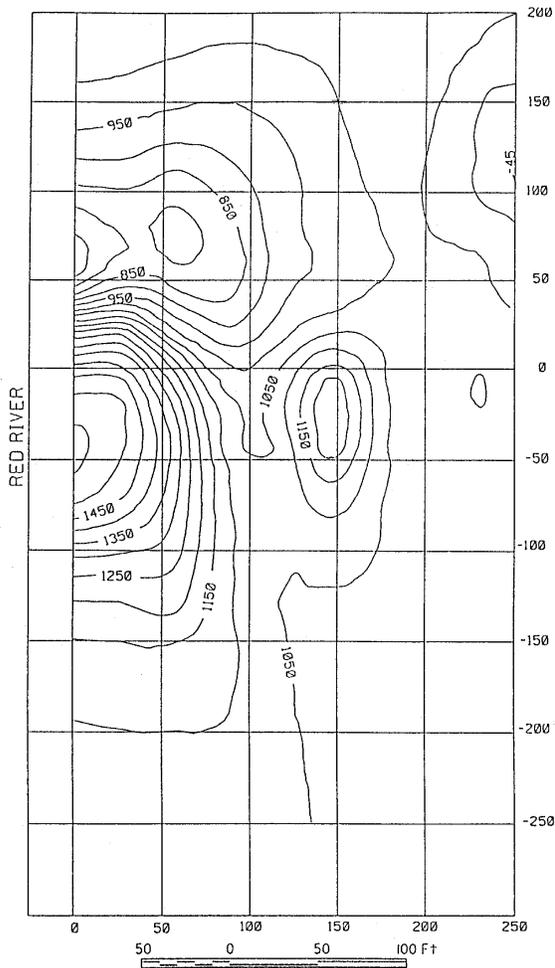
Figure 4-6. Initial magnetic contour map of the suspected wrecks of the *Eastport* and *Ed. F. Dix* (source: Birchett and Pearson 1995:Figure 19).

The data from this initial survey were used to produce a magnetic contour map using the mapping program SURFER (Figure 4-6). As seen in Figure 4-6, the magnetic signature consisted of a principal dipole signature (i.e., a signature consisting of a paired high and low reading) immediately adjacent to the river bank with the magnetic high to the south and the low toward the north. Another magnetic high was situated just east of the major one and another low appeared to the northeast of the primary signature. This low was picked up at the edge of the woods where the survey was stopped because of tree cover and undergrowth and because the ground began sloping down into an area that held standing water.

The magnetic anomaly recorded by Birchett was oriented in a generally east-west direction and covered an area about 250 by 360 ft (76 by 110 m). The principal dipole stopped abruptly at the river bank where the survey ended and it appeared as if the source object may extend into the river. The total magnetic deviation across the low and high of the major dipole was about 800 gammas. This signature can be classified as complex in that it consists of multiple highs and lows, although most of area occupied by the signature is composed of the single dipole. Complex magnetic signatures are considered characteristic of shipwrecks (Garrison et al. 1989) and the size and magnetic intensity of this signature seemed reasonable for the wrecks of vessels the size of the *Eastport* and *Dix*.

The initial assumption was that the wrecks would be buried by about 25 to 30 ft of modern alluvium. One technique for assessing the depth or distance to the source of a magnetic anomaly is known as the "half-width rule." "The half-width is the horizontal distance between the principal maximum (or minimum) of the anomaly (assumed to be over the center of the source) and the point where the value is exactly one-half the maximum value" (Breiner 1973:31). Breiner (1973:30) indicates that application of the rule varies according to the shape of the source object, but, in general, it can be assumed that the distance to a source object will range from the computed half-width to 2 times the half-width. Application of this formula to the magnetic signature shown in Figure 4-6, suggested that the source object lay from approximately 60 to 120 ft below the ground surface. At the time, it was thought that this

estimated depth was too great for the wrecks of the *Eastport* and *Ed. F. Dix*. Breiner (1973:31) does note that there can be a considerable amount of error in these depth computations, plus the computations tend to project a maximum depth. Thus, the half-width computation could be interpreted to indicate that the source object lay close to, but possibly less than 60 ft deep.

This method indicates a depth of about 50 ft for the source object of the signature in Figure 4-6. This estimate was closer to the presumed depths of the two wrecks, but still deeper than was anticipated.

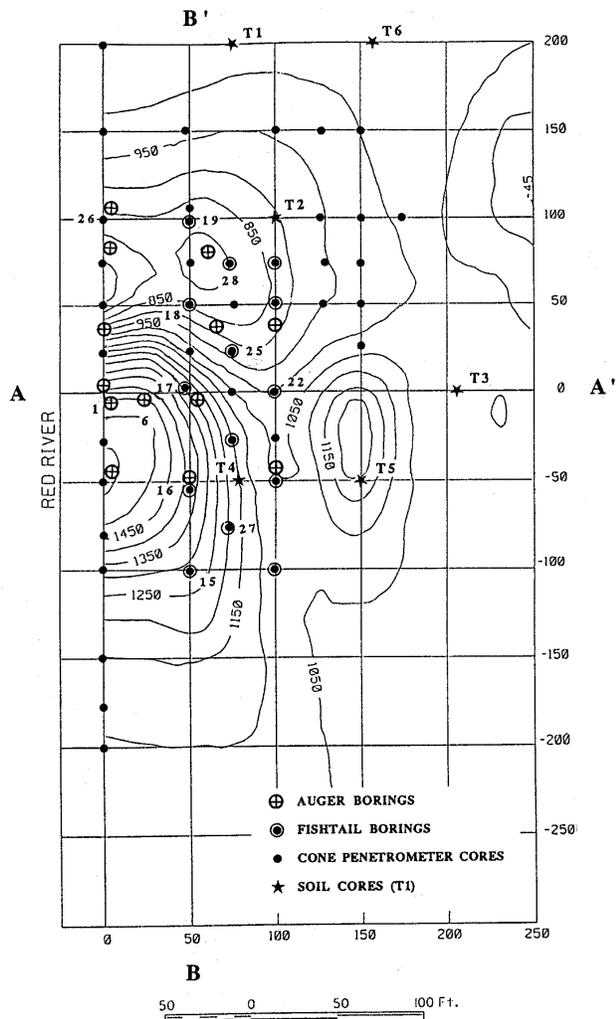
Figure 4-7. The locations of augers, boring, and soil cores at the suspected wrecks of the *Eastport* and *Dix* (source: Birchett and Pearson 1995:Figure 20).

In February 1990, a series of 14 fishtail borings were drilled at the site by the Vicksburg District under the direction of Tommy Birchett. These borings, labeled 15 through 28 in Figure 4-7, reached a greater depth than the previously-used auger and several of them encountered wood, coal, or metal at depths ranging from 38 to 51 ft (11.5 to 15.5 m) below the surface. The locations of these borings are shown in Figure 4-8. Some of the pieces of wood recovered were burned and some showed definite saw marks. These materials were thought to be associated with the remains of the *Eastport* and/or the *Ed. F. Dix*. Three borings (Numbers 18, 19 and 28 in Figure 4-7) encountered wood identified as natural driftwood.

In November 1991, a final set of borings was taken at the site. These consisted of 6 undisturbed sample borings denoted as T-1 through T-6 in Figure 4-7. These borings, taken by the Vicksburg District's Foundations and Material Branch, were to obtain soil samples for determining the engineering properties of the sediments at the site and to aid in refining geological interpretations. Two of these borings, T-3 and T-5, yielded sawn board fragments at depths of 35 (10.6 m) and 48 (14.6 m) ft, respectively, supplying additional information on the position of the buried vessel(s). Again, these two borings fell outside of the originally hypothesized *Eastport* outline shown in Figure 4-8. Both borings were somewhat downstream of the identified major concentration of buried material, where scattered wreckage was most likely to occur, or where the *Ed. F. Dix* might lie.

Figures 4-9 and 4-10 present profiles across the site derived from the several types of borings as interpreted in Albertson and Hennington (1992). The locations of these cross sections are shown in Figure 4-7. The east-west cross section (Figure 4-9) extends from the revetment at the river bank across the site area. As shown in Figure 4-9, the ground

surface lay at 100 to 106 ft NGVD (National Geodetic Vertical Datum) and dense claystone or sandstone Tertiary deposits were encountered at an elevation of 52 ft NGVD, or about 52 ft (15.8 m) below the ground surface. The hypothesized remains of the presumed *Eastport* and/or *Dix*, as derived from cone penetrometer probes and soil borings, are shown resting directly on the Tertiary surface; the surface presumed to have formed the "bar" that the *Eastport* had grounded on. Several cores and probes encountered the inferred wreck, indicating that the remains rose as much as 15 ft (4.5 m) above the Tertiary base. The highest (shallowest) parts of the suspected vessel, based on cores striking wood or metal, were encountered at an elevation of 68 ft NGVD, equivalent to a depth of 36 ft (11 m) below the surface. As shown in Figure 4-9, no cores encountered remains immediately adjacent to the river, however, the contoured magnetic data shown in Figure 4-7 suggested that the remains of a vessel could extend into or under the present river channel.

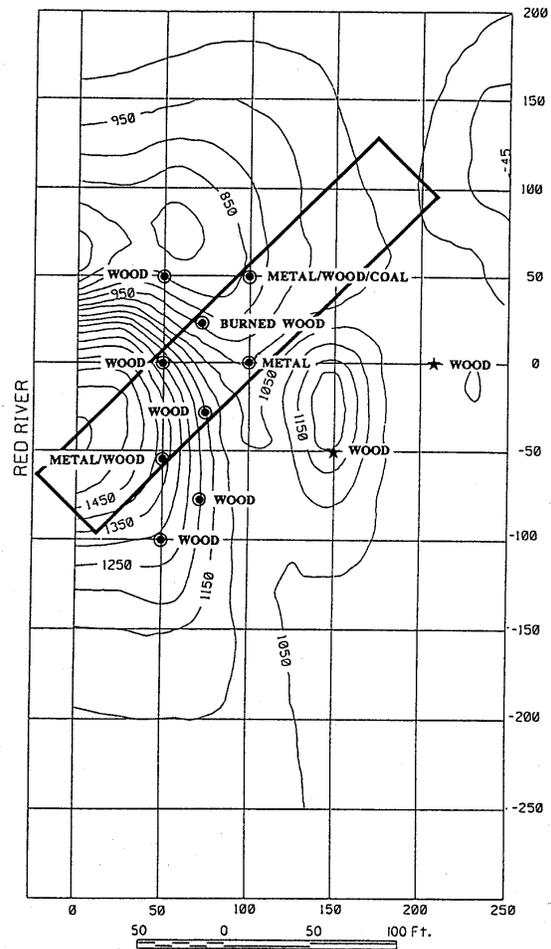
Figure 4-8. The locations of borings producing artifacts at the suspected wrecks of the *Eastport* and *Dix*. A rectangle the approximate size of the *Eastport* is shown (source Birchett and Pearson 1995:Figure 21).

corded as “hits” or “misses” and were used to refine the configuration of the buried material thought to represent vessel remains. A rectangle the approximate size of the *Eastport* was found to encompass most of the cone penetrometer “refusals” and the earlier borings that struck wood, metal or coal, as shown in Figure 4-8. Birchett and Pearson (1995:53) note that while this position seems reasonable for the wreck, it was not absolutely confirmed with the data collected. For example, borings numbered 15 and 27 hit wood presumed to be from a buried vessel, but these borings fall outside of the hypothetical wreck configuration. It was assumed that some of the corings had struck the *Ed. F. Dix*, whose po-

sition relative to the *Eastport* was unknown, or that portions of one or both wrecks were displaced and scattered downstream of the principal area of wreckage i.e., in the area of borings 15 and 27 (Birchett and Pearson 1995:51-52).

As noted, several borings recovered pieces of wood and coal from the presumed wreck(s) and, also, encountered impenetrable metal (iron ?) in a number of locations (see Figure 4-8). Several pieces of retrieved wood contained burned areas and/or exhibited distinctive saw marks. One of these pieces was identified as a species of white oak (*Quercus alba*), a type of wood commonly used in boat construction in the Ohio River valley area, where both the *Eastport* and the *Ed. F. Dix* were built.⁴ However, white oak, also, is a tree native to northern Louisiana, so its presence could not be considered

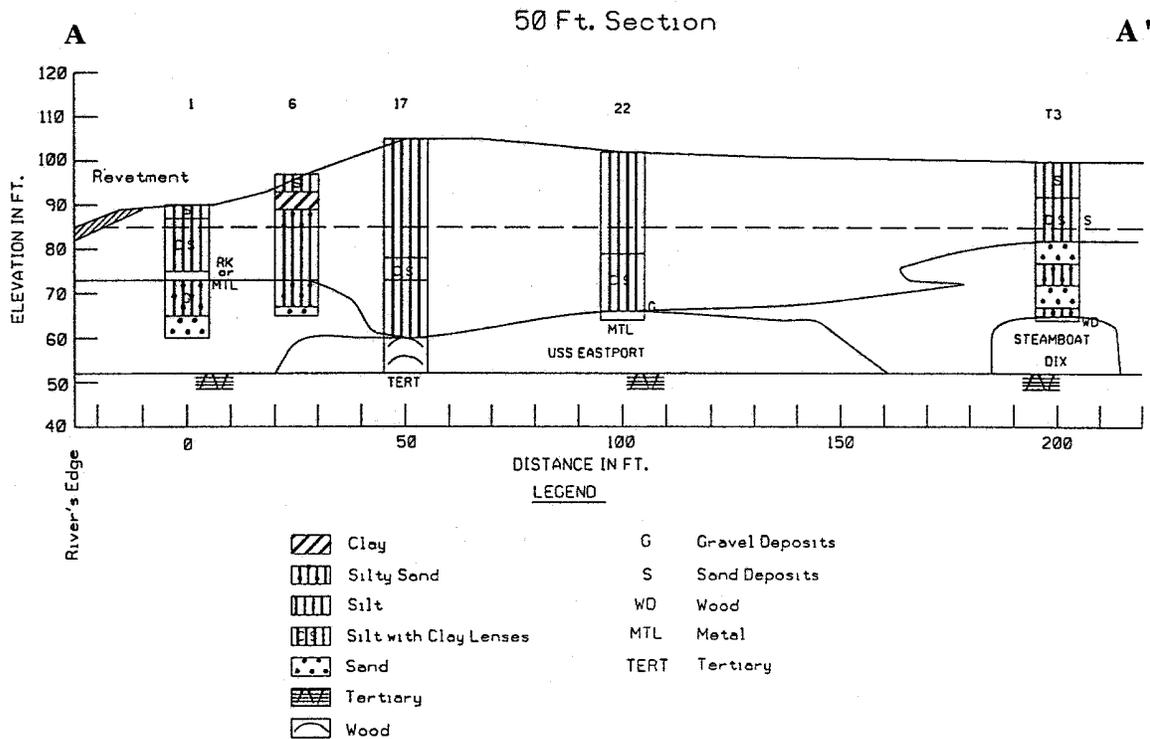
Figure 4-9. East-west cross section across the suspected wrecks of the *Eastport* and *Dix*. See Figure 4-7 for core locations (source: Albertson and Hennington 1992:20).

Soil boring T-3, which encountered sawn wood at a depth of about 35 ft (10.6 m) below the surface, was somewhat east of the other cores striking wood or metal (Figures 4-8 and 4-9). This suggested that

it might have struck a separate entity, hypothesized at the time to be the remains of the other steamboat thought to be at this location, the *Ed. F. Dix* (Albertson and Hennington 1992:20). This inference is depicted in Figure 4-9, however, it was impossible to identify with certainty any of the remains encountered in the corings. Further, as is discussed below, because the positions of the corings were determined by pacing, inaccuracies in the plotted locations of several borings were later discovered. This brought into question the reliability of the spatial relationships of objects depicted in the cross sections shown as Figures 4-9 and 4-10.

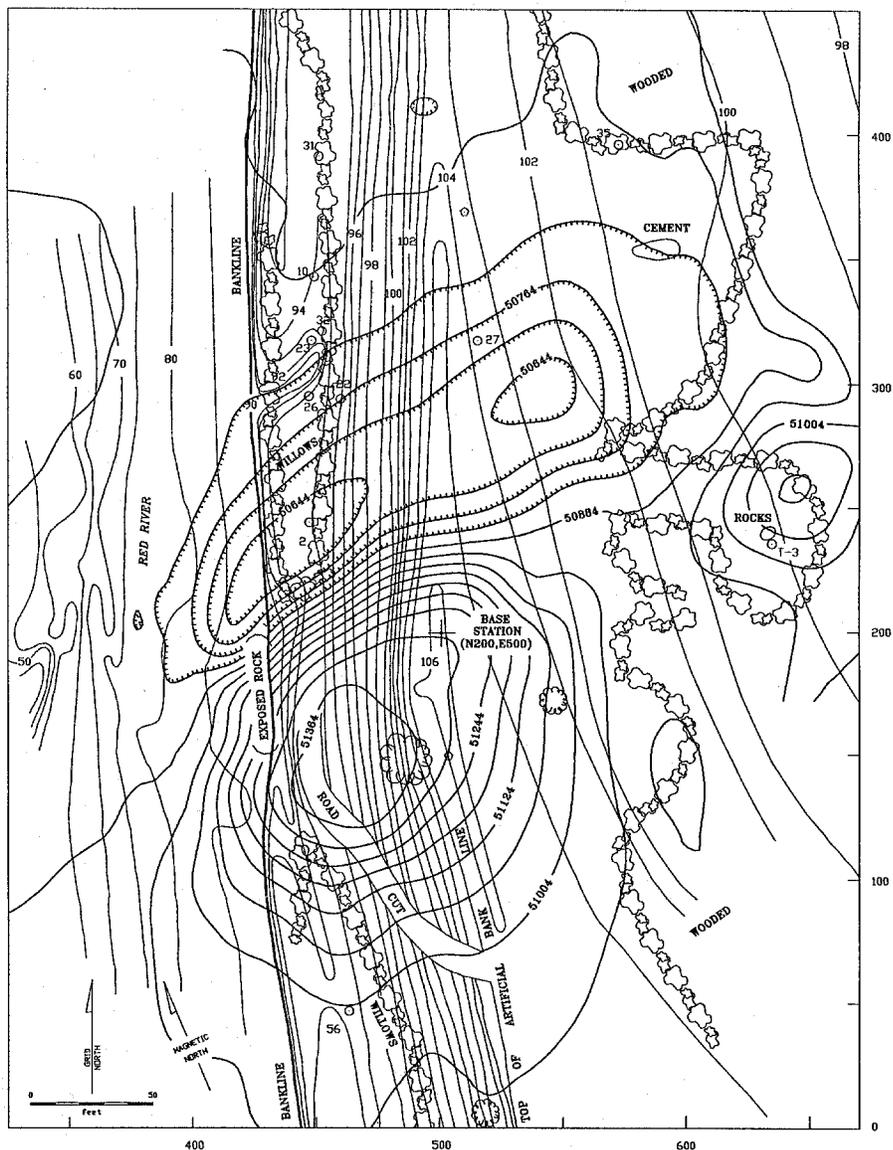
Figure 4-11. Magnetic and topographic contour map from the 1992 controlled survey at the wreck site of the *Eastport* and *Ed. F. Dix*. The locations of some borings taken by the USACE in 1989-1991 are shown.

The magnetic signature derived from the controlled survey covers an area measuring about 400 ft (122 m) north-south and 275 ft (84 m) east-west. The principal magnetic feature is a large dipole with, as anticipated, the magnetic low is to the north and the high to the south, as was the case with the anomaly recorded during the original survey. The maximum magnetic deflection across this dipole is approximately 800 gammas, about the same obtained during the original survey (Figure 4-11). As can be seen in Figure 4-11, however, the configuration of the contoured magnetic signature obtained with the controlled, systematic survey is slightly different from the one obtained in the original survey, shown in Figure 4-6. The highest readings of the principal dipole signature are located immediately adjacent to the river, as in the original survey, but the orientation of this major dipole, in particular the magnetic low, trends slightly north of east, while in the original survey it was more east-west. It is also quite apparent that the magnetic signature (and possibly the source object) extends into the river, although for only a short distance.

An isolated magnetic high is situated just to the east of the major dipole, immediately adjacent to the location of Boring T-3, that struck wood at a depth of about 35 ft. This boring location was one of the few core positions still marked when the controlled survey was conducted (see Figure 4-11). The original survey, also, had produced an isolated, monopole high slightly east of the main dipole, however, the center of that high fell about 50 ft to the riverside (west) of Boring T-3, as can be seen in Figure 4-7. The position of Boring T-3 was estimated to be about 200 ft from the river in the original survey, which is close to its actual position as plotted in the controlled survey. It would appear that the monopole high recorded near Coring T-3 in the controlled survey is not the one recorded during the original survey. However, in light of the obvious positioning problems of the original magnetometer survey this cannot be accepted without question. It is likely that the magnetic contours produced from the originally collected data and the various auger and bore locations shown in Figure 4-7 are not accurately correlated with one another. In addition, there is some question about the relative accuracy of the individually plotted auger and core locations. In trying to correlate the few core locations discovered during the controlled survey with their originally plotted positions as shown in Figure 4-7, it became apparent that several of the core holes had been inaccurately plotted or misidentified during the development of the initial map of the site. For example, a faded pinflag with the number 27 was found toward the northern side of the magnetic signature, about 90 ft from the river bank (see Figure 4-11). This was thought to represent the location of boring number 27, but the plotted position of this fishtail boring in the original survey shows it toward the southern edge of the magnetic signature (see Figure 4-7). It is possible that this core was misnumbered and should be number 28, which does fall, approximately, in the correct location, or the very faded number on the flag was misread entirely. Thus, as it turned out, while the corings proved very useful in indicating the depth to buried vessel remains and the general spatial distribution of these remains, it was difficult to tie most of them with any precision to the magnetic signature derived from the controlled magnetic survey. Further, the lack of accurate spatial control during the original magnetometer survey and during the collection of the cores, means that it is difficult to correlate these two data sets with one another with great precision. However, as noted below, the projected vessel locations developed by Albertson and Hennington (1992), as shown in Figure 4-9, proved

The exact relationship of the isolated magnetic monopole recorded adjacent to Coring T-3 to a source was more difficult to assess. The preliminary assumption was that it reflected a source object lying at its northwestern edge, again, in the “trough” between it and the larger magnetic low (see Figure 4-11).

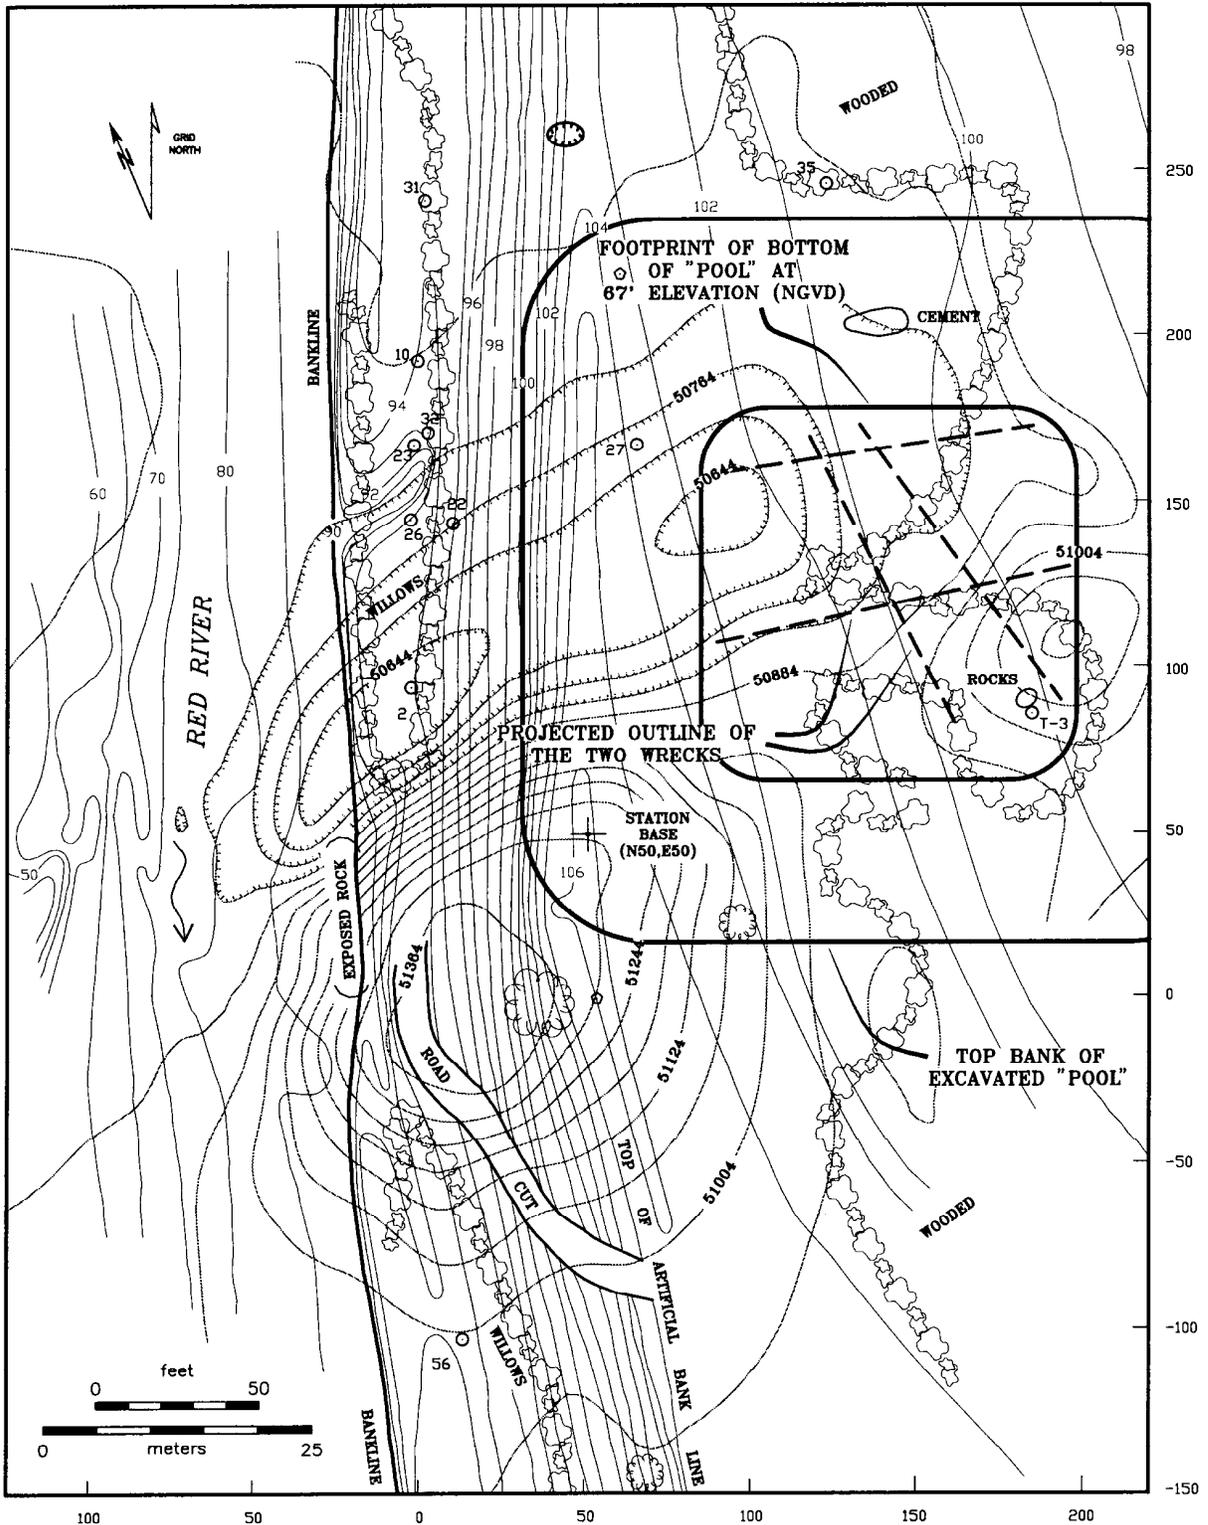
Figure 4-12. The excavated “pool” in relationship to the topography and the magnetics recorded at the site. The projected outlines of the wrecks of the *Eastport* and *Ed. F. Dix* as determined by probing are depicted (see Figure 4-15). The locations of some of the corings made by the USACE in 1989-1991 are shown.

As previously noted, the placement of the pool was guided by the results of the earlier magnetic surveys and coring programs. As shown in Figure 4-12, the floor of the excavated pool, ultimately, was situated toward the eastern end of the large, magnetic dipole anomaly recorded at the site and incorporated the western half of the smaller, isolated magnetic high. It appeared that the major part of the source object(s) creating the principal anomaly actually fell between

the bottom of the pool and the Red River, in an area which was impossible to examine.

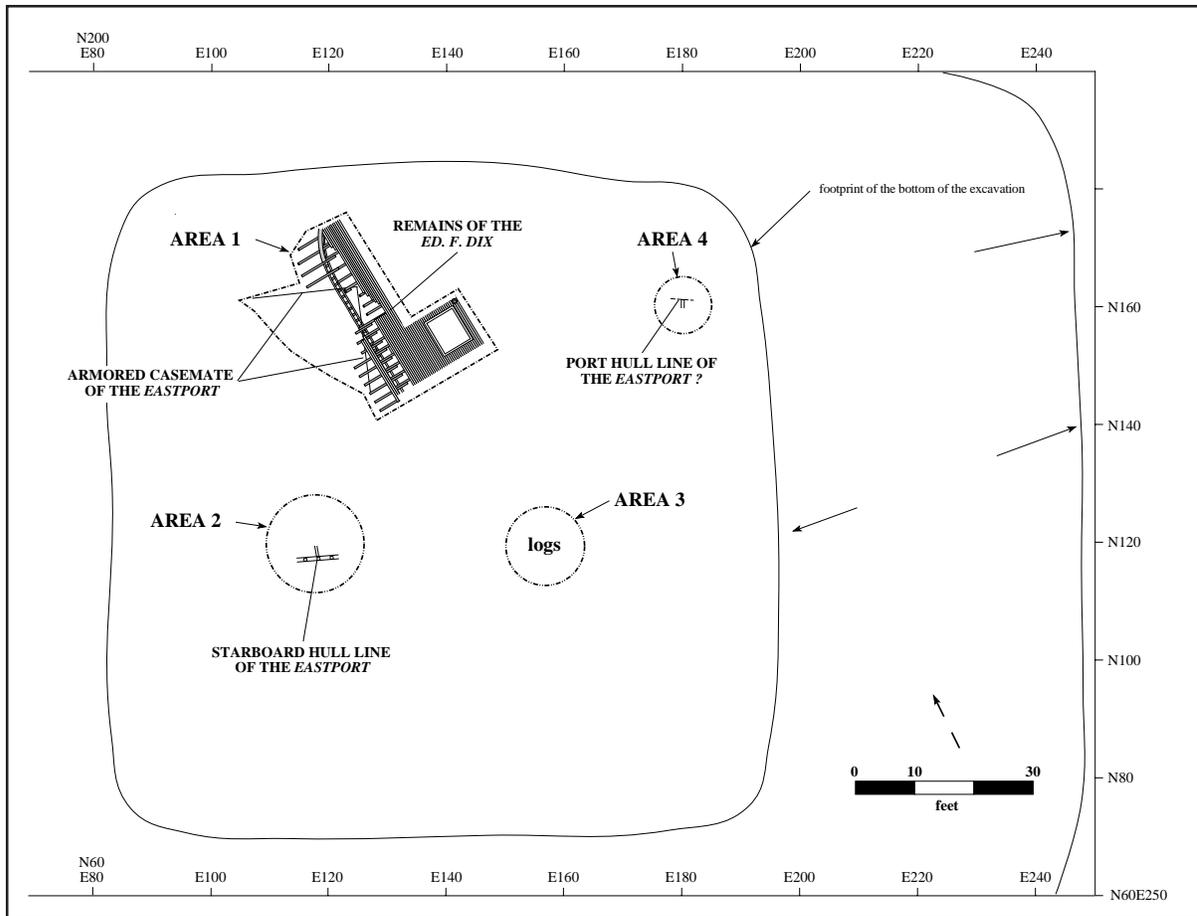
Figure 4-14. Site plan showing the bottom of the “pool,” the areas excavated and the critical features mapped.

The first phase of underwater work involved probing the bottom of the pool with a hydraulic probe to try to locate and fully delineate the buried remains discovered in the reconnaissance dives. The 10-ft-long metal probe powered by the 7-horsepower water pump was used. The probes were positioned using the grid put in place by the construction company for their activities. This grid actually used the baseline established during the controlled topographic mapping and magnetometer survey of the site in 1994 (see Figure 4-11). The original datum established by that survey had been assigned an arbitrary value of N200/W500; the construction contractors had used this same datum as their base station, but had assigned it an arbitrary value of N50E50. This base station lay near the river bank at the southwest corner of the pool, placing the excavated area within the northeast quadrant of the grid. The E250 gridline ran along the eastern edge of the pool and the N00 line ran along the southern edge. Flagged stakes were placed at 10-ft-intervals along these lines and they became the baselines for all measurements made in the pool. The bottom of the pool as completed extended from approximately E85 to E200 and from N70 to N180 (Figure 4-14); this was the area within which all diving took place.

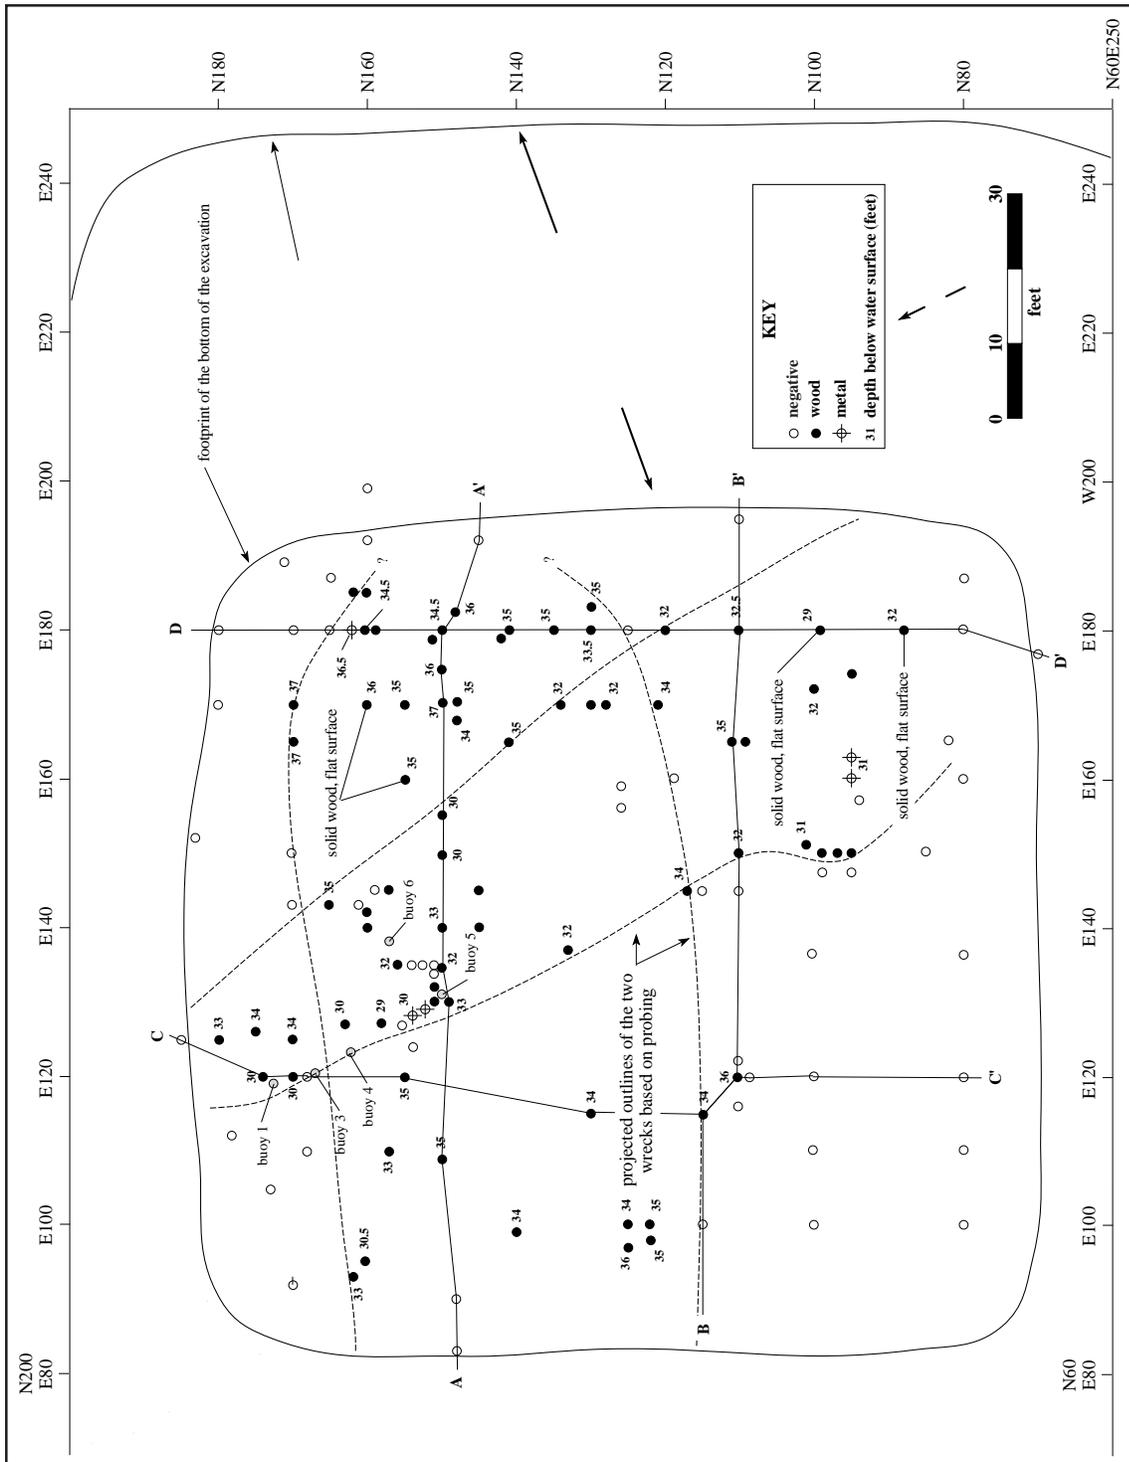
Figure 4-15. Results of the hydraulic probing. The approximate outlines of the hulls of the two vessels as indicated by the probing are shown

Figures 4-16 and 4-17 presents a series of profiles of the hydraulic probe data taken across selected transects. The locations of these profiles are shown

in Figure 4-15. All of the profiles clearly demonstrate the consistent differences in elevations of the two buried features thought to represent boat remains, even though the difference is on the order of only a few feet. Evaluation of these profiles and the plan map developed from the probing led to the presumption that the vessel extending in a north-south direction across the pool was the steamer *Ed. F. Dix*, and that it lay on top of the remains of the *Eastport*, represented by the structure lying in an east-west direction. As shown in the B-B' profile, the intact portion of the structure identified as the *Ed. F. Dix* measured about 30 ft across. Additionally, subsequent probing across the presumed wreck of the *Dix* in the vicinity of profile A-A' (see Figure 4-16) indicated that a level surface existed in this area and that it sloped down toward the east. This level surface was believed to be a deck, probably the main deck of the steamboat. Because the deck was tilted down toward the east, it was difficult to distinguish between the structures where the east side (e.g., the lower side) of the wreck of the presumed *Dix* rested on top of the presumed *Eastport*. The west side of the identified *Dix*, however, seemed to be tilted up such that it was 3 to 4 ft higher than the surface identified as the *Eastport*, making it much easier to distinguish between the two wrecks at this particular location.

The probing suggested that much of the wooden structure of both of the identified wrecks was in good condition. Several fairly large areas of flat wooden structure were found where the probe would literally "bounce" off of the wood, indicating a dense and hard surface. The specific identity of these surfaces could not be determined, but they were thought to represent areas of intact deck planking. Surprisingly, only a relatively few probes encountered what could be identified as metal, although it was thought that a considerable amount of metal, primarily iron armor, would be found in association with the *Eastport*. The few areas where metal was encountered during probing are shown in Figure 4-15. The largest expanse of metal (iron ?) was in the vicinity of grid coordinate N153E130 where initial probing encountered metal at a depth of 32 ft, slightly deeper than some immediately adjacent wooden structure (see Figure 4-15 and Figure 4-16, Profile A-A'). Extensive probing in this area suggested that the metal consisted of a flat piece (or pieces) of thin plate resting edge up, making it very difficult to delineate. Subsequent excavations in this area revealed that these plates represented intact portions of the *Eastport's* armored casemate. In addition, probes struck a small area of metal toward the eastern side of the pool, at coordinate N161E180 (see Figure 4-15). This material was thought to be on the wreck of the *Eastport*. A small area of metal also was encountered in the southeastern quadrant of the pool, in the area of grid coordinate N95E160. This metal was thought to be associated with the *Ed. F. Dix*, possibly in the area of her engines or side paddlewheels, assuming the bow of the boat was at the northern end of the pool (see Figure 4-15)

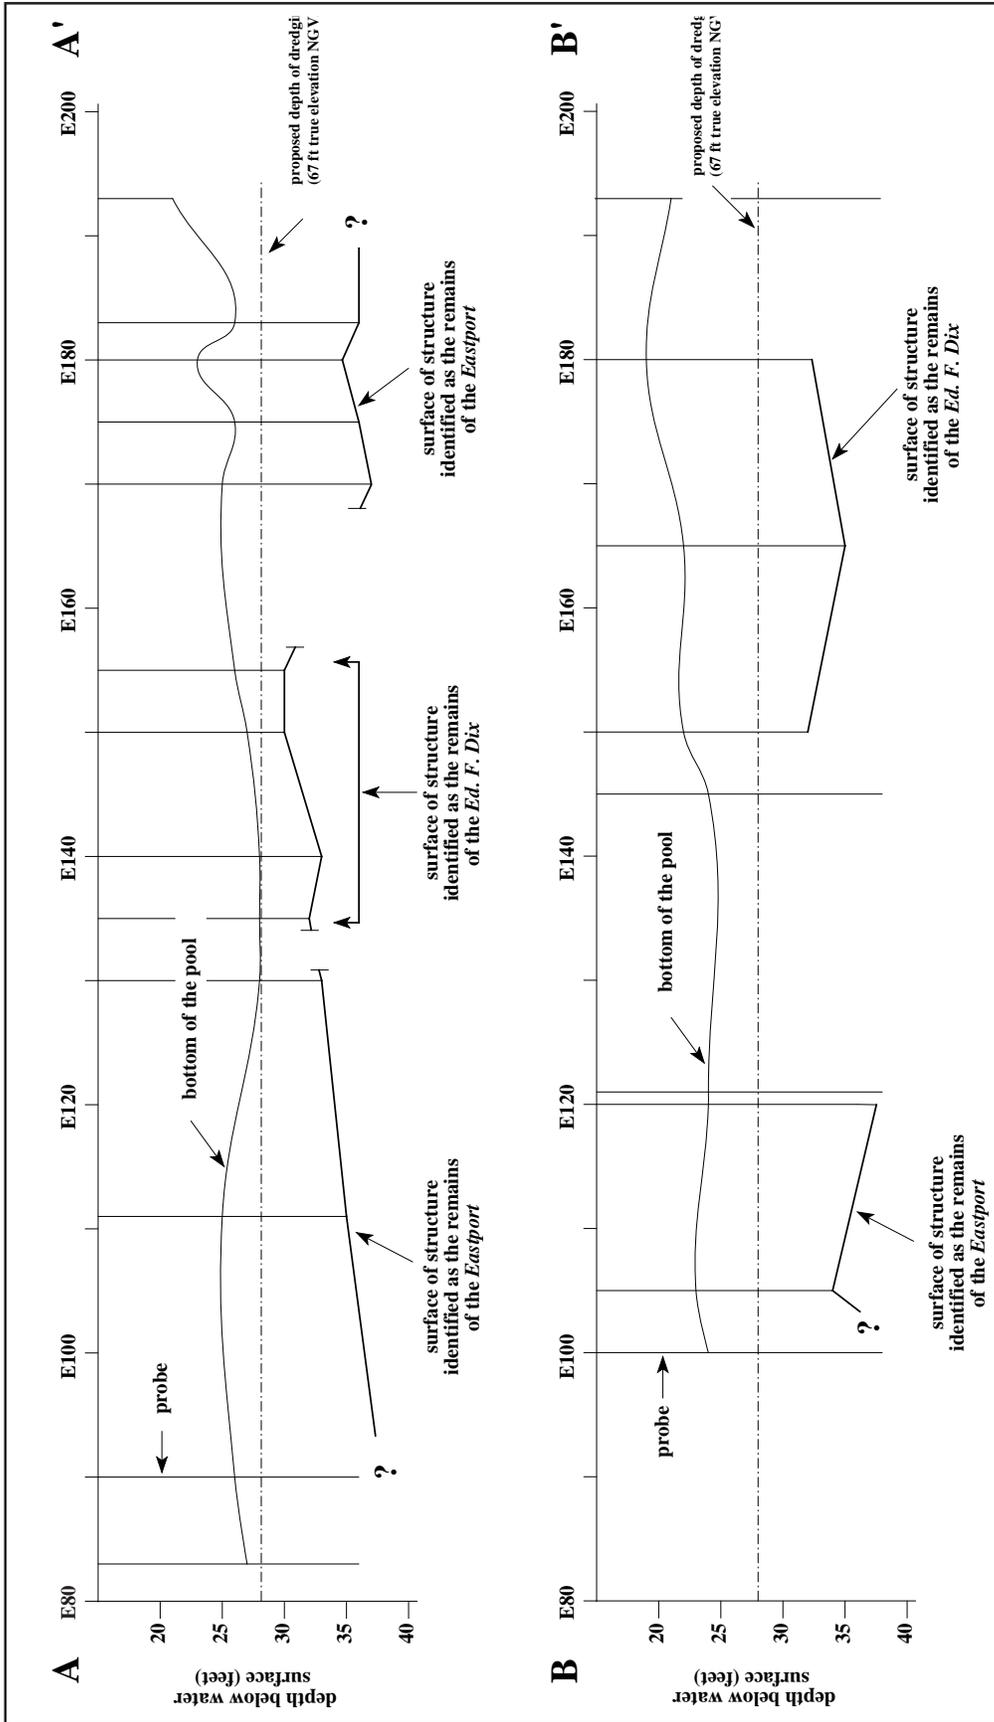
Figure 4-16. East-west profiles showing the interpreted results of the hydraulic probing. See Figure 4-15 for profile locations.
