CHAPTER 4

ARCHAEOLOGY OF THE *EASTPORT* AND THE *ED F. DIX*

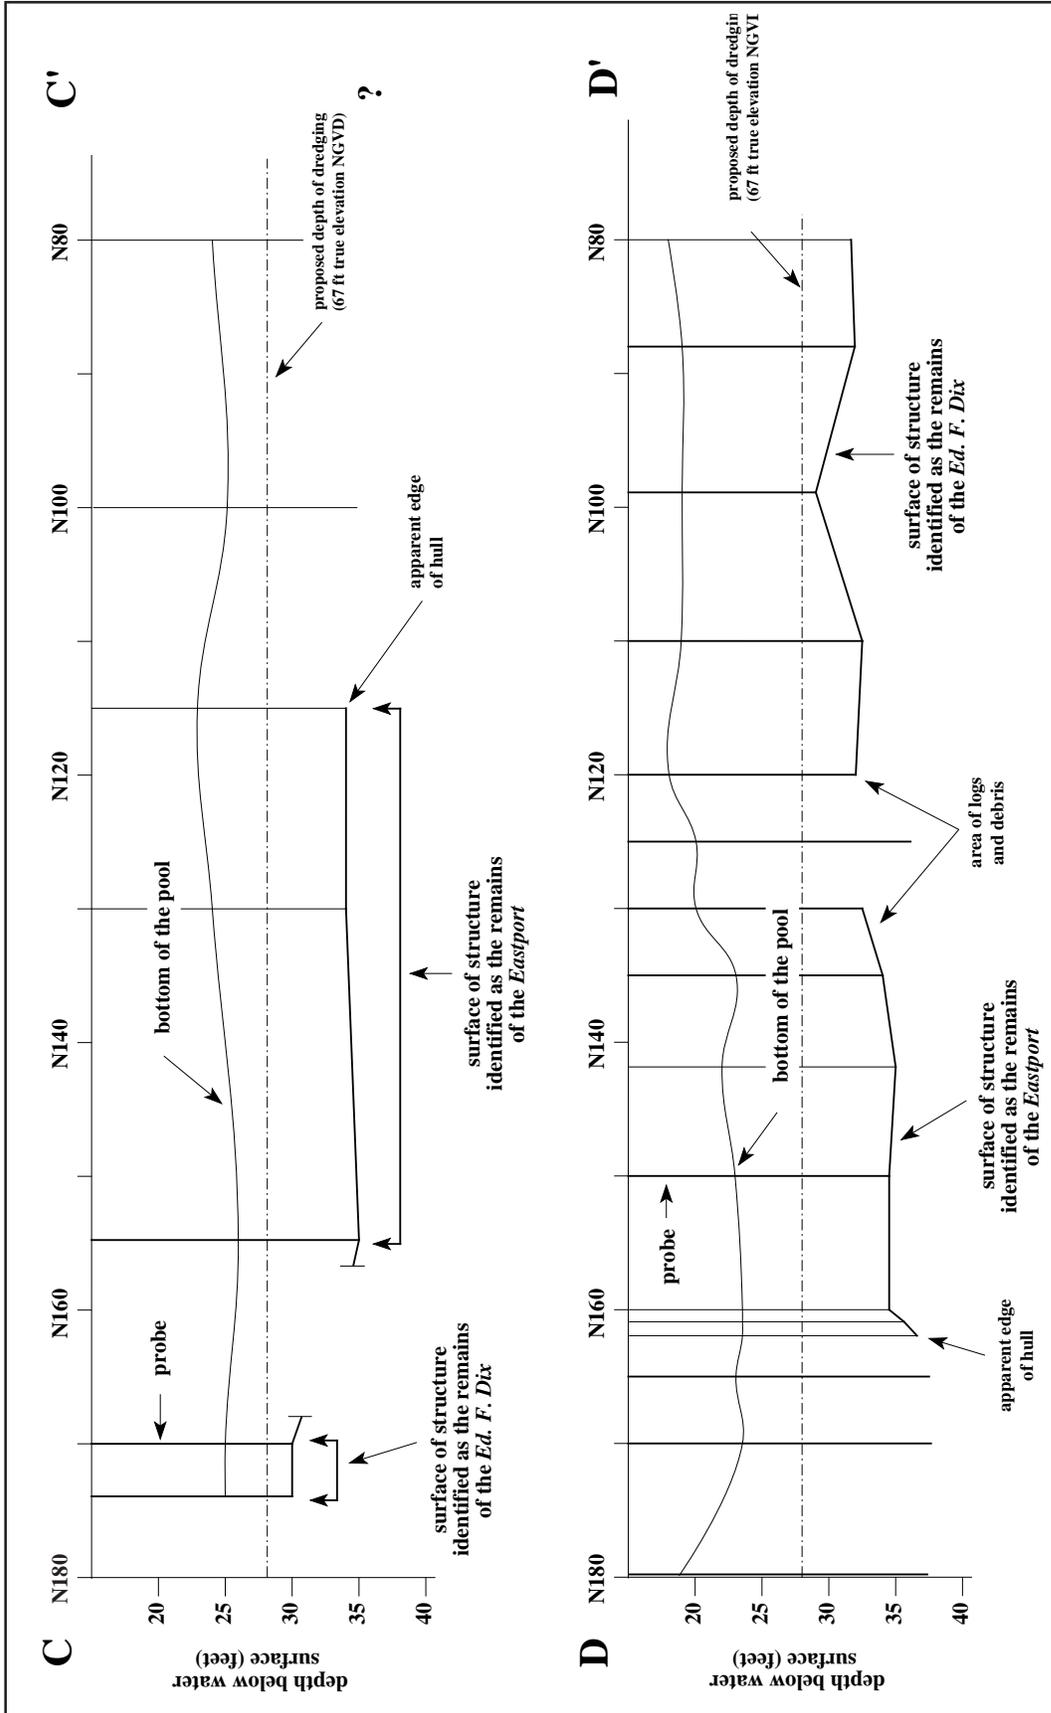
Figure 4-17. North-south profiles showing the interpreted results of the hydraulic probing. See Figure 4-15 for profile locations.

Figures 4-16 and 4-17 presents a series of profiles of the hydraulic probe data taken across selected transects. The locations of these profiles are shown

in Figure 4-15. All of the profiles clearly demonstrate the consistent differences in elevations of the two buried features thought to represent boat remains, even though the difference is on the order of only a few feet. Evaluation of these profiles and the plan map developed from the probing led to the presumption that the vessel extending in a north-south direction across the pool was the steamer *Ed. F. Dix*, and that it lay on top of the remains of the *Eastport*, represented by the structure lying in an east-west direction. As shown in the B-B' profile, the intact portion of the structure identified as the *Ed. F. Dix* measured about 30 ft across. Additionally, subsequent probing across the presumed wreck of the *Dix* in the vicinity of profile A-A' (see Figure 4-16) indicated that a level surface existed in this area and that it sloped down toward the east. This level surface was believed to be a deck, probably the main deck of the steamboat. Because the deck was tilted down toward the east, it was difficult to distinguish between the structures where the east side (e.g., the lower side) of the wreck of the presumed *Dix* rested on top of the presumed *Eastport*. The west side of the identified *Dix*, however, seemed to be tilted up such that it was 3 to 4 ft higher than the surface identified as the *Eastport*, making it much easier to distinguish between the two wrecks at this particular location.

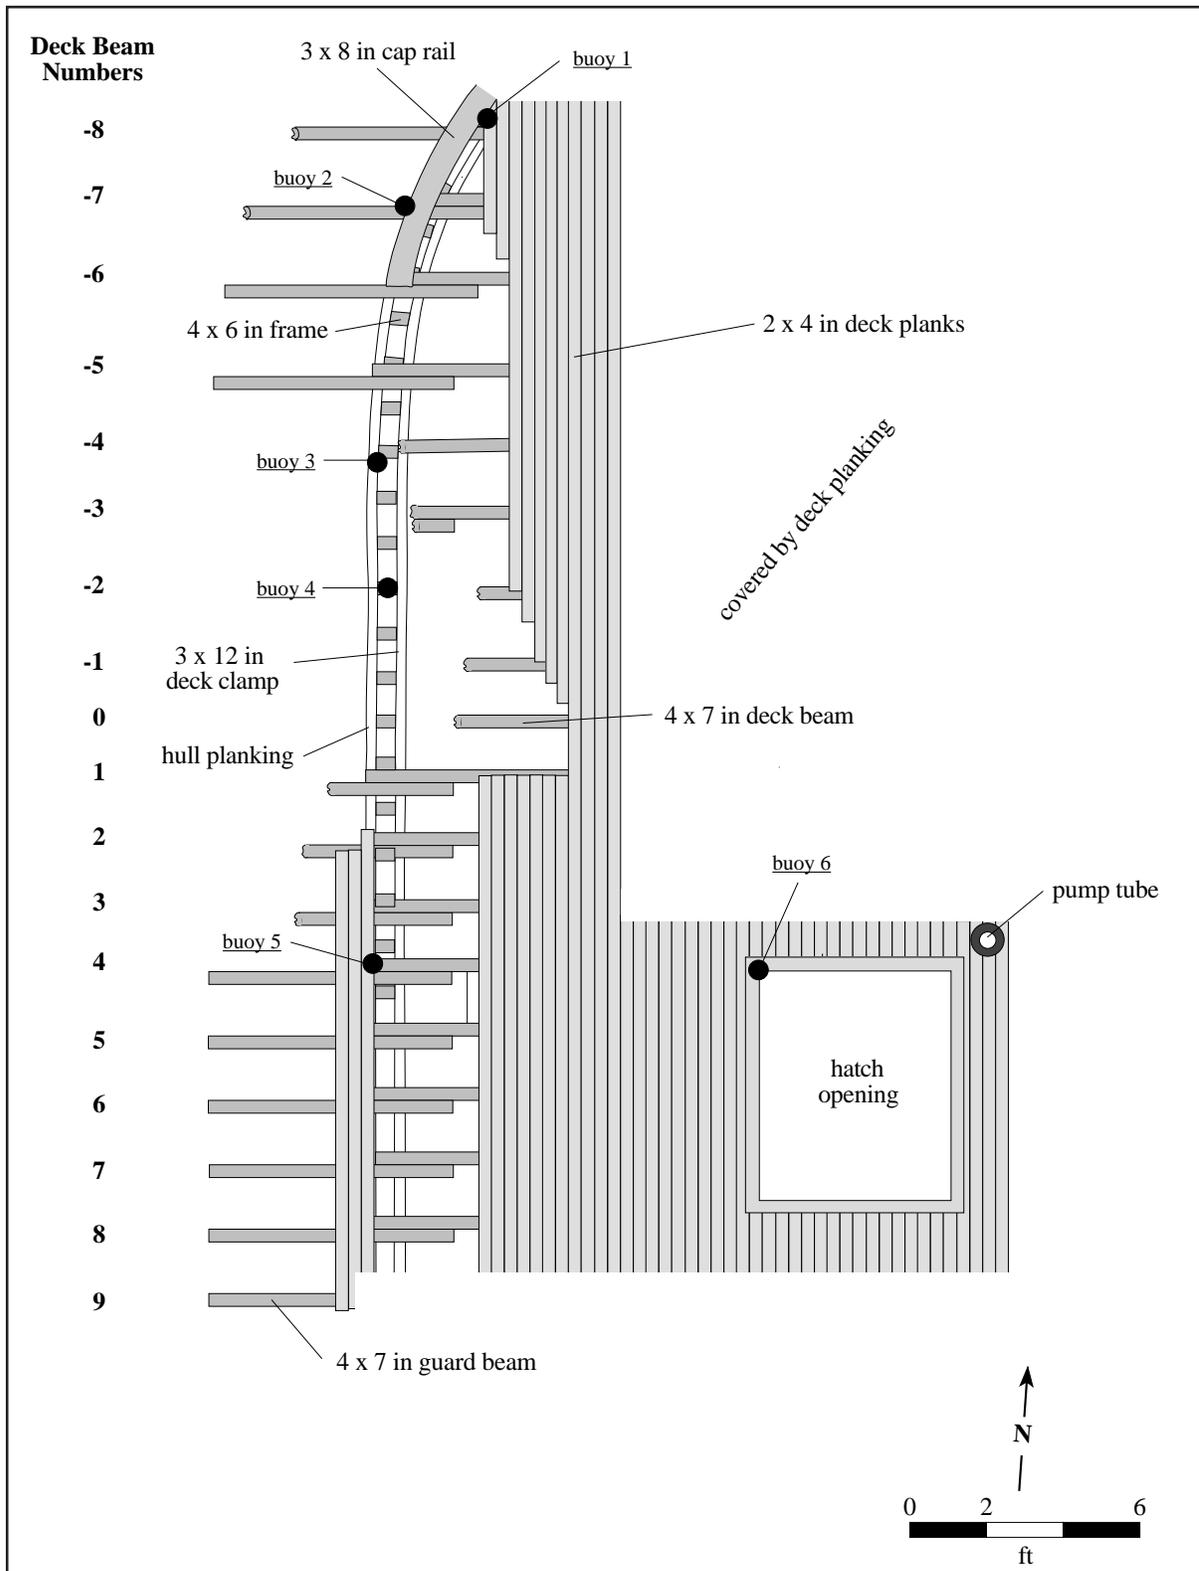
Figure 4-18. Plan of the mapped remains of the *Ed. F. Dix*.

Ultimately, a considerable portion of the portside, forward main deck area and hull of the steamboat *Ed. F. Dix* was uncovered and recorded. As shown in Figure 4-18, the structural elements found in this area were, for the most part, intact and articulated. Initial excavations were concentrated along the port edge of the hull and here were exposed the upper portion of the hull planking, frames, deck beams, guard beams (or "sponsons"), and planking of the main deck. Later, as excavations were extended to the east across the main deck, a hatchway was found and excavations were continued down into the hold of the boat. The first deck beam encountered and identified by divers was designated Deck Beam 0, and the other beams were numbered consecutively from this point; those to the north were assigned a negative number, while those to the south were given a positive number, as shown in Figure 4-18. This numbering system was instituted simply for convenience.

Where present, guard beams are attached to the aft side of deck beams and extend inboard of the hull for 24 in (see Figure 4-18). The guard beams are nailed to the deck beams with 7-in-long spikes, as revealed by portions of three guard beams that were recovered. Like the deck beams, the guard supports are constructed of white oak and are set into notches cut into the upper deck clamp and the upper strake of hull planking (see Figure 4-19). On several of the guard beams, a round iron drift bolt (or drift pin), measuring approximately 0.75 inches in diameter, was found extending down through the beam and into the underlying deck clamp. It is assumed that all of the beams had similar fastenings, plus, it is possible that drift bolts also attached the deck and guard beams to the upper hull plank, although this was not observed by divers. Commonly, the guards on steamboats sloped inboard slightly,

Structural elements of the hull of the *Ed. F. Dix* consist of upright frames (also called futtocks or ribs); horizontal floors, exterior hull planking, interior ceiling planking, several longitudinal timbers or “stringers,” interior stanchions and a bulkhead (see Figures 4-18 and 19). The frames on the *Dix* are composed of white oak timbers measuring 4 by 6 inches in section. Spacing between frames is approximately 10 in (see Figure 4-18). The tops of all of the frames that could be mapped are cut off flat and are flush with the top edge of the upper strake of hull plank, except where frames are crossed by deck and guard beams. In these instances, the tops of the frames are cut off or notched out like the upper strake to accommodate the beams. One complete frame piece from the vicinity of Buoy 4 (see Figure 4-18) was recovered. This piece (Artifact 52) measures 33 in long and represents only the upper end of the frame, or what would be called the first futtock (see Figure 4-19). This frame piece shows a slight curvature, characteristic of those found near the bow and stern of steamboats to accommodate the curvature of the hull in these areas. The frames found along approximately the central one-third of the hull of a typical western river steamboat would have been relatively straight. It was difficult to accurately measure the shape of the in situ frames found on the *Dix*, but it appeared as if most were slightly curved, suggesting that the straight sided portion of the boat (the “dead flat” area) was farther aft.

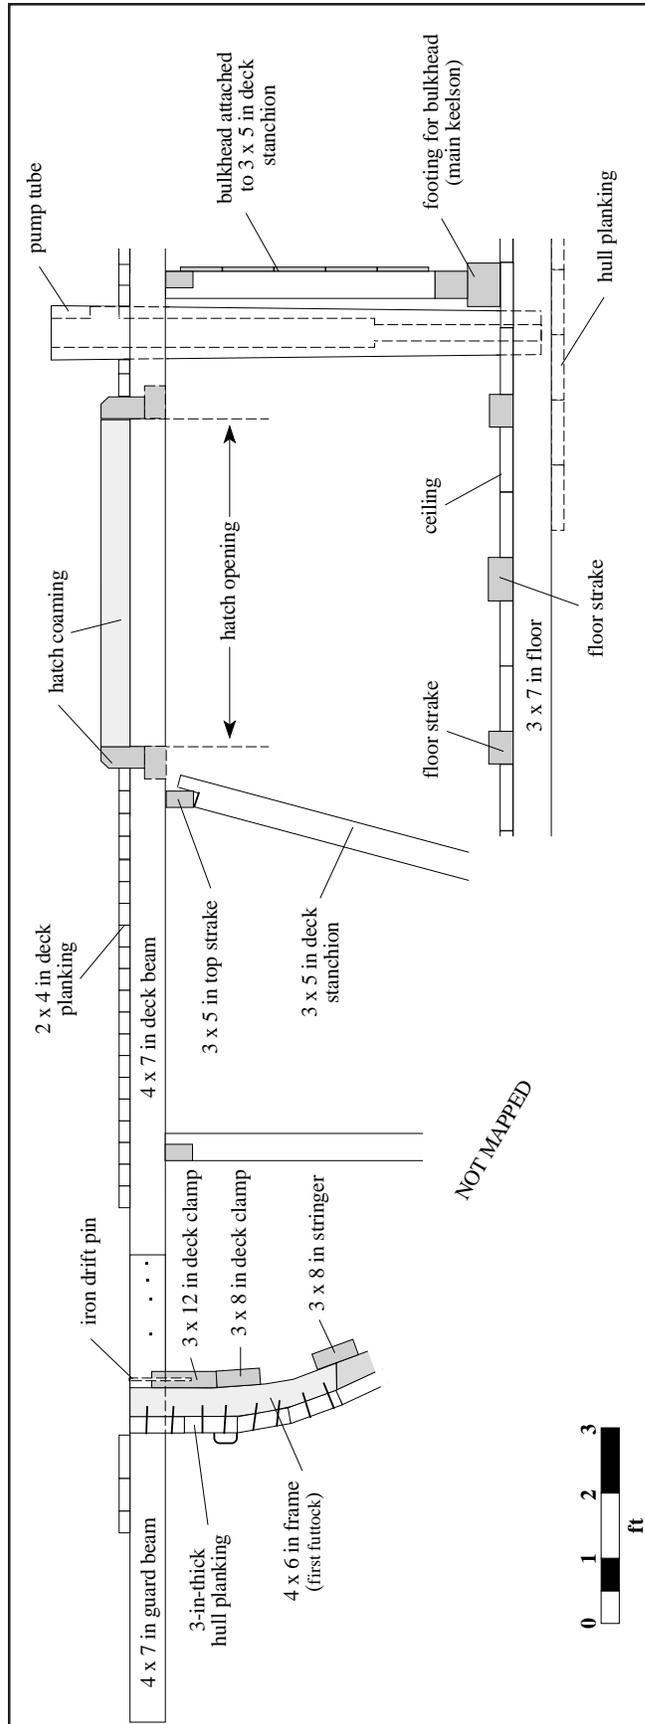
Figure 4-19. Cross section of the hull of the *Ed. F. Dix* at the forward end of the hatch opening (at Deck Beam 4).

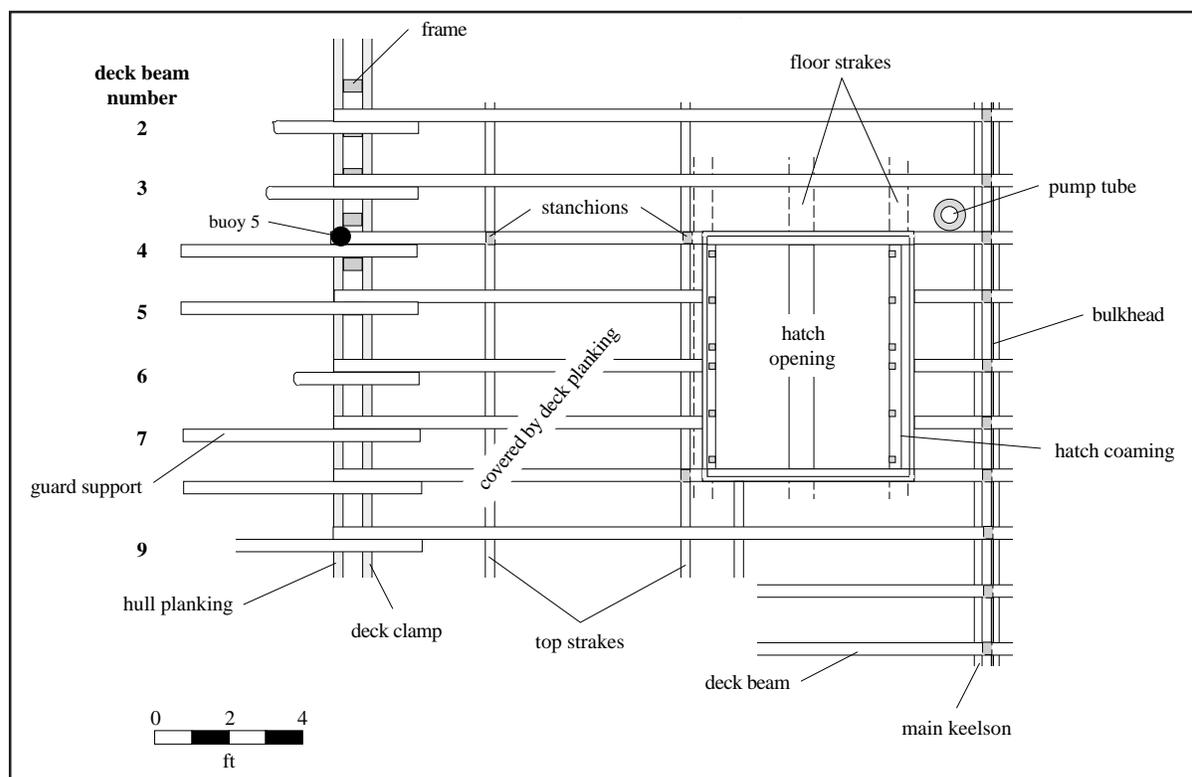
Figure 4-20. Plan view of the internal features of the *Ed. F. Dix* mapped in the area of the hatch opening.

The hatch opening itself measures 5 ft wide (athwartship) by 6 ft long (fore-and-aft) and is surrounded by a coaming rising about 3 in above the deck. The exterior rim of the hatch coaming is beveled and a series of rectangular notches are cut into the interior of the port and starboard coaming pieces, as shown in Figure 4-20. These notches, identified as strongback mortises, were to accommodate bat-

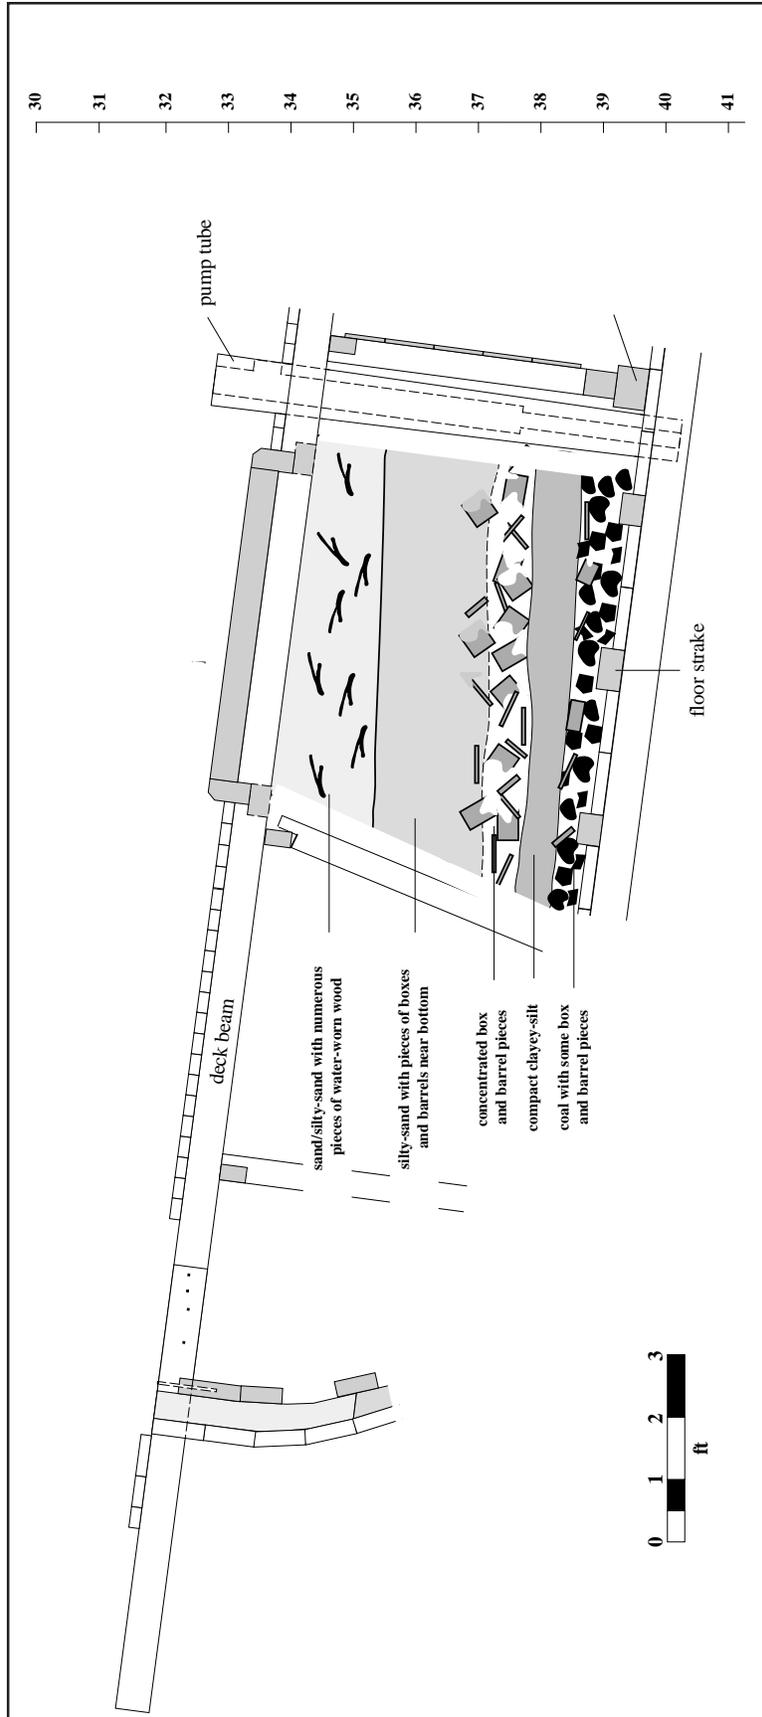
Figure 4-21. Profile along Deck Beam 4 of the *Ed. F. Dix* showing angle of list and the stratigraphy recorded in the hold below the hatch opening.

The top of the hatch opening is located at about 34 ft below the water surface. The upper 18 in or so of fill within the hold consisted of a stratum of fairly loose sand and sandy silt containing numerous pieces of sticks, tree branches, and small logs, as well as leaves (see Figure 4-21). Most of the pieces of wood appeared to be heavily water worn. This material was probably deposited as a sandbar was developing around the wreck, or soon after one had formed, and when swirling water could carry sand and river debris into the hold. Evidence for a sand bar forming around the wrecks was found elsewhere on the site. For example, a fairly thick stratum of medium

As recorded in the excavations through the hatch, beneath this sand deposit is a stratum consisting of hard-packed silty sand. This deposit extends from about 35.5 ft to 37.5 ft below the pool surface (see Figure 4-21) and is presumed to have accumulated prior to the formation of a sandbar on the wrecks, at a point in time when the remains of the *Dix* were exposed directly to the force of the Red River's current. It is impossible to estimate how long it took this deposit to form. Although it could have taken several years for this stratum to accumulate, it is more likely that it was formed within a much shorter period of time, possibly a matter of months, if not weeks. Also, it is believed that deposition of this stratum began very soon after the sinking. This rapid filling of the hold of the boat is assumed because of the very heavy sediment load carried by the Red River. A number of disarticulated pieces of wooden boxes and barrels were found in the lower couple of inches of this stratum. These containers represent some of the cargo carried by the *Ed. F. Dix* and, based on stenciled lettering on several fragments, most held United States government stores consisting of foodstuffs such as pilot bread (hard tack), flour and beans.

The hard-packed stratum of silty sand was underlain by a layer composed almost entirely of these container remains. This bed of concentrated box and barrel pieces was almost 1 ft thick (see Figure 4-21). Many of the container parts were disarticulated, probably meaning that water swirling around in the hold soon after the sinking had broken them up. However, it was also apparent that some of the boxes were intact and possibly in place, stacked one on top of the other. The box remains were thoroughly saturated and extremely fragile and it was very difficult in the zero visibility conditions to remove them intact. Ultimately, however, large portions of several boxes were recovered. These containers are discussed in detail below.

Immediately below the stratum of concentrated box parts was a fairly thin lens of compact silty clay (see Figure 4-21). It is possible that this was not a continuous stratum, but rather a small deposit of clayey material, because it was not noted by all of the divers when excavating at this depth. The origins of this stratum are unknown, although it had to have been deposited very soon after the sinking, before the cargo began to shift around within the hold.

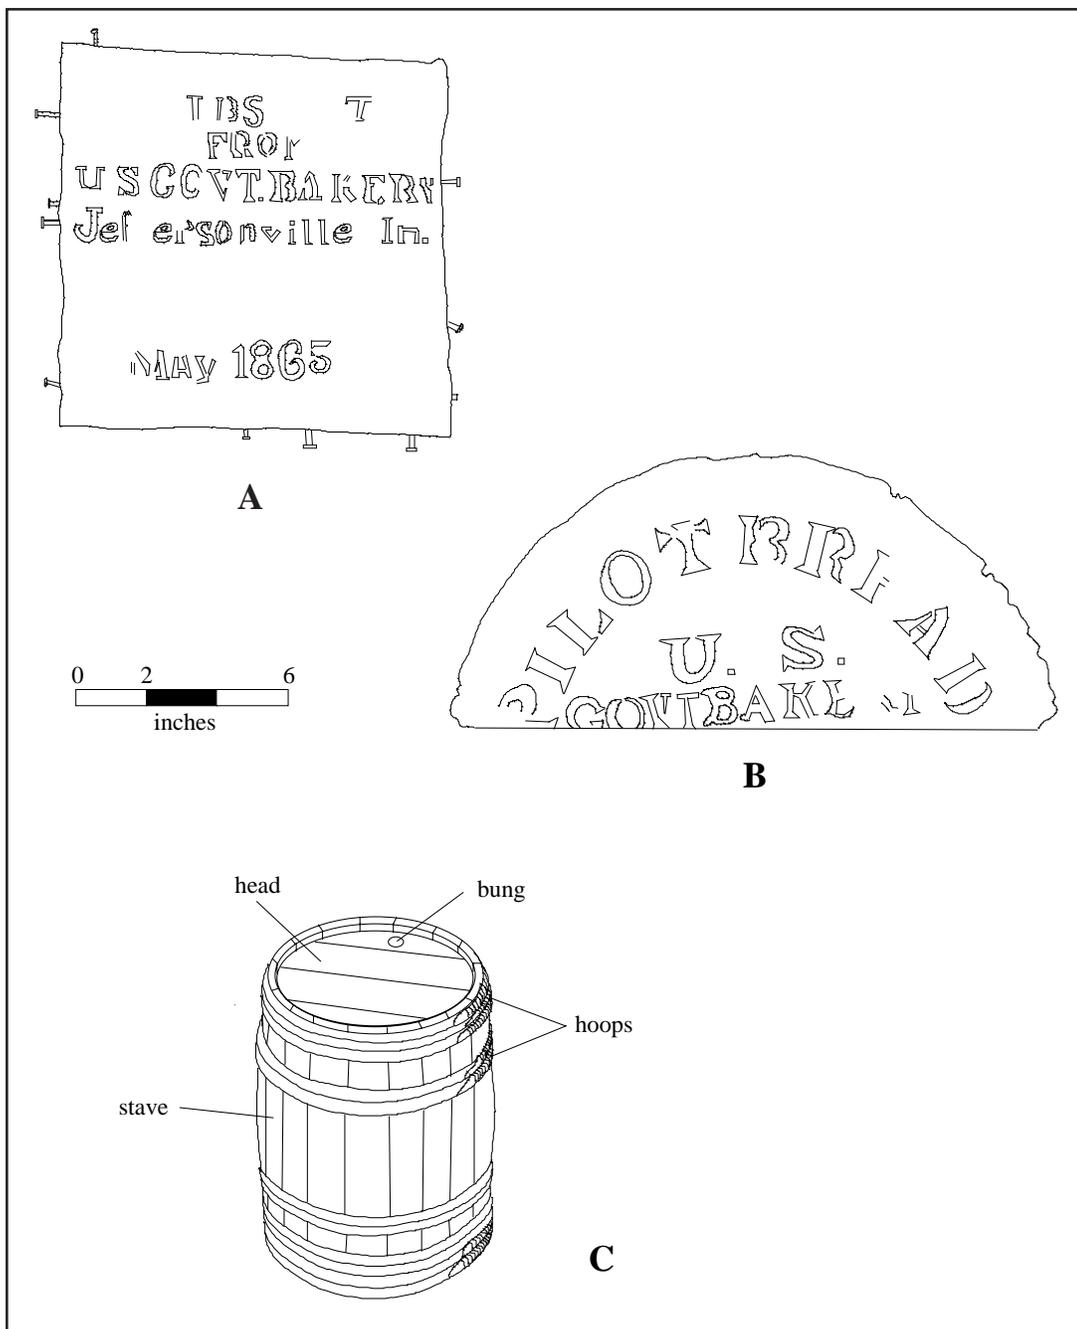
Figure 4-22. Container pieces recovered from the *Ed. F. Dix*. a. end of a box from the Jeffersonville Quartermaster Depot; b. piece of head of a barrel that contained pilot bread (hard tack); c. typical cask of the type carried by the *Ed. F. Dix*.

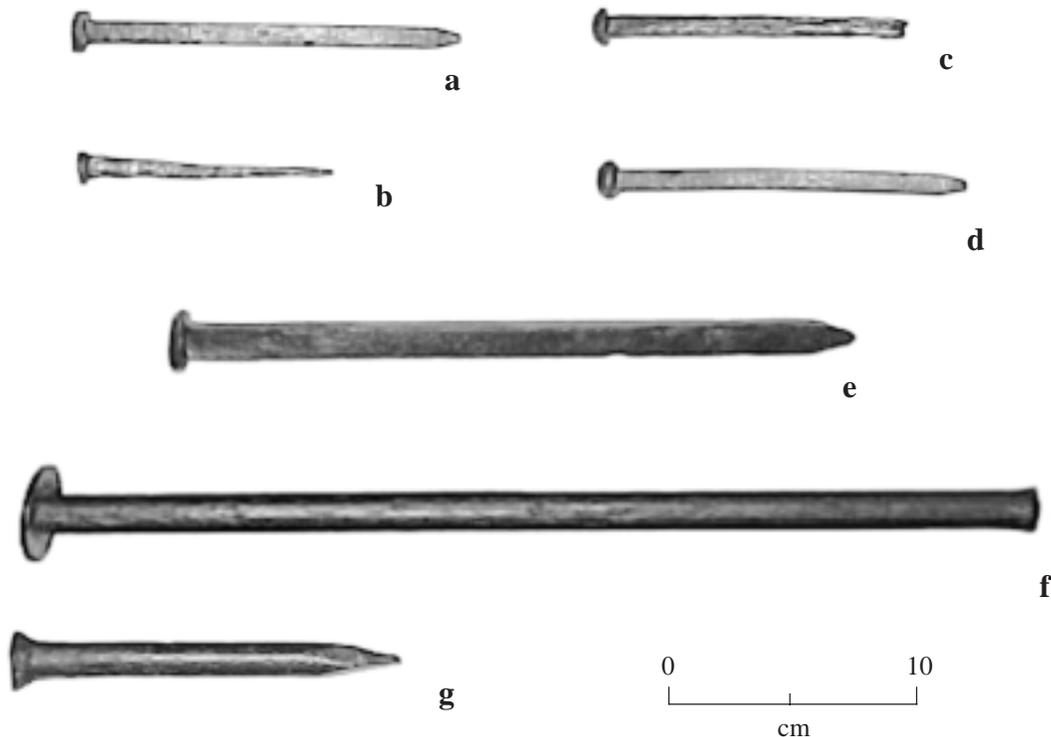
Figure 4-23. Examples of fasteners recovered from the *Ed. F. Dix* and *Eastport*. a) Hull plank spike from the *Ed. F. Dix*; b) machine-made nail from the *Eastport*; c-d) “Boat spikes” from the *Eastport*; e) Large spike from the *Eastport*; f) Drift bolt with “clinch ring” from the *Eastport*; g) “Chisel-pointed” rivet from the *Eastport*.

Although none were removed, 7-in-long (17.9 cm) spikes were used to attach the outboard guard beams to deck beams. These spikes have square shanks that are just slightly thicker than the hull plank spikes noted above.

These spikes, certainly the larger ones, are probably too thick to have been cut from a flat iron plate by machine, as smaller nails were at the time the *Dix* was constructed. Spikes of this size were commonly

made from bar stock of the appropriate thickness which was, first, cut into the desired length, then hammered on two sides to achieve a tapered point and hammered on the top of the other end to form the head. By the time the *Ed. F. Dix* was built in the 1860s, the manufacture of spikes, like nails, was largely done by machine.

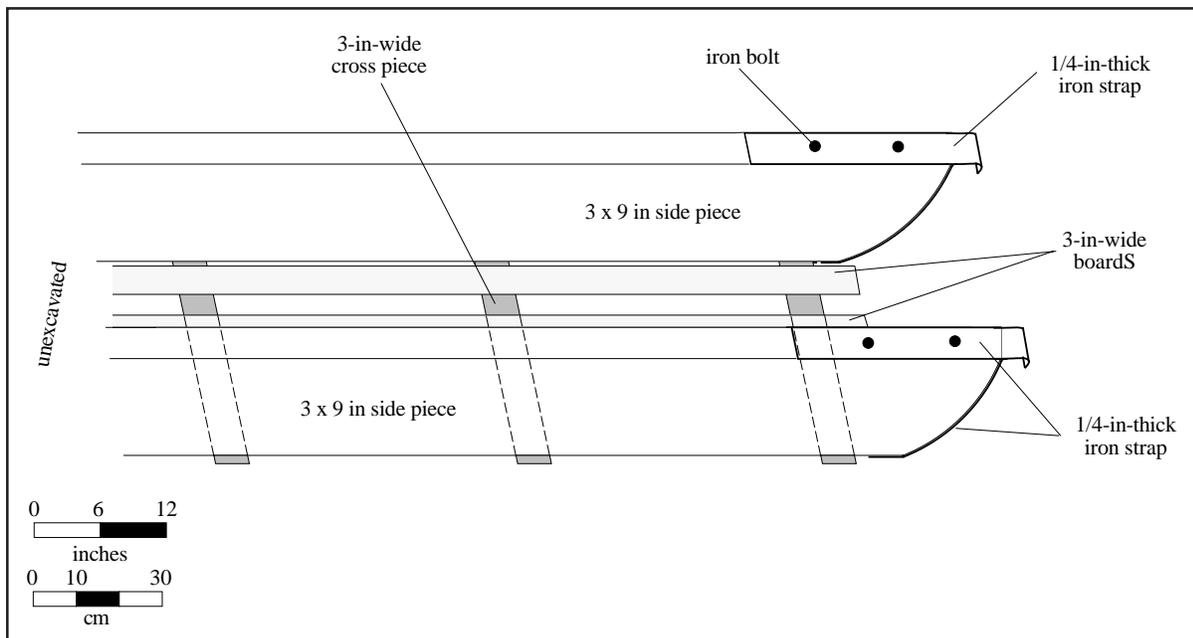
Figure 4-24. Possible loading ramp found in the hold of the *Ed. F. Dix*.

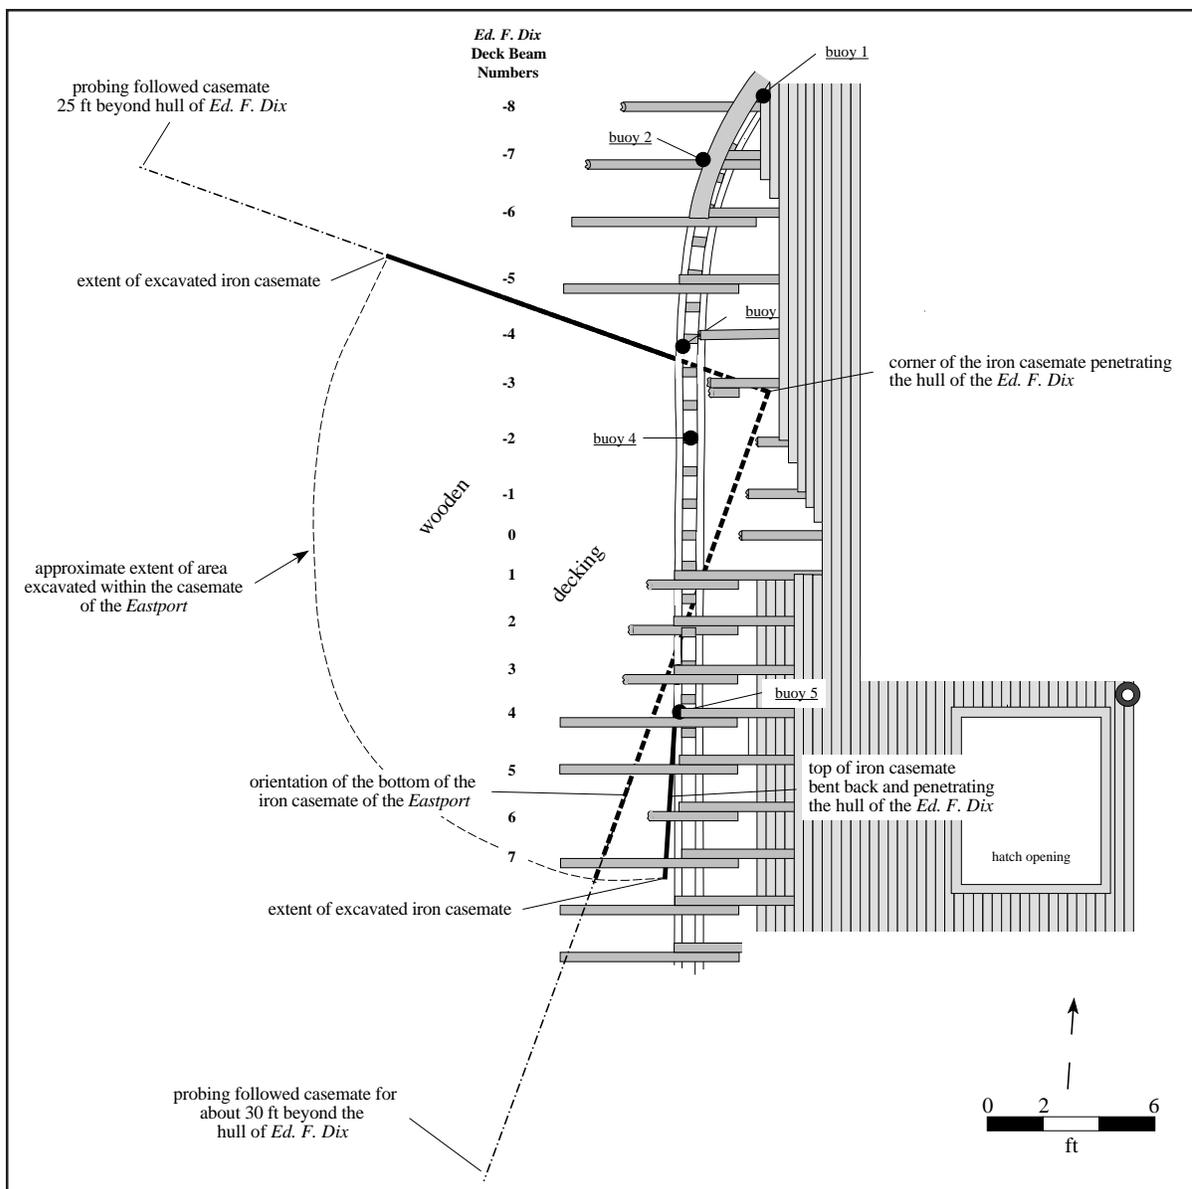
Figure 4-25. Plan view of the mapped remains of the *Ed. F. Dix* shown resting on top of the armored casemate of the *Eastport*.

to collapse and sand began to continuously flow into cleared areas. Eventually, excavations had to be halted because of the danger created by inflowing sediment. Divers were able to expose about 15 ft of both lines of armor plating and approximately 100 square ft of intact decking which lay between the two lines of plates (see Figure 4-25).

cause the hull of the *Dix* prevented any probing on the outside (i.e., to the east) of the line of armor. Like the plates in the east-west line, some were overlapping, believed to be the result of displacement and twisting. In fact, as shown in Figures 4-25 and 4-26, most of the vertical plates exposed along the north-south line of armor were bent toward the east at a considerable angle; probably as a result of the collision of the *Ed. F. Dix*. As noted, several of these vertical iron plates were found to have penetrated completely through the hull of the *Dix*.

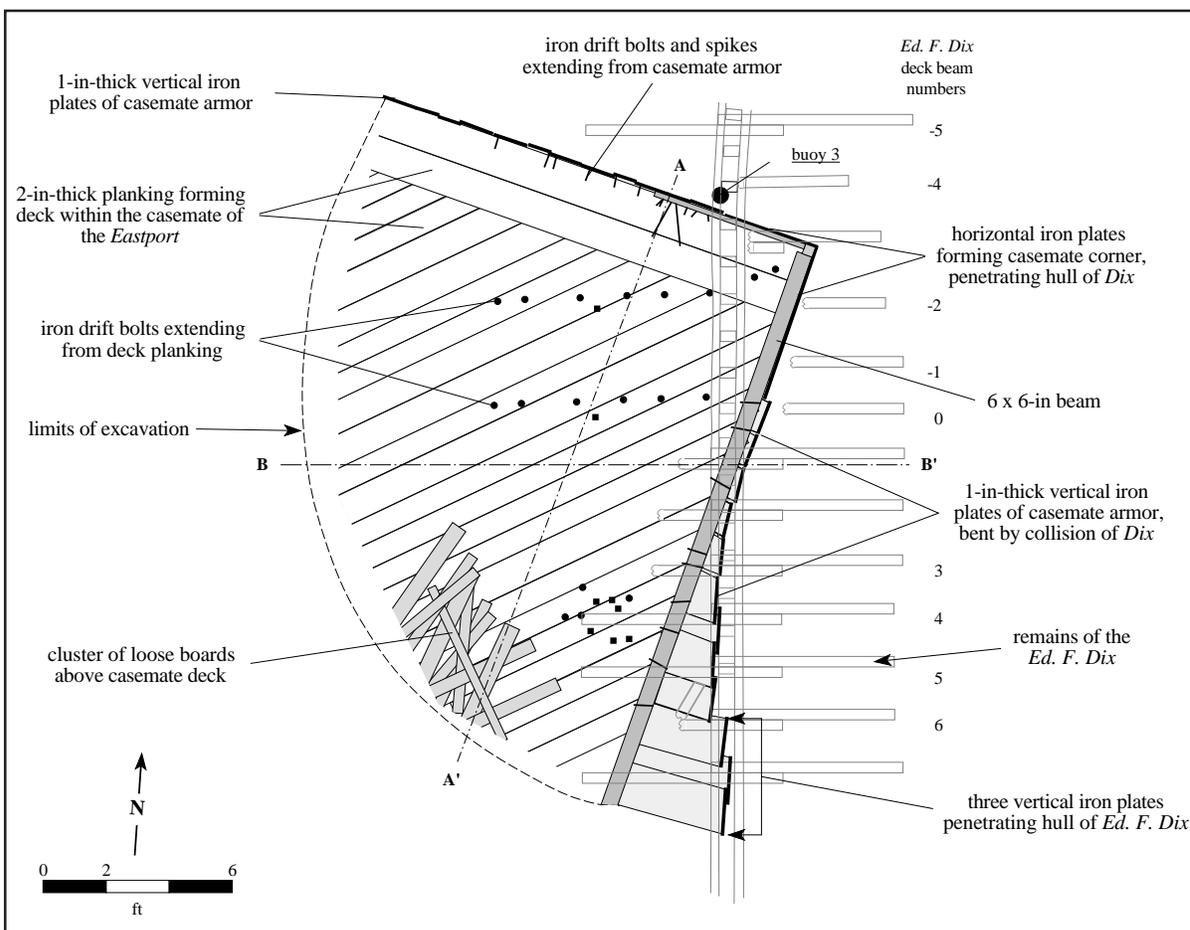
Figure 4-26. Plan view of the features excavated within the casemate of the *Eastport*.

As excavations extended under the *Dix*, it was found that the iron plates in the corner produced by the two lines of armor were attached in a horizontal, rather than vertical position. The horizontal plates in the east-west line of armor were estimated to be about 3 ft long and 8 in wide; those in the north-south wall are the same width, but closer to 4 ft long (Figure 4-26).

Two, 6-x-6-in timbers were found attached to the base of the north-south (forward) casemate wall, as shown in Figures 4-26 and 4-28. These timbers extend across the entire area excavated, and they may continue across the entire width of the casemate. Several iron spikes and/or drift pins extend out from these timbers, some as far as 6 to 8 in, meaning that at least this thickness of wood is missing. It was along this forward casemate wall that several plates of armor were found penetrating the hull of the *Ed. F. Dix*. As shown in Figure 4-28, immediately below Deck Beam -1 armor plates penetrated through the hull of the boat, producing a fairly large hole, and extended into the hold of the steamboat several inches. Other iron plates just forward of this point extended even farther into the hull of the *Dix*.

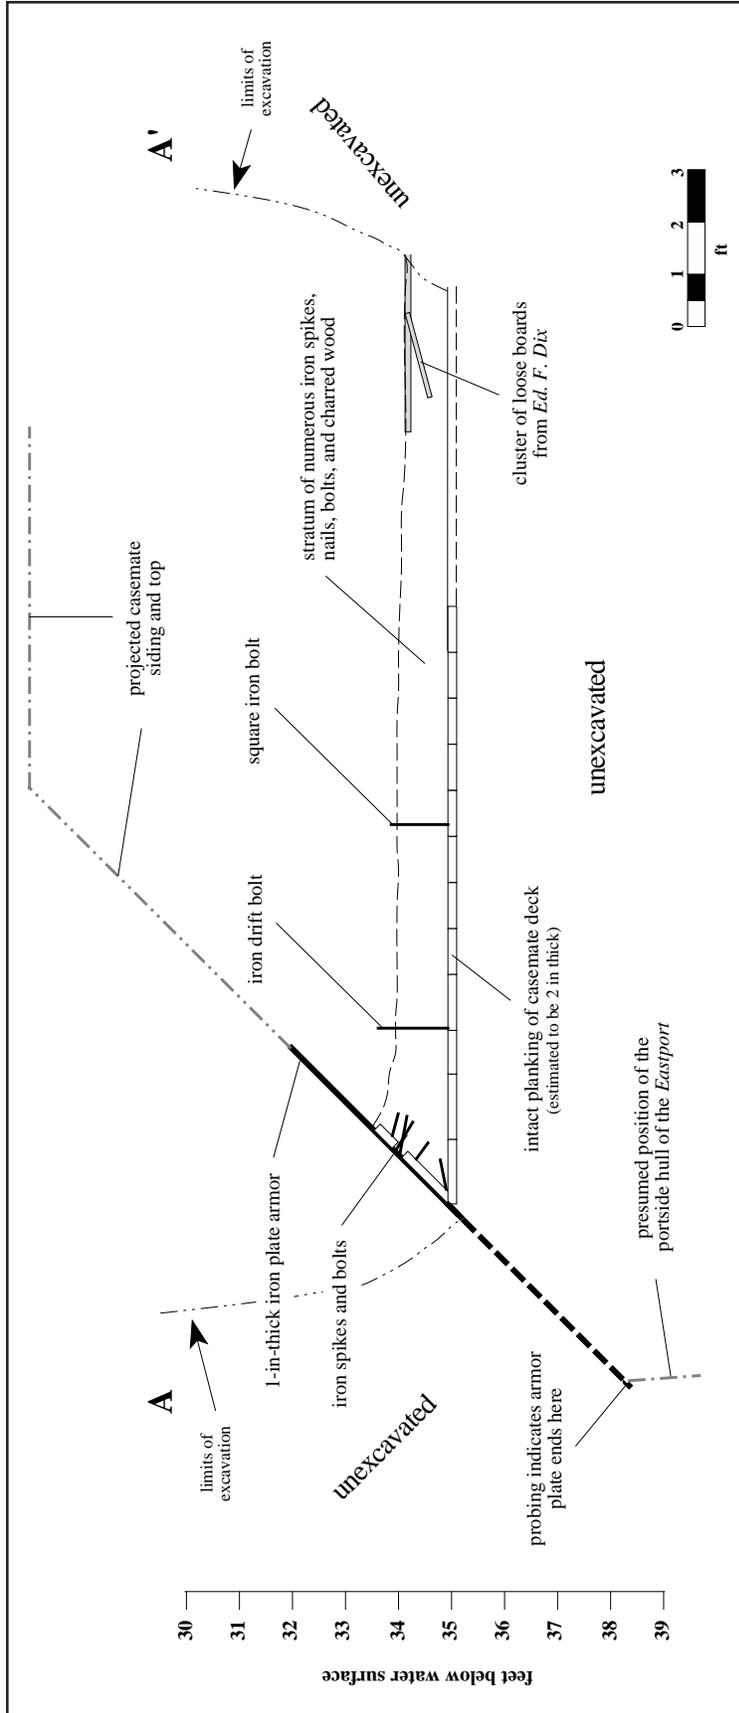
Figure 4-27. Thwartship cross section of the excavated portion of the casemate of the Eastport, looking toward the bow. See Figure 4-26 for location of section.

Just above the level of the intact deck, some of the wooden structure of the casemate that served as support and backing for the iron armor is preserved. As shown in Figure 4-27, remnants of horizontal, 2-in-thick boards are still attached to the east-west line of iron armor (i.e., the portside casemate wall) just above the intact deck. These planks felt burned in places and are extant only at the eastern end of the wall of armor plating. However, numerous iron spikes and drift pins project from the armor plating toward the interior of the casemate (see Figures 4-26 and 4-27) indicating the former existence of wooden framework and backing for the armor along the entire section cleared. All of these spikes are located within a foot or so of the deck, beneath the top of the stratum of burned construction debris. Similar spikes and drift pins would have existed above this level, but these all have been displaced by the explosion and/or the burning. Some were probably hurled away from the

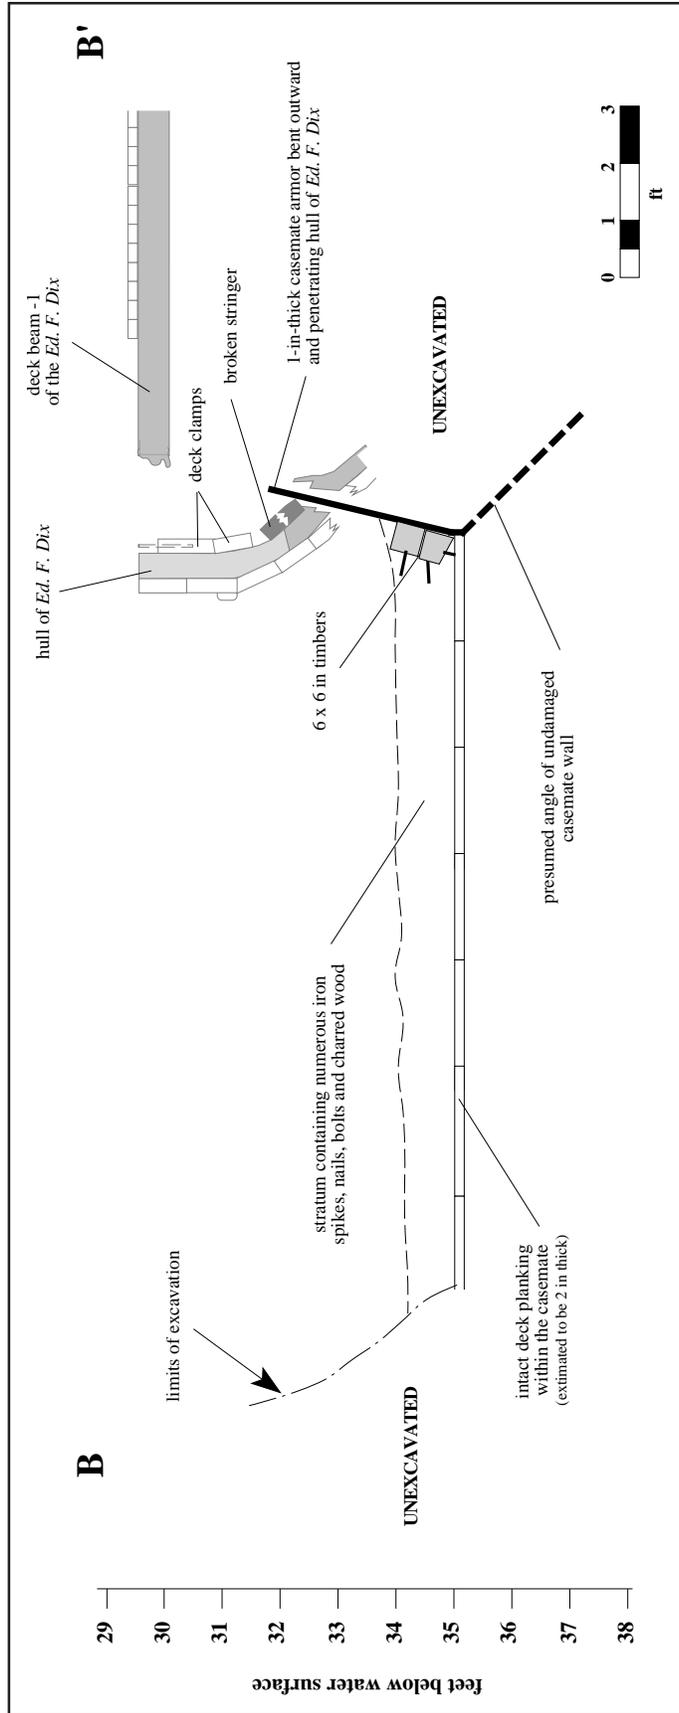
Figure 4-28. Fore-and-aft section of the excavated portion of the casemate area of the *Eastport* showing the armor plate of the forward casemate wall penetrating the hull of the *Ed. F. Dix*. Looking toward the port side of the *Eastport* and toward the bow of the *Ed. F. Dix* along her port side. See Figure 4-26 for location of section.

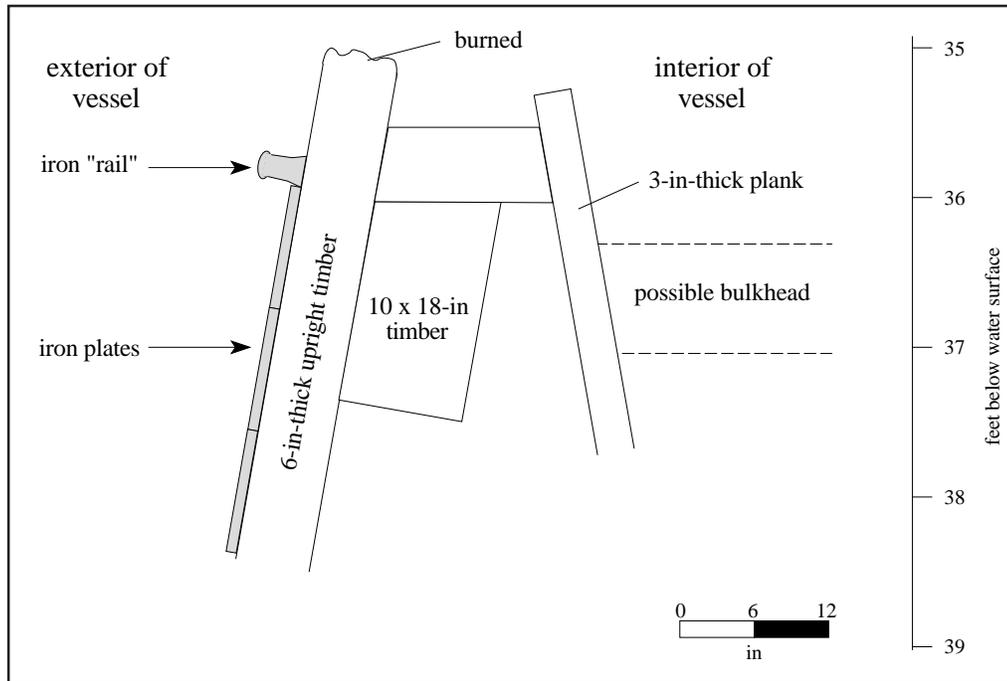
Figure 4-29. Cross section of the structure recorded in Area 2 thought to be at the starboard hull line of the *Eastport*. Looking west toward the stern of the *Eastport*.

At a depth of 34 ft below the pool surface, excavations in Area 2 encountered a number of pieces of 0.5-in-thick, broken and fragmented tongue and groove boards. These boards are identified as pieces of cabin structure from the *Ed. F. Dix* and are believed to be equivalent to the cluster of loose boards found just above the casemate deck in Area 1 (see Figure 4-26). Excavations continued below the boards and at a depth of 35 ft below the surface several large wooden timbers, plus pieces of iron were encountered. By this time, the excavated area was continually filling, and the re-digging was expanding the hole toward the south and east such that these timbers and iron were later found to be located at grid coordinate N117/E118, several feet away from where the excavations had started (see Figure 4-14). Eventually, divers were able to clear an area about 5 ft across at this point and an effort was made to record what was found. Several divers examined the cleared structure and all had slightly different interpretations. In general, it appears that the structure exposed consists of several vertical timbers, each measuring about 6 in square and spaced about 8 to 10 in apart with iron plate attached to the south side and wooden planks attached to the north side. The tops of one of the 6-in uprights felt crumbly, as if it was burned. This entire structure slopes slightly toward the north, or toward the interior of the boat, as shown in Figure 4-29. The iron plates are attached on the outside of the boat in a horizontal position, adjacent and parallel to one another. It was roughly estimated that the plates are about 10 in wide and at least 5 ft long, although this length represents the area which could be cleared and the plates extend beyond this. While the measurements of the iron plates are inexact, they appear to be about the same size as those found in Excavation Area 1 on the opposite side of

the boat. Several fasteners, possibly rivets, could be felt protruding from the iron plates. These are spaced about 6 in apart along the long axes of the plates. Two divers reported finding what felt like a “railroad track” or iron “rail” attached horizontally to the outside of the upright frames and near the upper edge of the iron plates; however, others could not find this piece.
