**PROSPECTUS
HORSESHOE LAKE MITIGATION BANK
MVK-2018-663**

ATTALA & MADISON COUNTIES, MISSISSIPPI

Sponsored by:
Horseshoe Lake Land Company, LLC

September 2020

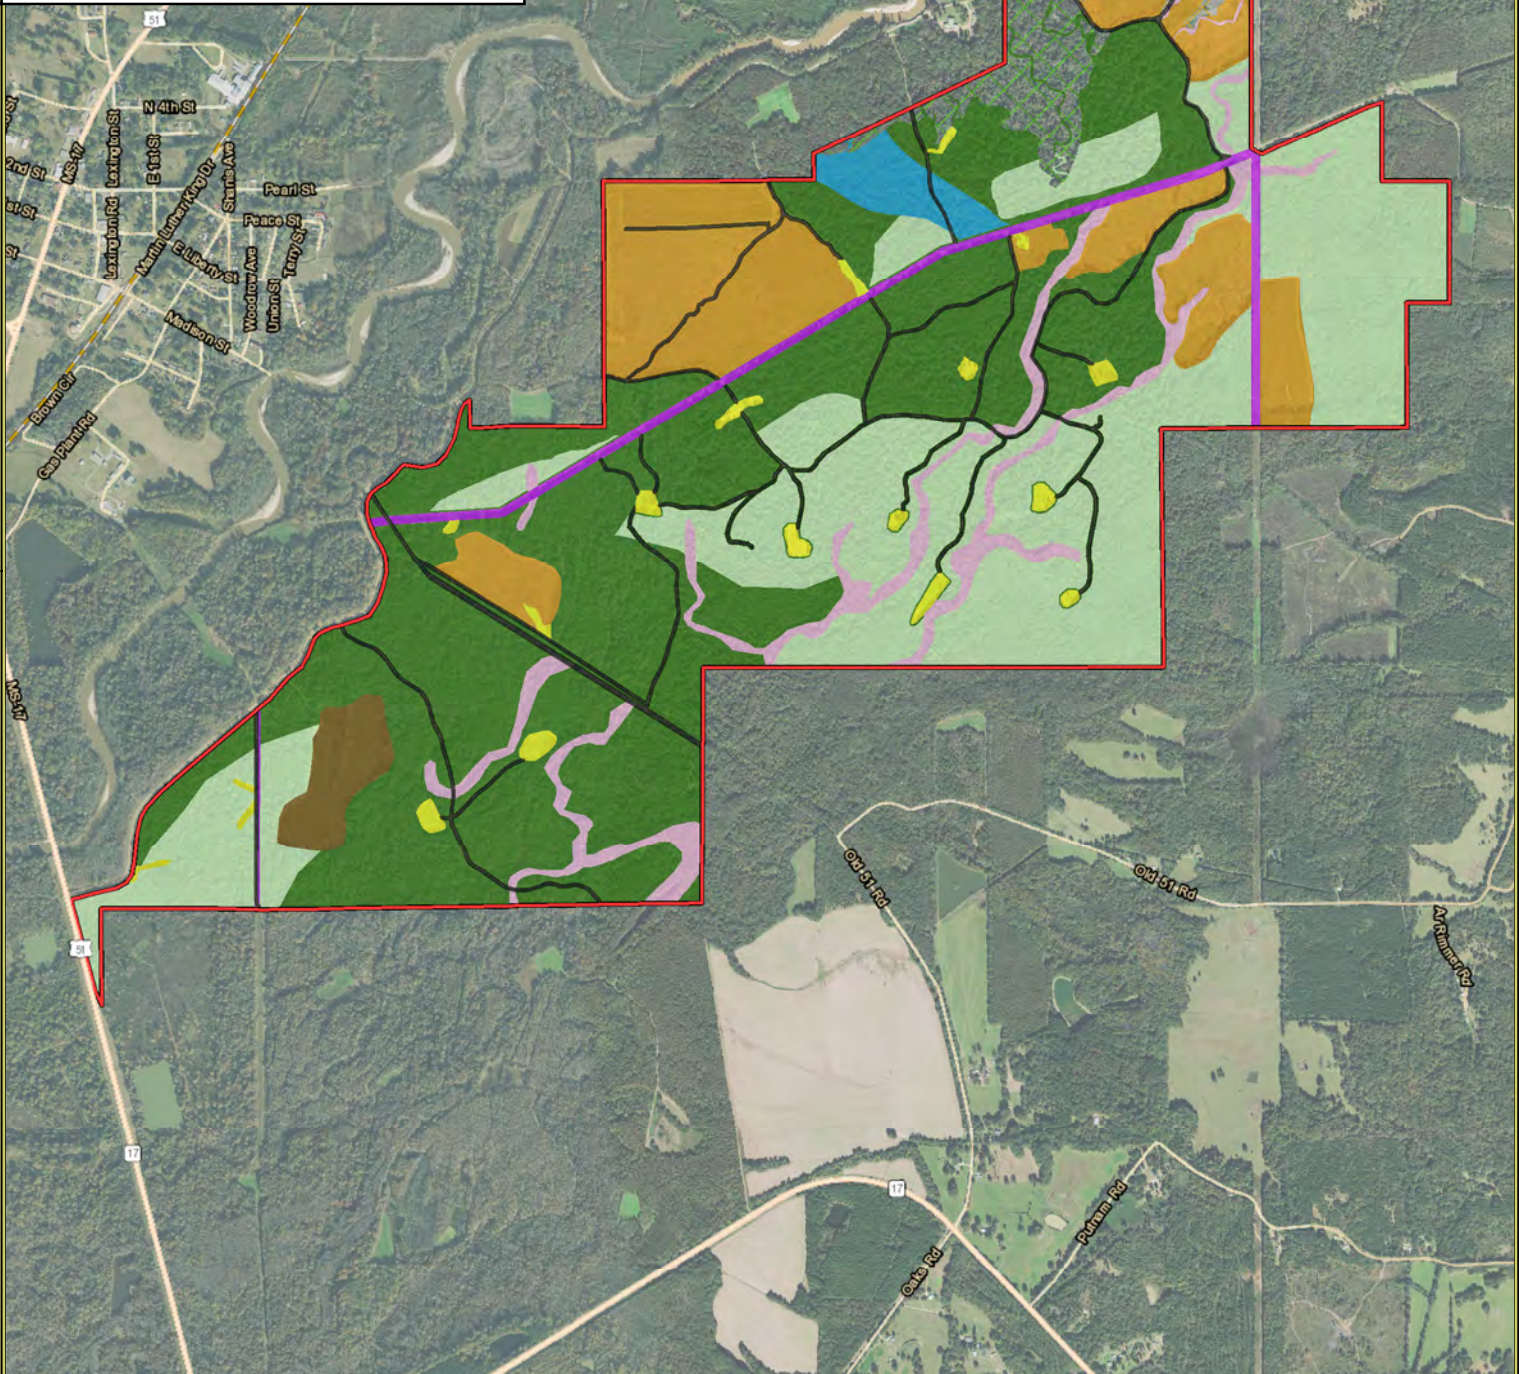
- Legend**
- Horseshoe Lake Boundary (1,677.47 ac)
 - Interior Access Roads (Non-Mitigation) (27.96 ac)
 - Utility Easements (Non-Mitigation) (33.23 ac)
 - BLH Forested Wetlands (490.02 ac)
 - Cypress/Tupelo Slough (86.20 ac)
 - Degraded BLH Forested Wetlands (672.69 ac)
 - Storm Damaged Wetlands (25.46 ac)
 - Emergent Wetlands (21.07 ac)
 - BLH Clearcut Wetlands (28.32 ac)
 - Pine Clearcut Wetlands (223.62 ac)
 - Upland Clearcut (22.05 ac)
 - Upland Hardwoods (45.58 ac)
 - Upland Open Field (1.27 ac)
